Progressive failure of composite wind blades with a shear-web spar subjected to static testing

T Y Kam* and Y H Chiu

Mechanical Engineering Department, National Chiao Tung University
Hsin Chu 300, Taiwan

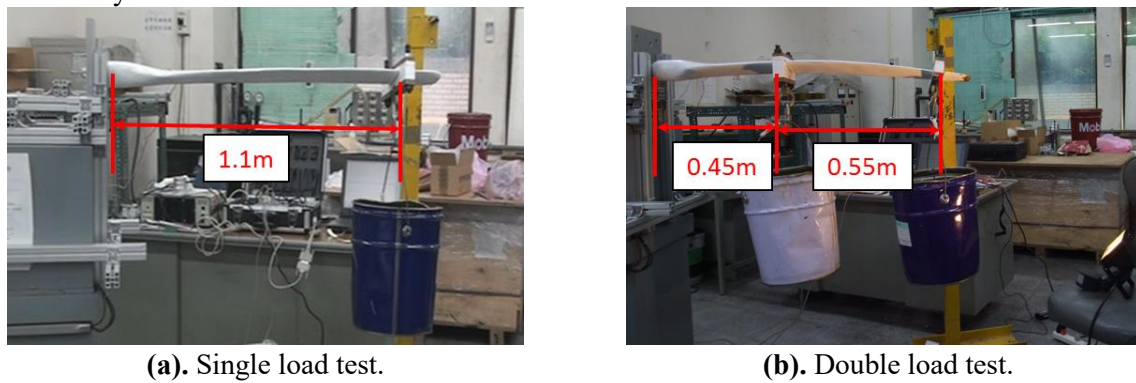
Figure 5. Load-control test of wind blade.

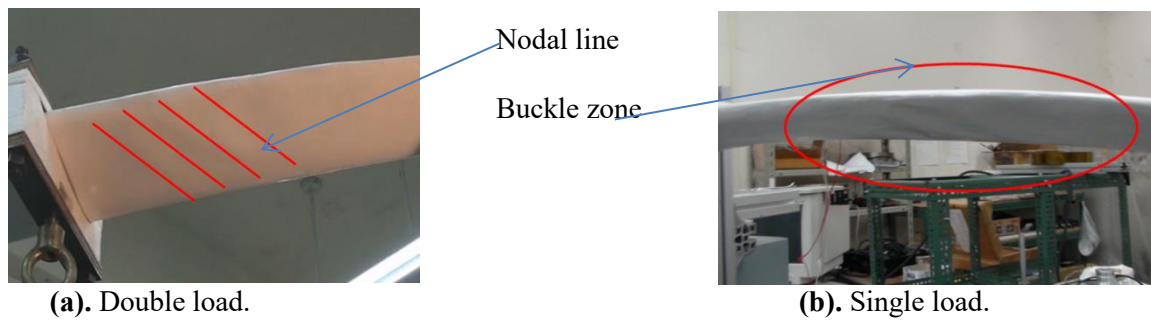
Figure 6. Incipient buckling of blades under load-control testing.

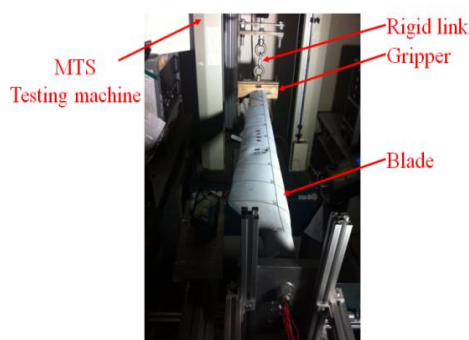
Figure 7. Stroke-control test of blade.

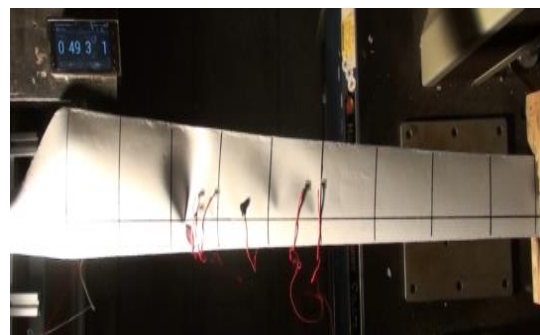
vertical movement of the top end of the link was controlled using the testing machine which was increased incrementally at a speed of 3mm/min. A load cell was used to measure the load associated with the assigned vertical displacement of the link top. The vertical displacements of the link top at different stroke stages together with the associated loads were recorded by a data acquisition system to construct the load-displacement curve. When the blade tip vertical displacement was increased to a certain value, the incipient buckling of the front (top) skin of the blade would occur by inducing a dimple on the skin. The location of the first dimple on the front blade skin and the strains were recorded to determine the incipient buckling load. As the stroke was kept increasing, additional dimples would be developed and a crack would be formed due to the failure of the blade material at the edge of the first dimple as shown in Figure 8. The extension of the crack across the blade skin would finally lead to the total failure of the blade.

Figure 8. Crack developed from material failure.
