Electromigration induced failure in SnAg_{3.8}Cu_{0.7} Solder Joints for Flip Chip Technology

Y-C Hsu, T-L Shao and Chih Chen

National Chiao Tung University

Abstract

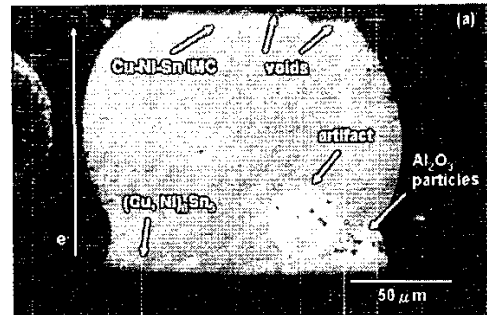
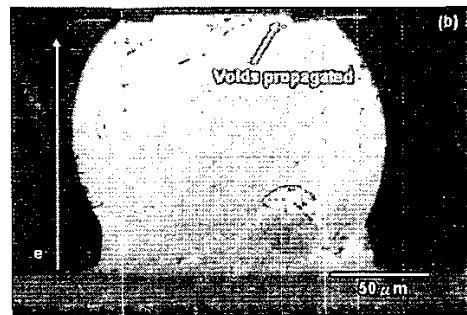
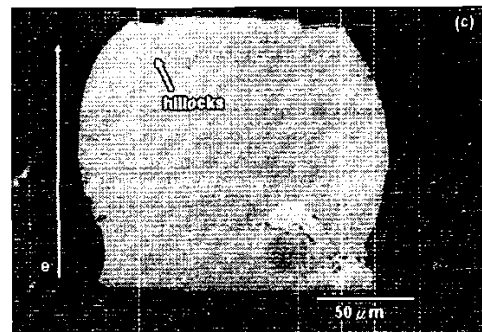
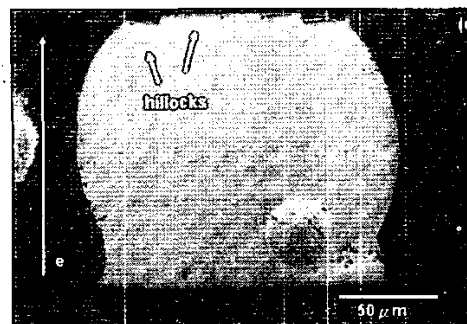
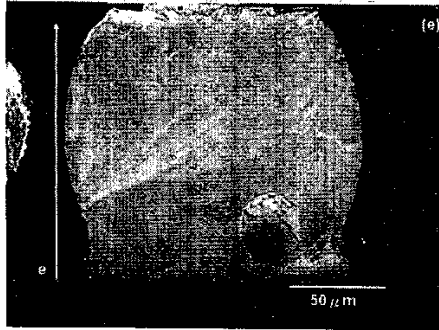
Fig. 2(a) through 2(e) illustrate the electromigration phenomenon in $\text{SnAg}_{3.8}\text{Cu}_{0.7}$ solder bump before and after stressing for 20, 70, 110, 168 hours, respectively. Intermetallic compounds $(\text{Cu, Ni})_6\text{Sn}_5$ was observed at the interface of solder and Ni UBM interface and also in the solder. However it is only a few intermetallic compounds at the interface of solder and Cu UBM. This is attributed to the thickness of Cu at UBM. Cu may almost dissolve into the solder and react with Tin after reflowed.

The direction of the electron flow is from board side Ni UBM toward chip side. The original voids at solder and Cu thin film UBM interface can be observed in Fig. 2(a). Voids propagated as stressing time increased, and hillocks were observed at the left side of the UBM as shown in Fig. 2(b) through 2(d). At Ni thick film and solder interface, voids were only observed at the center of the interface after stressing as shown in Fig. (3). The solder bump was failed after 168 hours stressing, the surface sank and become very rough.

At Cu thin film and solder interface, hillocks and lump were observed. They are due to mass transport by the electron flow. Also the voids can be observed and propagated during current stressing. It is attributed that, in the solder bump, metal atoms were migrated with electron flow from the board side to the left corner of chip side, the more and more metal atoms were accumulated at the left upper corner, and mass transport by metal atoms induced voids concentration gradient at the solder and UBM interface, voids were pushed from the left side to the right side during electromigration. Consequently voids propagated and became crack. Fig. 4(a) through 4(e) illustrate the electromigration phenomenon with opposite polarity before and after stressing of 20, 70, 110, 168 hours, respectively. The direction of electron flow now is from the chip side to the board side. Voids and hillocks were observed at cathode side and anode side, respectively. The voids were propagated as stressing time increased. The solder bump was failed after 168-hour stressing, the surface sank and become very rough.

Fig. 2. Cross-sectional SEM images of the solder bump under the current density of 2×10^4 A/cm² at 100 °C (a) 0hr, (b) 20hrs, (c) 70hrs, (d) 110hrs, and (e) 168hrs

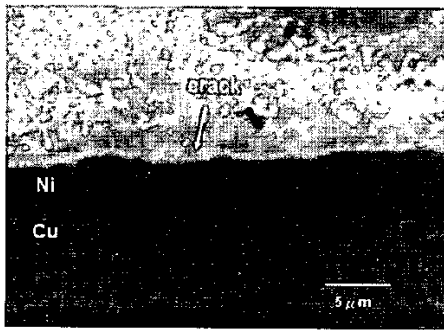
Fig. 3 Cross-sectional SEM image of the solder bump after 168 hrs stressing. Voids were observed at the middle of the interface.

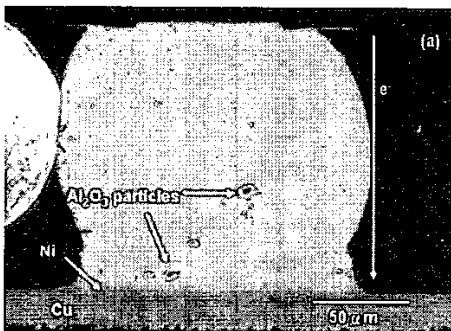
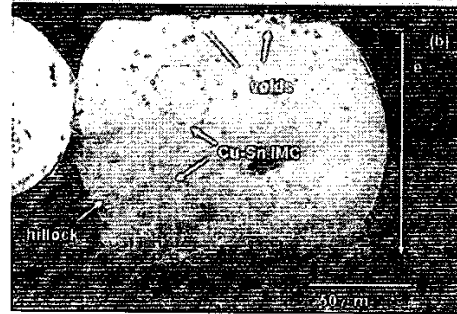
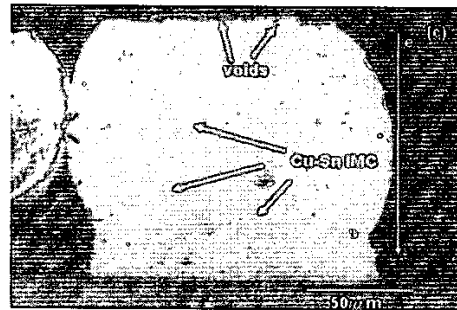
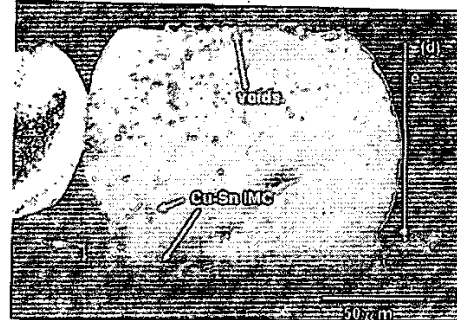
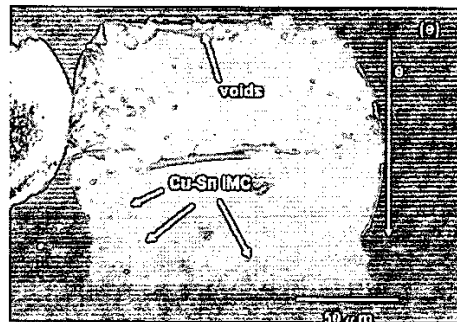
Intermetallic compounds of Cu-Sn and Cu-Sn-Ni were observed to spread into the solder bump due to current stressing. Intermetallic compound found in the solder is not uniformly distributed, there were more compound particles on the right-hand. This is due to the current crowding effect, since electron flow is from the left corner of the chip side downward to the board side. Besides intermetallic compounds of Cu-Sn and Cu-Sn-Ni were observed to accumulate at solder and UBM interface as shown in Fig. 4(e). Fig. 5(a) and 5(b) are the enlarged image of Fig. 4(e). The elemental EDS mapping and Cu accumulation were observed at the left side of the UBM clearly due to current stressing. However, in the solder bump which with opposite direction of electron flow, Cu-Sn and Cu-Sn-Ni intermetallic compound were not found to spread into the solder bump. This is due to that the opening of Ni UBM is larger than Cu UBM, which means that the current density of the Ni UBM is much lower than

of Cu UBM. Therefore, the electromigration damage at Cu UBM side is more serious than that of Ni UBM.

Fig. 4 Cross-sectional SEM images of the solder bump under the current density of 2×10^4 A/cm² at 100 °C (a) 0hr, (b) 20hrs, (c) 70hrs, (d) 110hrs, and (e) 168hrs.

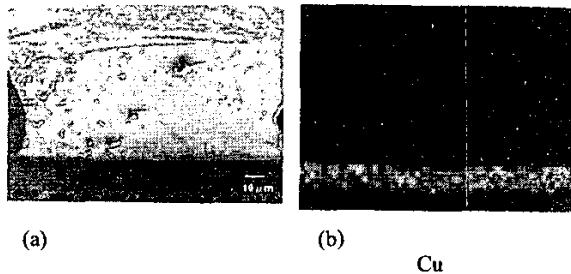
Fig. 5(a) enlarged image of Fig. 4(e), and (b) the elemental EDS mapping, dot map of Cu element.
