Engineering Geology 71 (2003) 157–179

The influence of surface ruptures on building damage in the 1999 Chi-Chi earthquake: a case study in Fengyuan City

Keywords: Hangingwall; Building damage; Chi-Chi earthquake

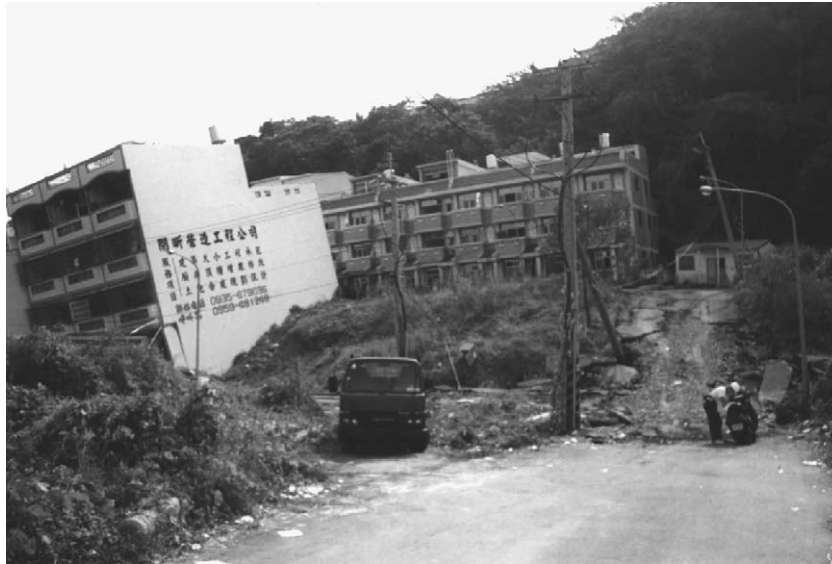
Fig. 3. Main fault near Park No. 1 Bridge. At ruptures along foot of the hill and appears to be a thrust with a slight left-lateral component. The vertical uplift is 4–5 m and the apparent horizontal separation is 7 m.

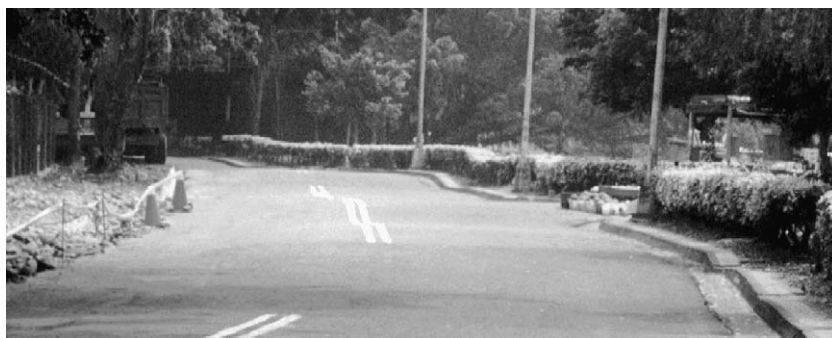
Fig. 4. The wavy road surface due to hangingwall deformation near the Chung-Cheng Park.

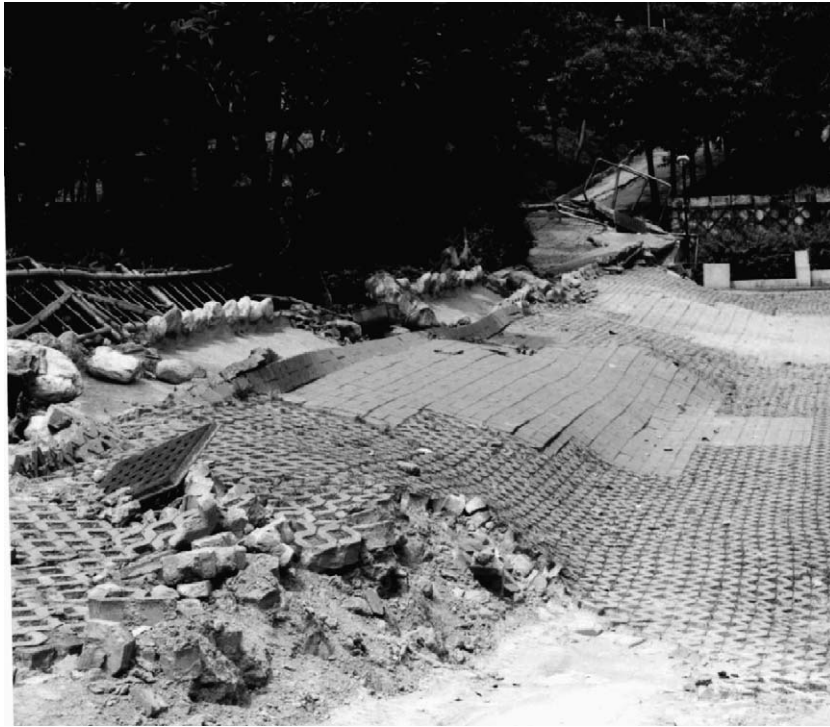
Fig. 5. Rupture-A in the Chung-Cheng Park. The left side of this photo faces west. The vertical uplift is 0.9 m.

Rupture-A is the most important secondary surface rupture near the Chung-Cheng Park. It is on the east of the main rupture. The distance between the surface rupture of rupture-A and the main rupture is about 300 m. The length of this surface rupture is about 350 m. The strike of this surface rupture is N10°W. The vertical uplift of the surface rupture is 0.9–1.8 m. The east side of the surface rupture is lower than the west side (Fig. 5).

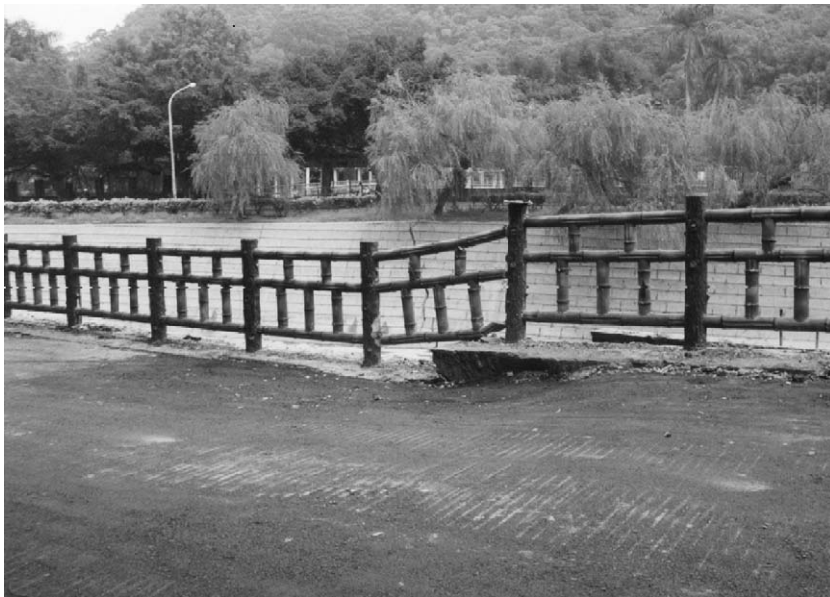
Fig. 6. Rupture-B near the Chung-Cheng park. Rupture-B lies between the main rupture and rupture-A. The vertical uplift of the surface rupture is 0.1–0.2 m. The east side of the surface rupture is higher than the west side.

Rupture-B lies between the main rupture and rupture-A. The distance between the rupture-B and the main rupture is about 100 m. The length of this surface rupture is about 250 m. The strike of this surface rupture is N12°E. The vertical uplift of the

surface rupture is 0.1–0.2 m. Contrast to the rupture-A, the east side of the surface rupture is higher than the west side (Fig. 6).

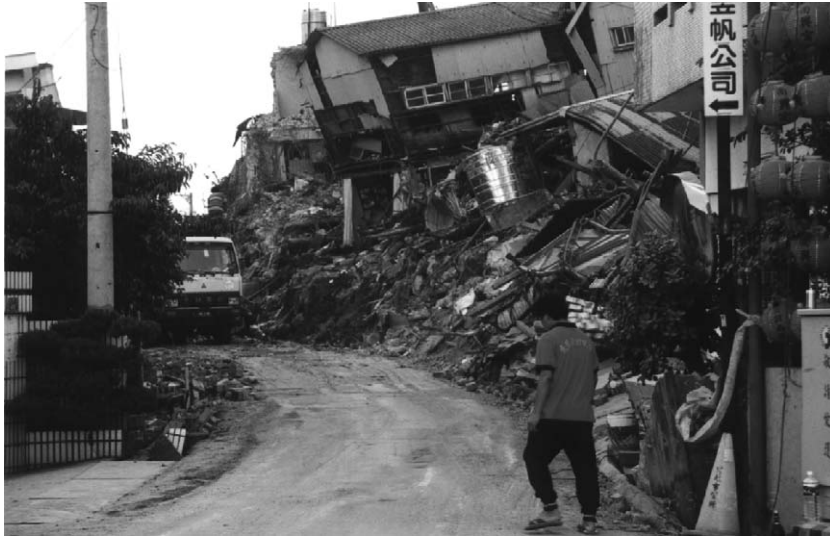
Fig. 7. Buildings damaged by the main rupture near the Chung-Cheng Park (1).

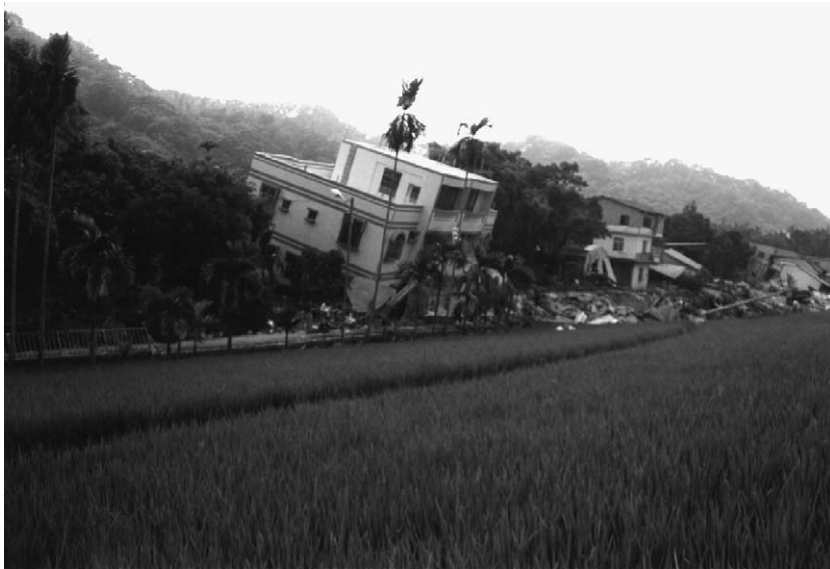
Fig. 8. The buildings damaged by the main rupture near the Chung-Cheng Park (2). The main rupture extends along foot of the hill.

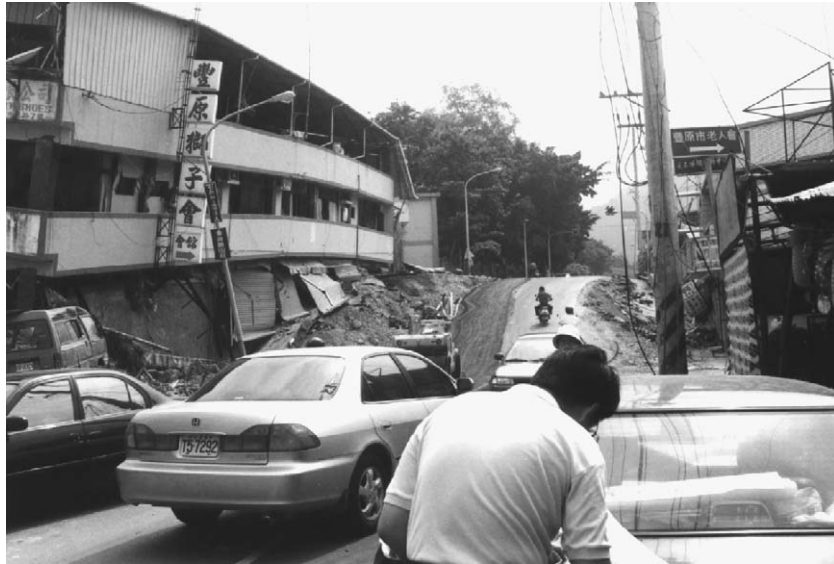
Fig. 9. Buildings damaged by the main rupture near the Chung-Cheng Park (3).

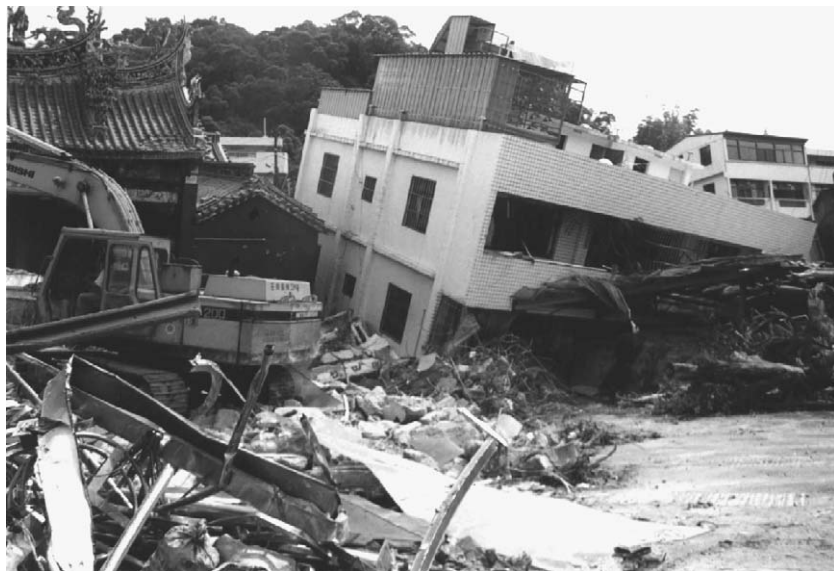
Fig. 10. Buildings damaged by the main rupture near the Chung-Cheng Park (4).

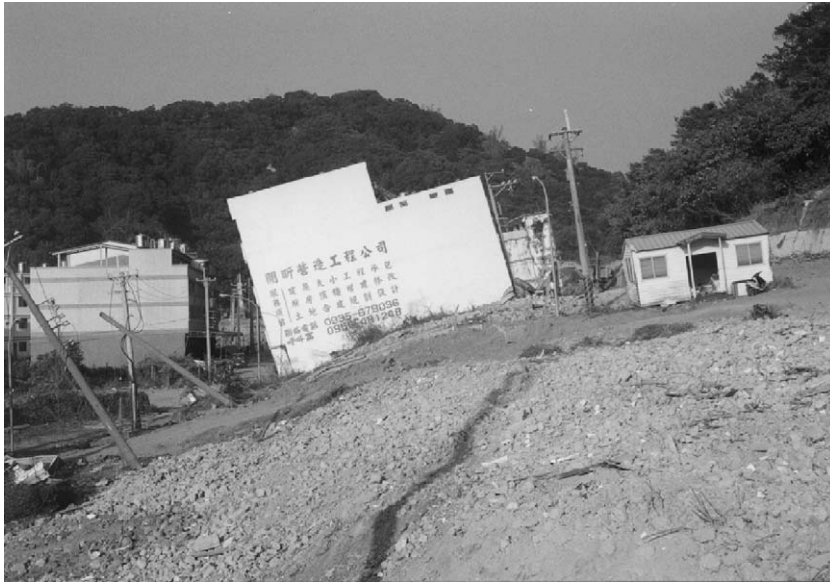
Fig. 20. Building in the center of the photo was tilted by uplifting of the hangingwall, but the structure remained intact.

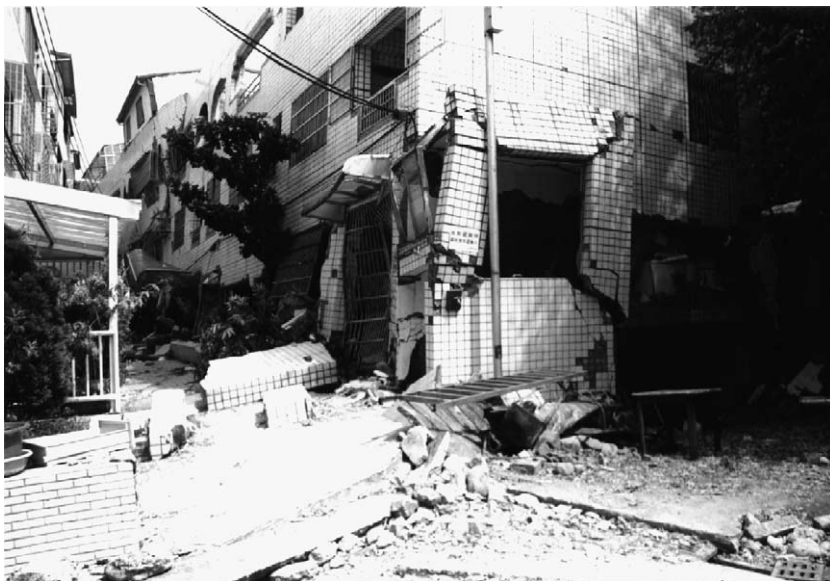
Fig. 21. Building on the hangingwall is damaged while the one on footwall remains intact.

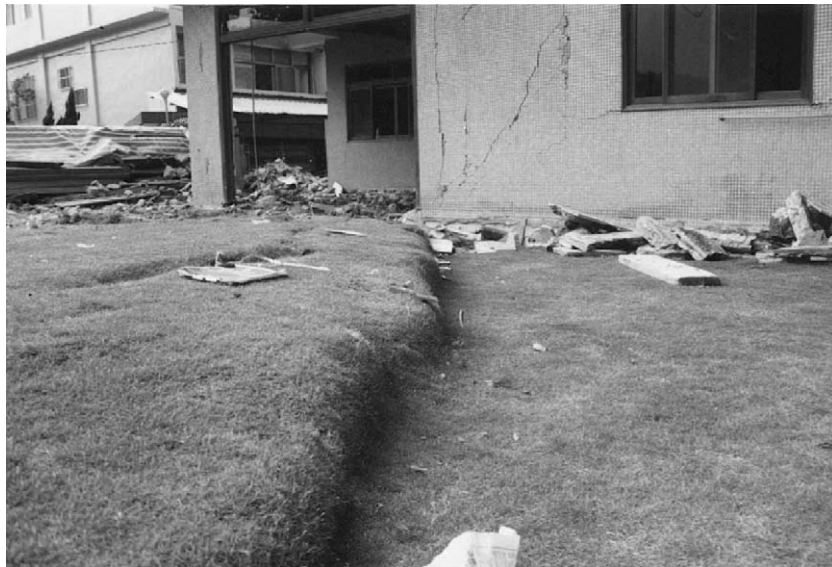
Fig. 23. Buildings in the uphill of village where rupture-B passed through were severely damaged.

The rupture-B is a minor surface rupture (the vertical uplift is only about 10 cm) comparing to the main rupture and rupture-A. Yet, some buildings are damaged seriously. The photograph shown in Fig. 23

The differential settlement of single footings resulted in shear crack and damaged the structure seriously as shown in Fig. 23. The building in Fig. 23 would have survived if a mat foundation had been used. Structures of many buildings astride the main rupture (which raised 4–5 m) remain intact (but tilted) (Fig. 20). The survivability of a building during earthquake surface rupturing depends on its foundation type.

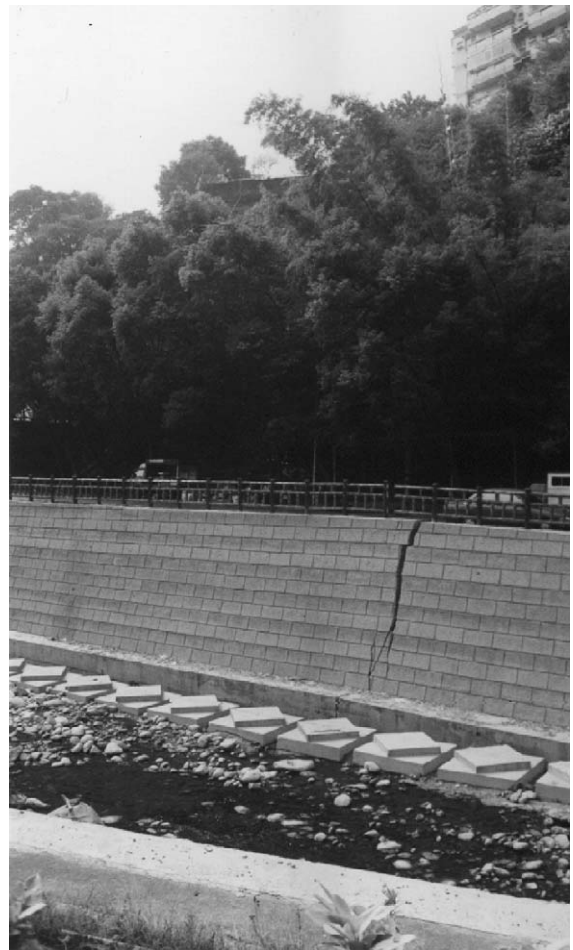
Fig. 24. Roadway and barricade are broken due to rupture-B. A building on the uphill is tilted due to ground deformation.

illustrates structure damages caused by surface rupture of rupture-B. The roadway and barricade are also broken due to the rupture (Fig. 24).

A five-storied building up the hill shown in Fig. 24 is tilted due to ground deformation and without surface rupture. The structure is still in function but the maximum rotation is about 1/50. The maximum rotation is toward east, consistent with the kinematics of wedge motion according to the geological model.
