# Electromigration Study in SnAg<sub>3.8</sub>Cu<sub>0.7</sub> Solder Joints on Ti/Cr-Cu/Cu Under-Bump Metallization

This paper investigates the electromigration-induced failures of SnAg<sub>3.8</sub>Cu<sub>0.7</sub> flip-chip solder joints. An under-bump metallization (UBM) of a Ti/Cr-Cu/Cu trilayer was deposited on the chip side, and a Cu/Ni(P)/Au pad was deposited on the BT board side. Electromigration damages were observed in the bumps under a current density of  $2 \times 10^4$  A/cm<sup>2</sup> and  $1 \times 10^4$  A/cm<sup>2</sup> at 100°C and 150°C. The failures were found to be at the cathode/chip side, and the current crowding effect played an important role in the failures. Copper atoms were found to move in the direction of the electron flow to form intermetallic compounds (IMCs) at the interface of solder and pad metallization as a result of current stressing.

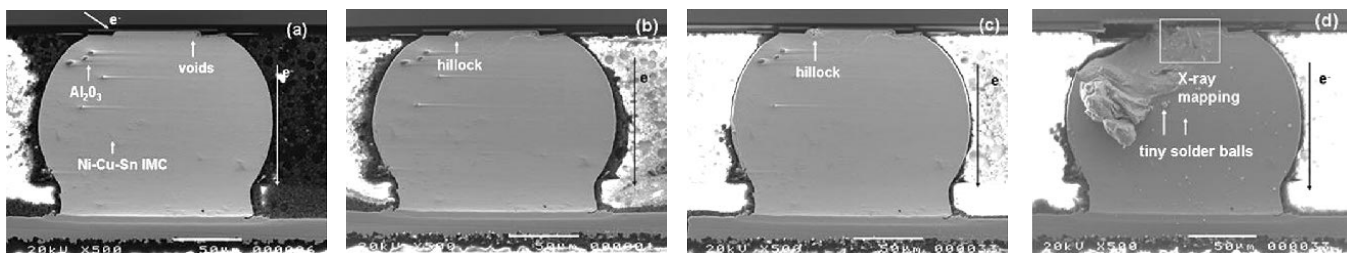
Figure 4a–d shows the microstructure evolution in the cross-sectioned SnAgCu bump before and after stressing by the current of  $0.085\ \text{A}$  for 20 h, 264 h, and 408 h at  $100^\circ\text{C}$ , respectively. The bump was polished in cross-section plane A before stressing, and the remaining cross-section area on the chip side was measured by the cross-sectional UBM length. Thus, the current density for the bump can be obtained. The current density used to stress the cross-sectioned bump is  $2 \times 10^4\ \text{A}/\text{cm}^2$ . The direction of electron flow is from the chip side to the board side, as shown in the left bump of Pair A in Fig. 2b. Voids, formed at the solder and UBM interface after reflow, can be seen in Fig. 4a. After stressing for 20 h, a hillock was observed at the chip side, as indicated by the arrow in Fig. 4b. From EDS analysis, this hillock contained both Sn and Al. As shown in the left bump in Fig. 2b, the electrons enter the bump from the back left corner of the UBM on the chip side, migrating both Al and Sn atoms to form the hillock. After stressing for 264 h, no further

damage was observed, as shown in Fig. 4c. However, after 408 h of stressing, the solder bump failed. In the upper left corner of the bump in Fig. 4d, a large void was observed, which may be responsible for the failure of the Pair A bump. Figure 5a shows the enlarged SEM images of the rectangular area in Fig. 4d. The surface of the void appears to be very smooth; from which, it may be inferred that the vicinity underwent a liquid state before failure occurred. Furthermore, some tiny solder balls were found on the surface near the void, which implies that the local temperature in the void may surpass the melting point of the solder at the moment of failure. Figure 5b shows the corresponding x-ray mapping for Al atoms. The migration of Al atoms can be clearly seen in the figure.

Fig. 4. The cross-sectional SEM images of the solder bump stressed at  $100^\circ\text{C}$  for (a) 0 h, (b) 20 h, (c) 264 h, and (d) 408 h.

In the case of the cross-sectioned bump, the solder bump failed after 408 h of current stressing, as shown in Fig. 4a–d. The corresponding schematic picture of the bump is shown in the left bump of Pair A in Fig. 2b, where the electrons crowded into the bump from the upper left, back corner. At the early stage of current stressing, it was speculated that atoms around the corner migrated to the board/anode side, and voids started to form at the point where the current crowding occurred. As voids aggregated to form cracks, the contact area on the chip side decreased, forming a vicious cycle that deteriorated the contact. As the cracks moved toward the cross-sectioned surface, current density increased dramatically, heating up the bump locally because of joule heating. It is believed that the local temperature at the failure site was ramped over the melting point of the solder before failure because there were tiny solder balls observed near the voids. Furthermore, the surface morphology of the void has a smooth appearance, which also implies that the solder may have been in a molten state before the failure.

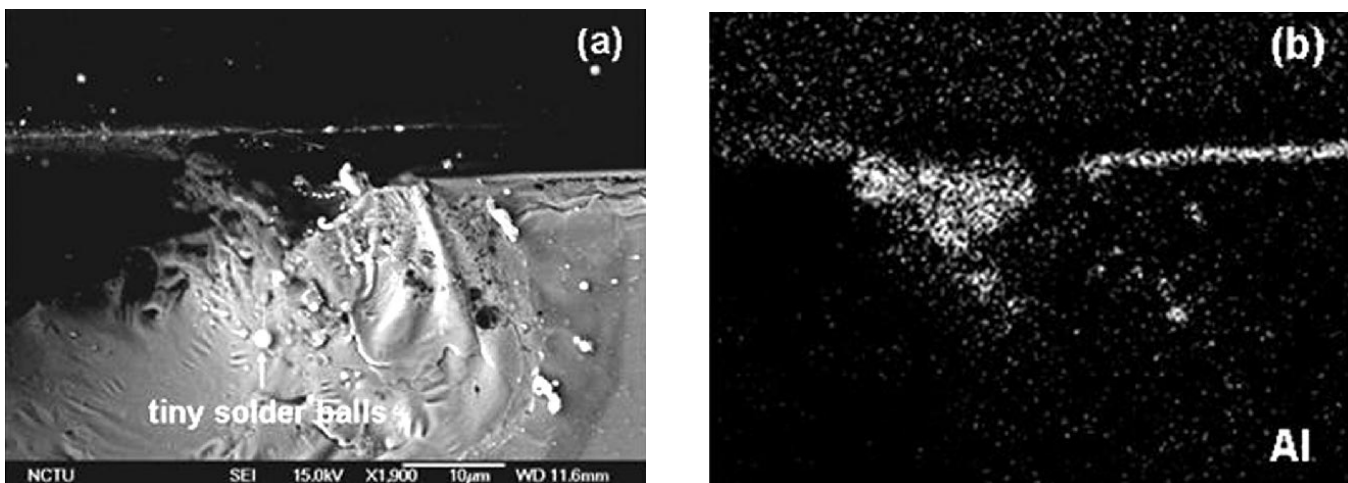
Fig. 5. (a) The enlarged SEM image of the rectangular area in Fig. 4d, and the corresponding x-ray mapping of (b) Al.

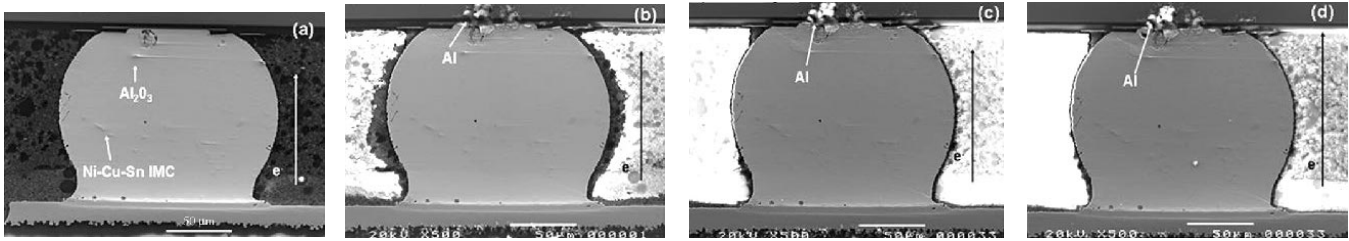
To examine the polarity effect, the current direction was reversed for the other bump of Pair A, i.e., the direction of electron flow goes from board side to chip side. Figure 6a–d shows the microstructure evolution before and after current stressing for 20 h, 264 h, and 408 h at  $100^\circ\text{C}$ , respectively. The Al was squeezed out at the chip/anode side after stressing. Figure 7a and b shows the enlarged SEM images of the damage and the corresponding x-ray mapping for Al at the interfacial region. On the board side, no obvious electromigration damage was found for the preceding two bumps. This may be attributed to the lower current density on the board side.

Fig. 6. The cross-sectional SEM images of the solder bump stressed at 100°C for (a) 0 h, (b) 20 h, (c) 264 h, and (d) 408 h.

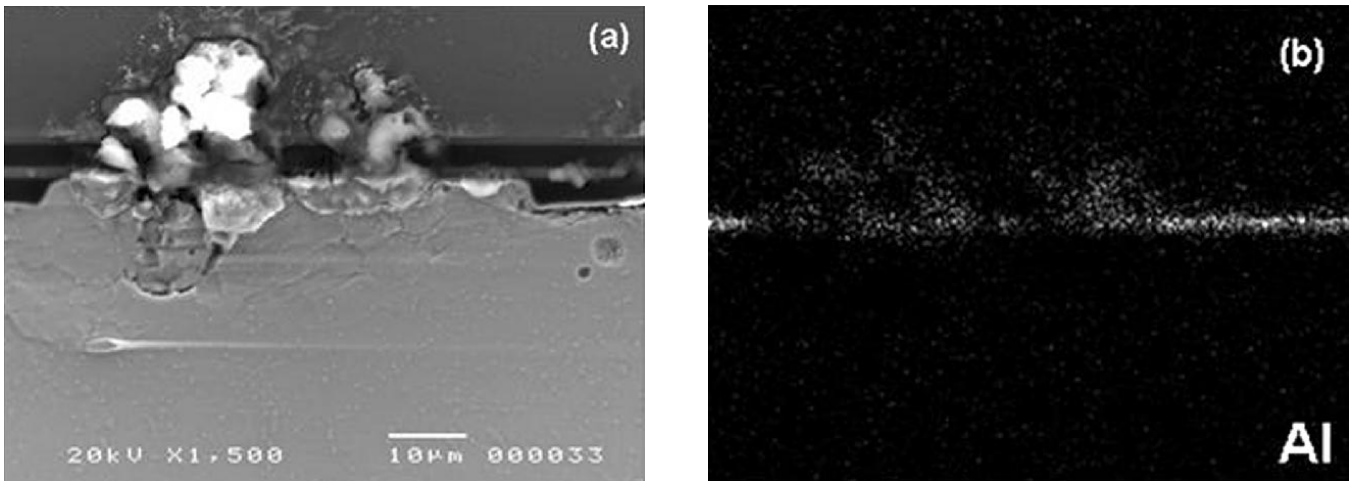
Fig. 7. (a) The magnified SEM image of the rectangular area in Fig. 6d and (b) are the x-ray elemental mapping for Al at interfacial region in (a).

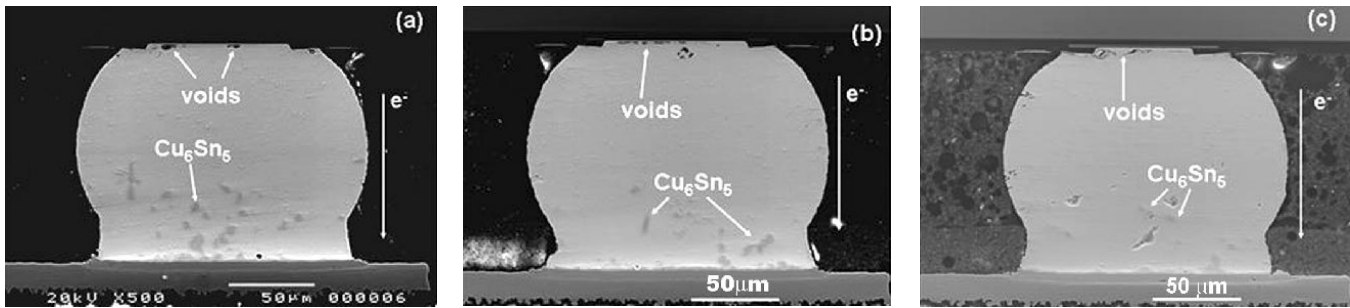
In the Pair B case, the set of whole bumps were stressed at the current density of  $1 \times 10^4 \text{ A/cm}^2$  until failure occurred. Afterwards, they were subject to cross sectioning for failure analysis. Figure 8a shows the cross-sectional SEM image of the solder bump along cross-section plane A. The bump failed after stressing for 140 h at 100°C and was then ground, cut, and polished away approximately 1/3 volume of the solder bump. The Cu-Sn IMCs were accumulated at the anode/board side, which implies that the copper atoms on the chip side and in the solder were caused to migrate by the electron flow to the board side.

To examine the microstructure beneath the cross-sectioned surface in Fig. 8a, further polishing was performed. Figure 8b and c shows the microstructures after polishing away half the volume and two-thirds the volume of the solder bump. Comparing both figures, cracks appear to be larger as the bump was polished down.

Fig. 8. The cross-sectional SEM image of the solder bump stressed at 100°C for 140 h: (a) after polishing to one-third of the bump volume, (b) after polishing half of the bump volume, and (c) after polishing two-thirds of the bump volume.

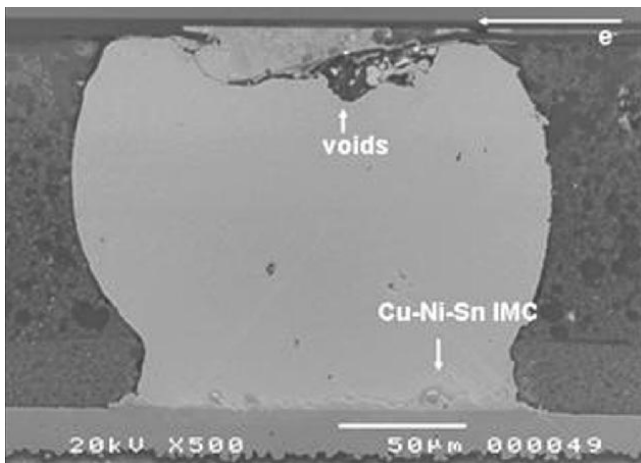
Figure 9 shows the cross-sectional SEM image of the solder bump along cross-sectioned plane B. The solder bump failed after 42 h of current stressing at 150°C. Because the test temperature was raised to 150°C, the failure time decreased from 140 h at 100°C to 42 h. Obviously, the voids at the right are much bigger than the ones on the left as the result of the current crowding effect.

In Fig. 9, voids at the upper right corner are much bigger than those at the upper left corner. This may be the result of current crowding, where the electrons crowded into the bump from the upper right

Fig. 9. The cross-sectional SEM image of the solder bump stressed at 150°C for 42 h.

corner of the bump. At the board side in Fig. 9, the Cu-Ni-Sn IMC grew thicker at the lower right corner, which was attributed to the current crowding on the board side.

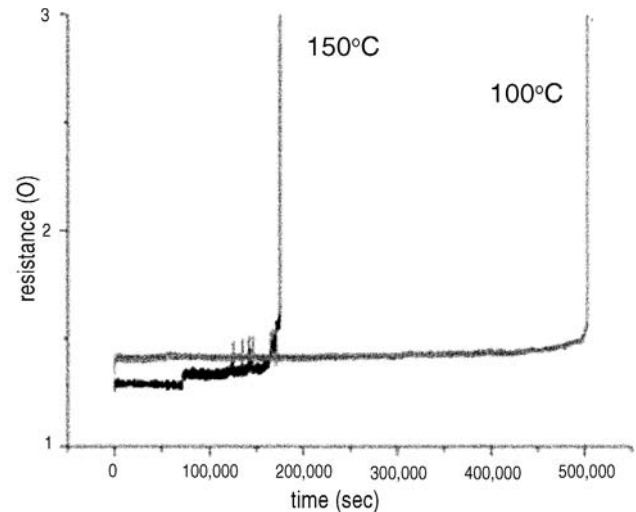
The results for the measured resistance of the stressing circuit as a function of stressing time is shown in Fig. 10. Although the resistance included both the resistance of the conduction lines and that of the bump pair, it was still observed that the failure time depended on the dramatic increase of the resistance. As expected, the bump failed within 42 h of stressing time at 150°C and within 142 h at 100°C because the diffusivity of metal atoms are larger at high temperature. To examine the microstructure changes caused by the thermal effect, reference bumps were employed to undergo a similar thermal history during current stressing. Figure 11 shows the microstructure changes resulting from the thermal effect only. The bump was kept at 150°C for 42 h, and no obvious microstructure change was observed.

Fig. 10. The measured resistance of the stressing circuit as a function of stressing time.

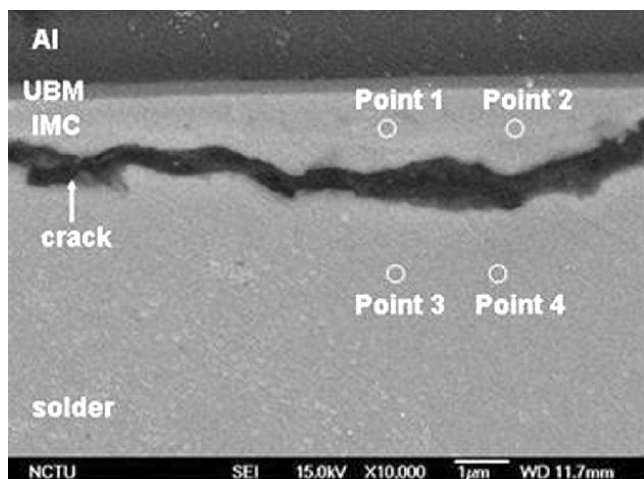
An enlarged image of the chip side of the bump in Fig. 8c is shown in Fig. 12. The crack was found at the solder/IMC interface. Above the crack, the EDS

composition analysis at points 1 and 2 indicated that there were Al, Ti, Cr, Cu, and Sn in this region. It is believed that Al, Ti, and Cr atoms migrated by the electron flow into the IMC. Because Cu atoms were caused by the electron flow to migrate toward the board side to form a Sn-Cu compound, the analysis at points 3 and 4 revealed that only Sn and

Fig. 12. The enlarged SEM image of the chip side in Fig. 8c

Ag atoms were detected at this region. The composition of these points in the solder is shown in Table I.
