# Electromigration Studies of Flip Chip Sn95/Sb5 Solder Bumps on Cr/Cr-Cu/Cu Under-Bump Metallization

The electromigration-induced failure of Sn95/Sb5 flip chip solder bumps was investigated. The failure of the joints was found at the cathode/chip side after current stressing with a density of  $1 \times 10^4$  A/cm<sup>2</sup> at 150°C for 13 sec. The growth of intermetallic compounds (IMCs) was observed at the anode side after current stressing. Voids were found near the current crowding area in the cathode/chip side, and the (Cu,Ni)<sub>6</sub>Sn<sub>5</sub> IMC at the cathode/chip end was transformed into the Sn phase. The failure mechanism for Sn95/Sb5 flip chip solder joint is proposed in this paper.

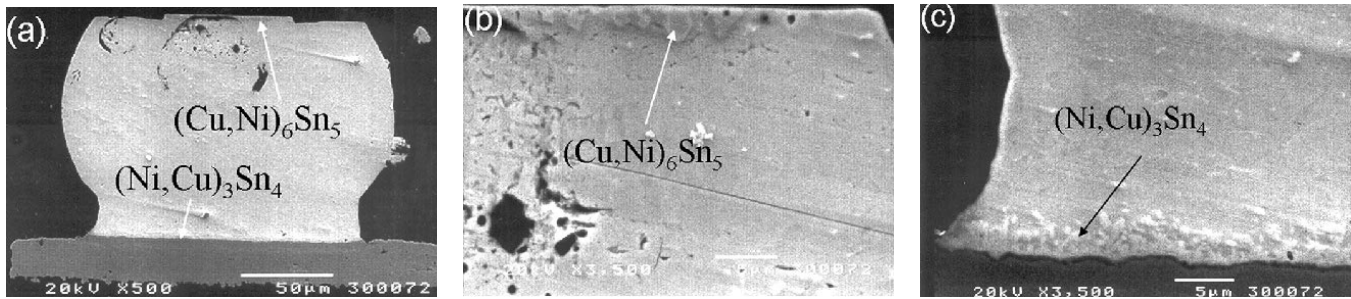
Figure 3a shows the SnSb bump structure of Bump 2 before current stressing. Some voids formed inherently during the reflow process and these inherent voids were of larger size and were generally of circular appearance. On the chip side, the  $(\text{Cu,Ni})_6\text{Sn}_5$  compound (IMC) formed between UBM and SnSb solder, as shown in Fig. 3b, while the IMC near the board side was identified to be  $(\text{Ni,Cu})_3\text{Sn}_4$ , as seen in Fig. 3c. Figure 4a shows the microstructure of Bump 2 after  $2 \times 10^4 \text{ A/cm}^2$  current stressing for 110 h at  $150^\circ\text{C}$ , in which the chip side was the cathode and the board side was the anode. Voids were found near the upper-right corner of the bump, as indicated by Arrow 1 in Fig. 4a. The location at which voids formed after current stressing is the current crowding area. For this package, electron flow enters the bump from the right-back corner of the UBM, as indicated by Arrow 2 in Fig. 3a. Similar current crowding has also been reported in SnPb and SnAg flip chip bumps.<sup>5,6</sup>

Before current stressing, the  $(\text{Ni,Cu})_3\text{Sn}_4$  compound and  $\text{Ni}_3\text{P}$  layer were found in the board side, as shown in Fig. 3c. It is intriguing to note that  $(\text{Cu,Ni})_6\text{Sn}_5$  replaced  $(\text{Ni,Cu})_3\text{Sn}_4$  after the current stressing, as indicated by the arrow in Fig. 4(c). The thickness of the Ni-Cu-Sn compound increased on the board side, which was the anode. The Ni-Cu-Sn compound was squeezed out at the anode. Furthermore,  $(\text{Cu,Ni})_6\text{Sn}_5$  on the chip side was replaced by

Fig. 3. The cross-sectional SEM images of Bump 2 before current stressing: (a) complete cross section, (b) chip side, and (c) board side.

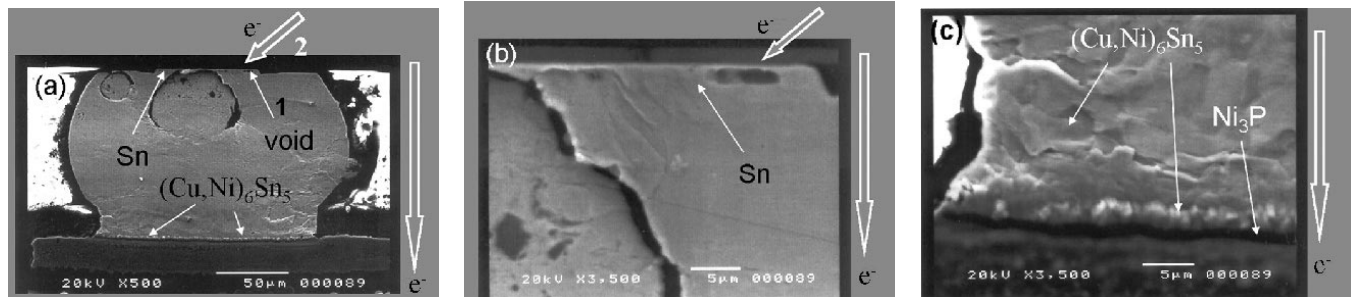
Fig. 4. The cross-sectional SEM images of Bump 2 after current stressing with current density  $2 \times 10^4$  A/cm<sup>2</sup> at 150°C: (a) complete cross section, (b) chip side, and (c) board side.

Sn after the current stressing, as indicated by the arrow in Fig. 4(b). The movement of Cu and Ni atoms due to electromigration may explain these findings.

Before the current stressing, Ni-Cu-Sn IMC formed on the cathode (the chip side Cr/Cr-Cu/Cu UBM), and its composition was determined to be Ni (22.0%): Cu (30.3%): Sn (47.7%) by EDX. Tables I and II summarize the composition evolution of IMC for the samples. After the current stressing, the signals of Ni and Cu could not be detected by EDX on the cathode and the atomic ratio of Sn increased to 98%. This indicates that the electron flow drives the

Ni and Cu atoms in the  $(\text{Cu,Ni})_6\text{Sn}_5$  IMC away from the cathode. In contrast,  $(\text{Cu,Ni})_6\text{Sn}_5$  compound formed near the anode and  $\text{Ni}_3\text{P}$  layers were also observed on the board side after the current stressing, as shown in the Fig. 4c. The Sb atoms in the bump were undetectable in this system due to signal positions overlapping with those of Sn atoms; thus, the effect of electromigration upon Sb atoms was unclear.

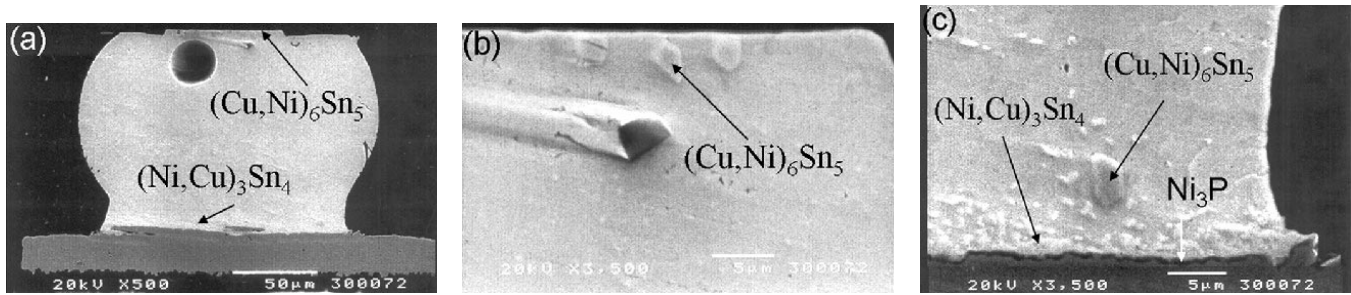
To investigate the polarity effect, Fig. 5a shows the SnSb bump structure of Bump 1 before current stressing. A large void formed inherently during the reflow process near the chip side. Intermetallic com-

Fig. 5. The cross-sectional SEM images of Bump 1 before current stressing: (a) complete cross section, (b) chip side, and (c) board side .

pound of  $(\text{Cu,Ni})_6\text{Sn}_5$  formed near the chip side, as seen in Fig. 5b. Nevertheless, the IMC near the board side was  $(\text{Ni,Cu})_3\text{Sn}_4$ , as shown in Fig. 5c. The SEM image of Bump 1 after  $2 \times 10^4$  A/cm<sup>2</sup> current stressing for 110 h at 150°C is shown in Fig. 6a. The void, which originally formed inherently during the reflow process, disappeared after current stressing, as shown in Fig. 6a.

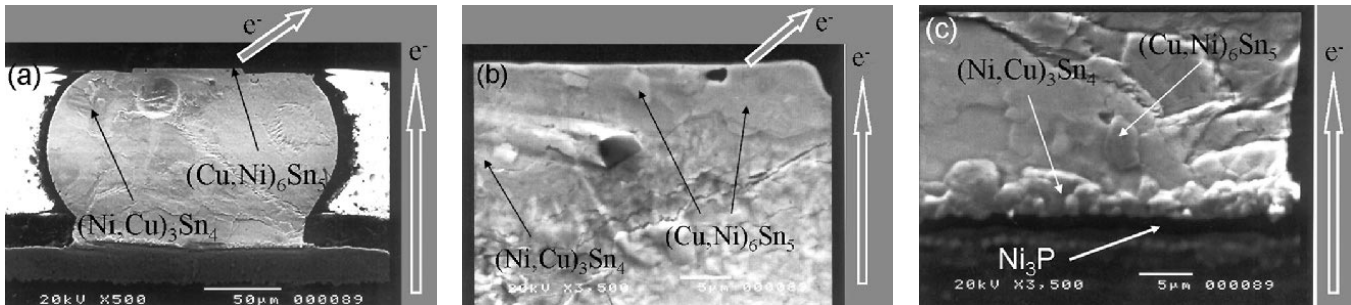
Fig. 6. The cross-sectional SEM images of Bump 1 after current stressing with current density of  $2 \times 10^4$  A/cm<sup>2</sup> at 150°C: (a) complete cross section, (b) chip side, and (c) board side.

Before current stressing, the  $(\text{Ni,Cu})_3\text{Sn}_4$  compound was found on the board side. It is interesting to note that the thickness of the Ni-Cu-Sn compound increased on the cathode side after current stressing, as shown in Fig. 6c. Furthermore,  $(\text{Cu,Ni})_6\text{Sn}_5$  IMC formed near the upper-right corner of the bump, as indicated by Arrow 1 in Fig. 6b. The location at which  $(\text{Cu,Ni})_6\text{Sn}_5$  IMC formed after current stressing is the current crowding area. For this package, electron flow exits the bump from the right-back corner of the UBM, indicated by Arrow 2 in Fig. 6b. These results suggest that the current density is not uniform inside the solder joint and the electromigration effect is stronger in the current crowding region. At the same time, the  $(\text{Ni,Cu})_3\text{Sn}_4$  compound formed near the anode and within the solder matrix of the bump, as shown in Fig. 6a. It is likely that the Ni atoms were pushed toward the anode, resulting in the formation of the  $(\text{Cu,Ni})_6\text{Sn}_5$  IMC and  $(\text{Ni,Cu})_3\text{Sn}_4$  IMC.

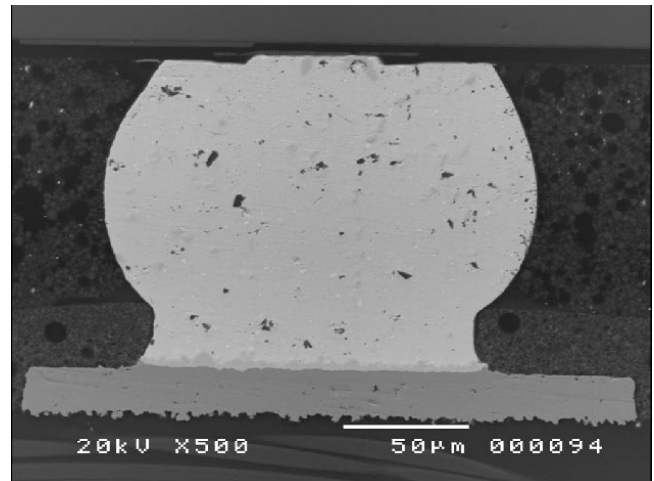
Figure 7 shows the cross-sectional SEM images of the solder joints of the entire flip chip package after stressing at 150°C without current passing through it. Figure 8a shows the microstructure of Bump 1 for the entire flip chip package after  $1 \times 10^4$  A/cm<sup>2</sup> current stressing for 13 h at 150°C, in which the

Fig. 7. The cross-sectional SEM images of the entire flip chip package at 150°C without current density.

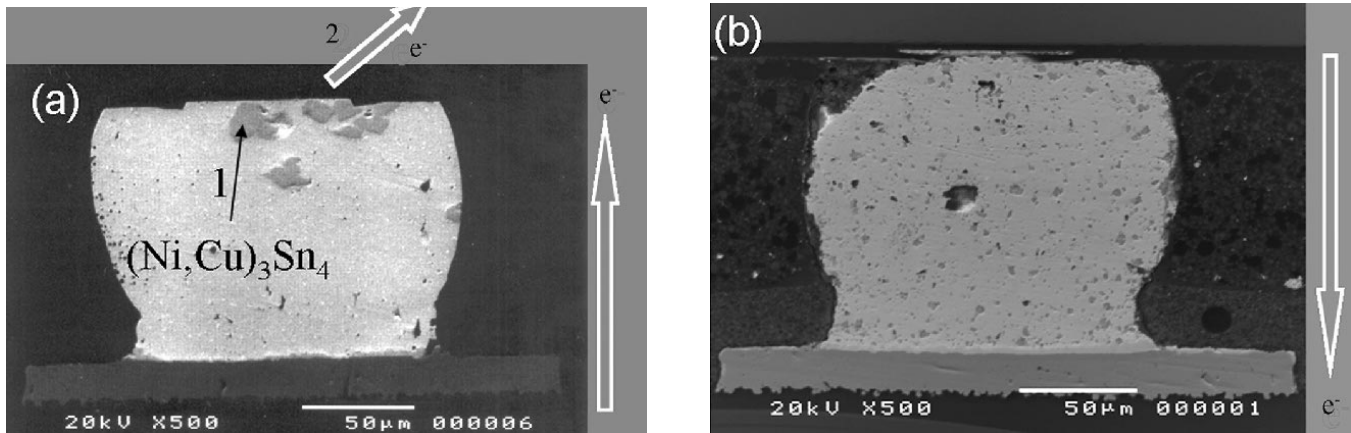
chip side was the anode and the board side was the cathode. The  $(\text{Ni,Cu})_3\text{Sn}_4$  IMC is obviously clustered near the upper-right corner of the bump, as indicated by Arrow 1 in Fig. 8a. The location at which IMC was formed after current stressing is the current crowding area. For Bump 1, electron flow exits the bump from the right-back corner of the UBM, as indicated by Arrow 2 in Fig. 8a. Thus, it may be stated that the formation of IMC is strongly related to the current crowding effect. Fig. 8b shows the microstructure of Bump 2 for the entire flip chip package after  $1 \times 10^4$  A/cm<sup>2</sup> current stressing for 13 h at 150°C, in which the chip side was the cathode and the board side was the anode.

Fig. 8. The cross-sectional SEM images of the entire flip chip package after current stressing with current density of  $1 \times 10^4$  A/cm<sup>2</sup> at 150°C: (a) Bump 1 and (b) Bump 2.

The solder joint failure was observed for the entire flip chip package stressed with current density of  $1 \times 10^4$  A/cm<sup>2</sup> for 13 h at 150°C. Figure 8b shows that the failure was located at the interface of the solder and chip side Cr/Cr-Cu/Cu UBM, where the chip side was the cathode. The crack was clearly seen from the enlarged cross-sectional SEM image in Fig. 9a. However, there was no crack found on the board side, as shown in the Figs. 8b and 9b, where the board side was the anode. It is speculated that the major reason for the package failure is the higher current density at the chip side. In this package, the current density on the chip side is about 3 times larger than that on the board side. However, no solder joint failure was found in the previously cross-sectioned and polished flip chip package sample. There was a free surface for the solder bump of the cross-sectioned flip chip package, whereas the solder bump of the entire flip chip package was surrounded by the underfill. The practical temperatures of the solder bump for the cross-sectioned flip chip package sample and the entire flip chip package sample were different,

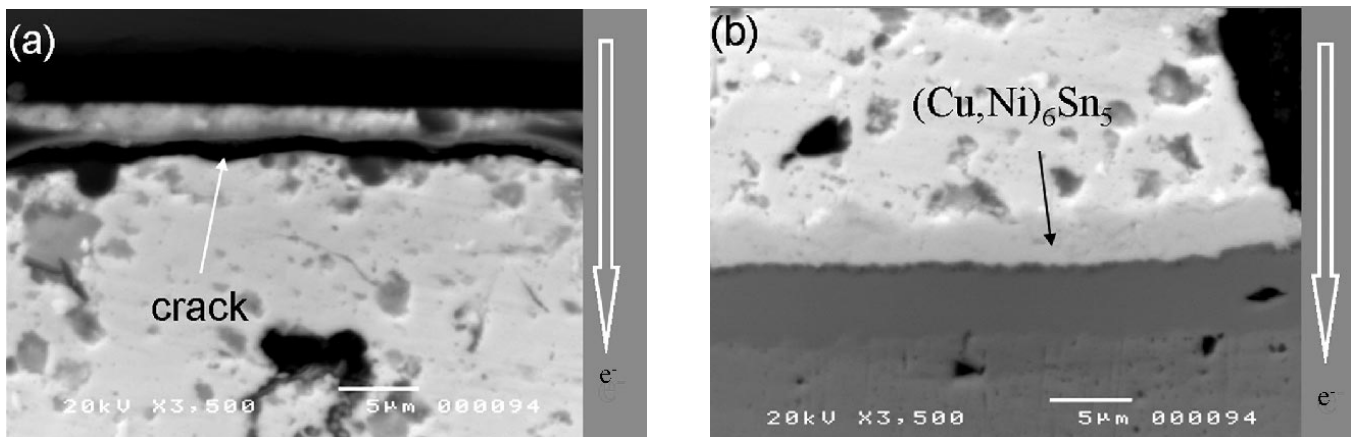
Fig. 9. The enlarged cross-sectional SEM images of the entire flip chip package after current stressing with current density of  $1 \times 10^4$  A/cm<sup>2</sup> at 150°C: (a) the cathode/chip side and (b) the anode/board side.
