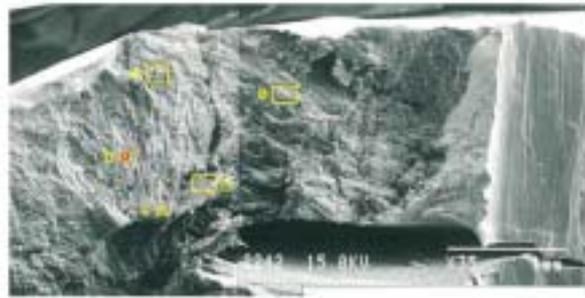
圖 34 疊接銲道缺陷顯示有雜質偏析現象及樹枝狀熱裂特徵圖

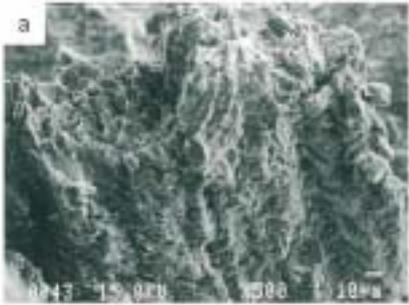
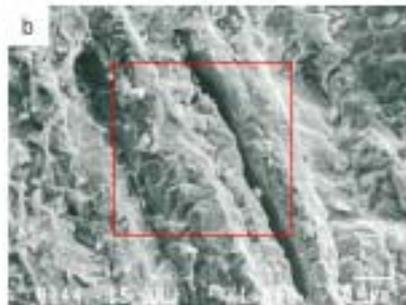
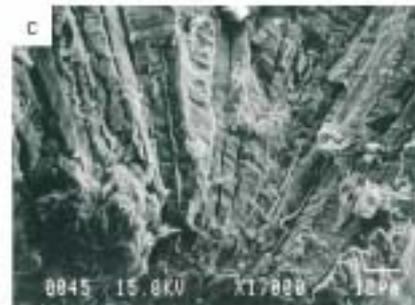
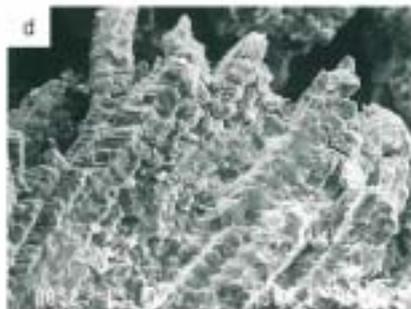
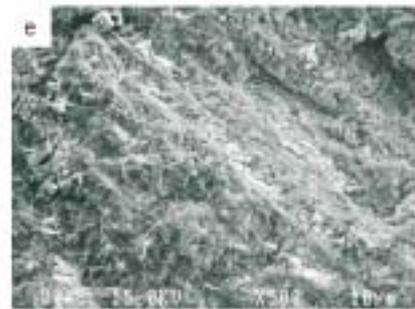
Dendritic feature was observed on fracture surface.

Results of FPM6 (%)								
Composition	Si	P	S	Cl	Cr	Mn	Fe	Ni
Approximate quantitative analysis (%)	1.3	0.06	0.67	0.16	28.6	0.79	61.6	6.8

圖 35 鐳道缺陷顯示樹枝狀熱裂特徵

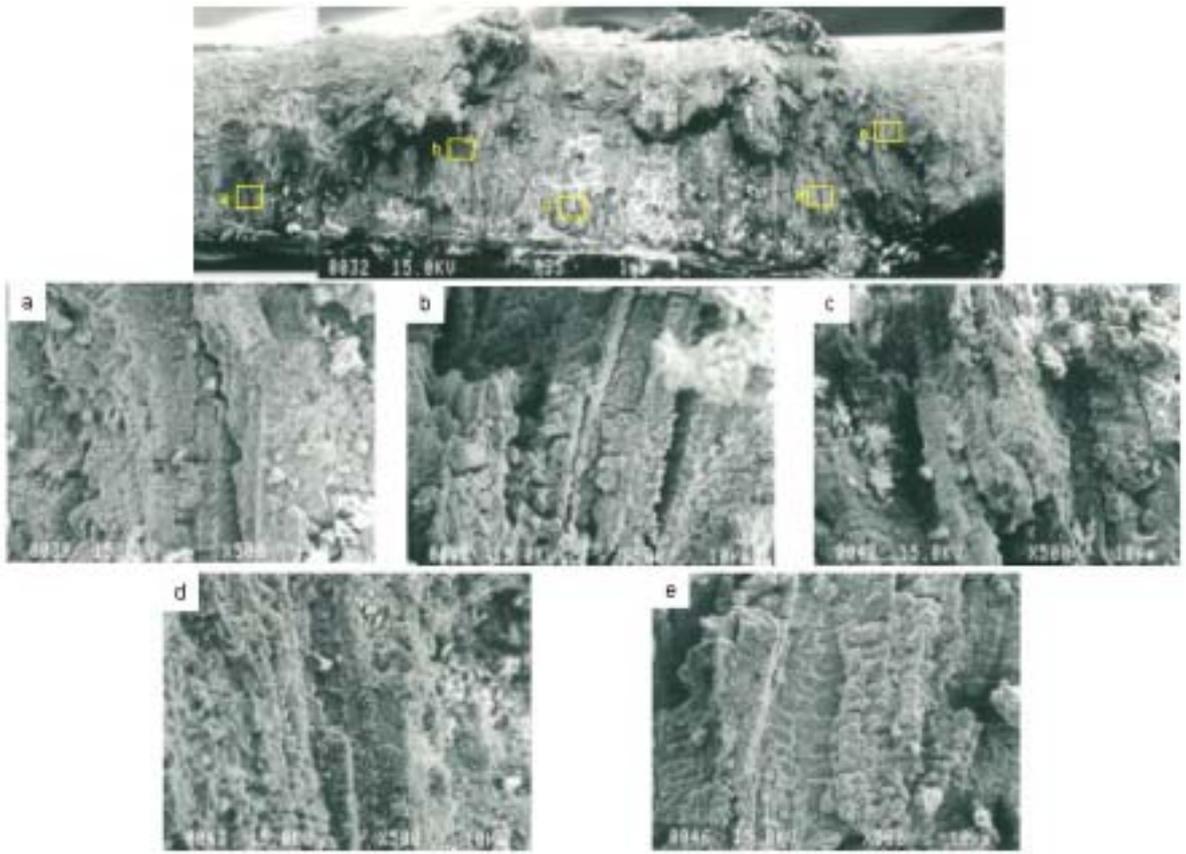
圖 36 疊接銲道缺陷型態

疊接銲道(lap weld)

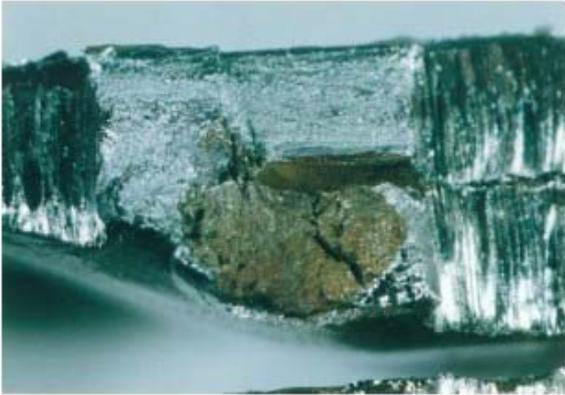
垂直於銲道裂紋

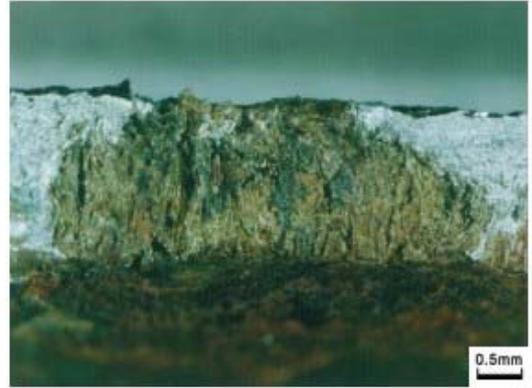
平行於銲道裂紋

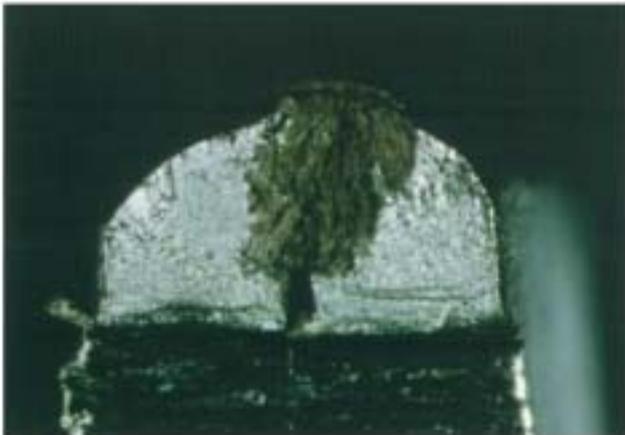
圖 37 邊緣銲道缺陷型態

垂直於銲道裂紋

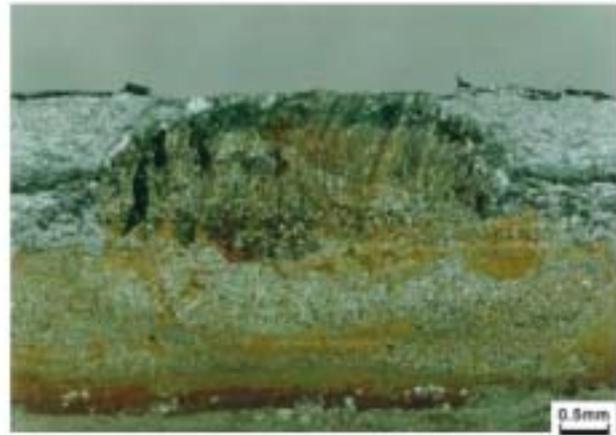
平行於銲道裂紋
