在高電漿密度蝕刻機中 SF_6 電漿分解產物對產品的影
響與研究

**Study of SF_6 Decomposition Products
of DPS Poly Etcher in IC's
Manufacturing**

研究生：許時齊

National Chiao Tung University
in Partial Fulfillment of the Requirements
for the Degree of
Master of Science
in
Electronics and Electro-Optical Engineering
June 2004
Hsinchu, Taiwan, Republic of China

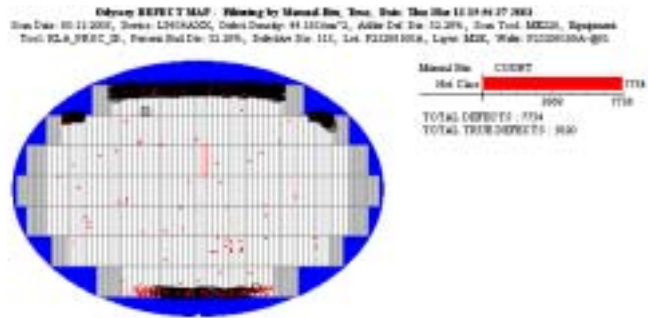
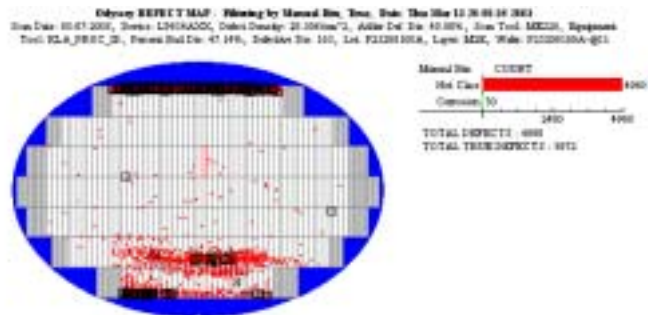
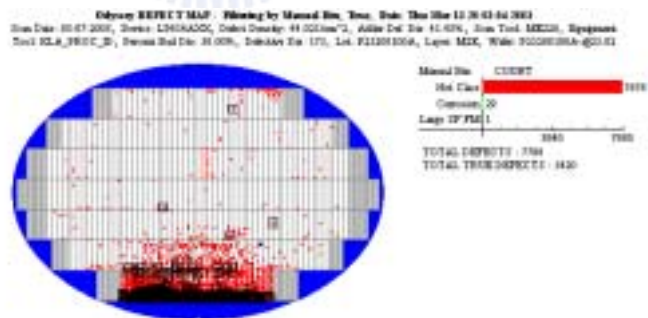
In IC's manufacturing, the corrosion Al-Cu film is happened irregular and inspected by KLA TENCOR tools. Figure 2.1 shows the corrosion wafer map of slots 1,11,25 in whole cassette of 25 wafers. The corrosion appeared seriously on top/bottom of wafer and Slot 25 was lighter than the others. In manufacturing, the corrosion metal appeared sometime and somewhere, the period was irregular. Figure 2.2 shows the pictures of corrosion metal by optical microscope inspection (OM) and second electron microscope inspection (SEM). The most striking feature in these micrographs is the presence of small raised bump in the border of metal line.

In order to find where the fluorine residues come from? From Figure 2.1 shows the corrosion wafer map of slots 1,11,25 in whole cassette of 25 wafers. The corrosion appeared seriously on top/bottom of wafer and Slot 25 was lighter than the others. Therefore, the contamination may have correlation with cassette in some kind of environment. Planning experiments were:

Fig 2.1 Wafer map of metal corrosion inspected by KLA TENCOR tools, KLA map of slot 1,11,25 in whole cassette of 25 wafers

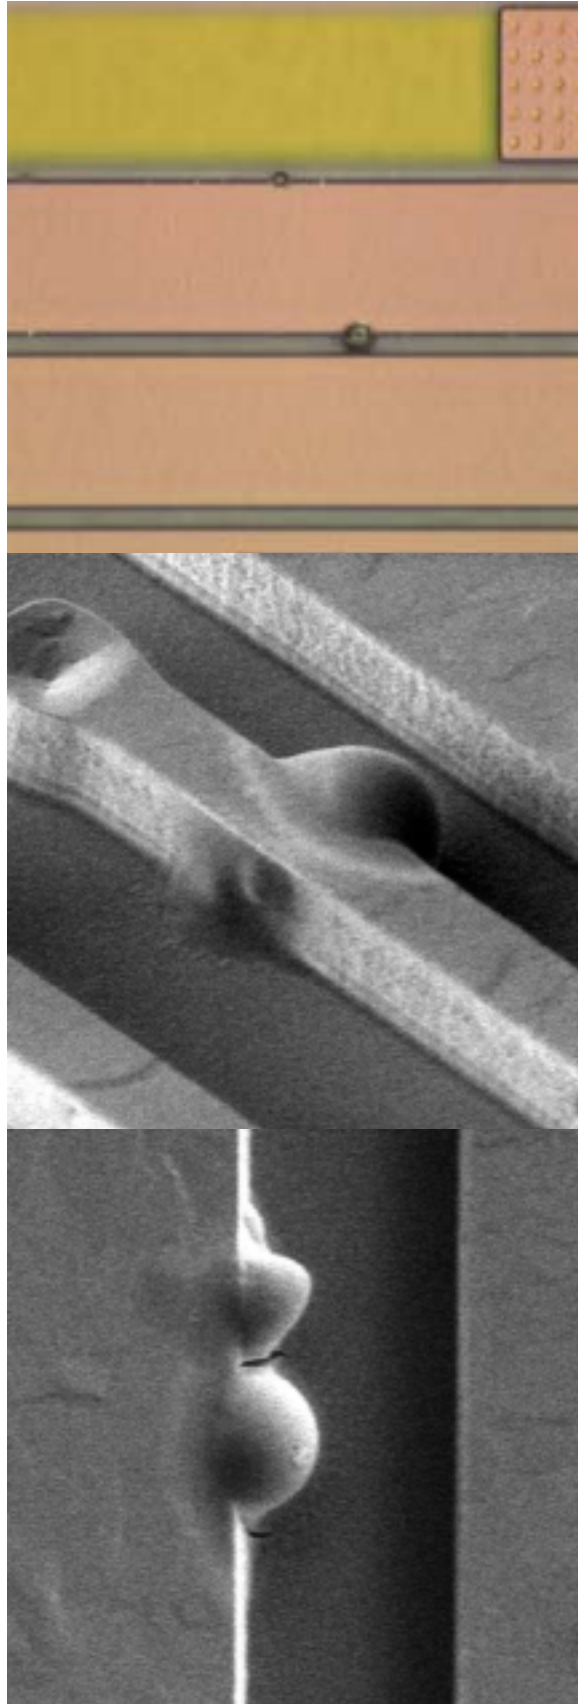
Fig 2.2 the pictures of corrosion metal, the top picture inspected by optical microscope (OM), the others inspected by second electron microscope (SEM)

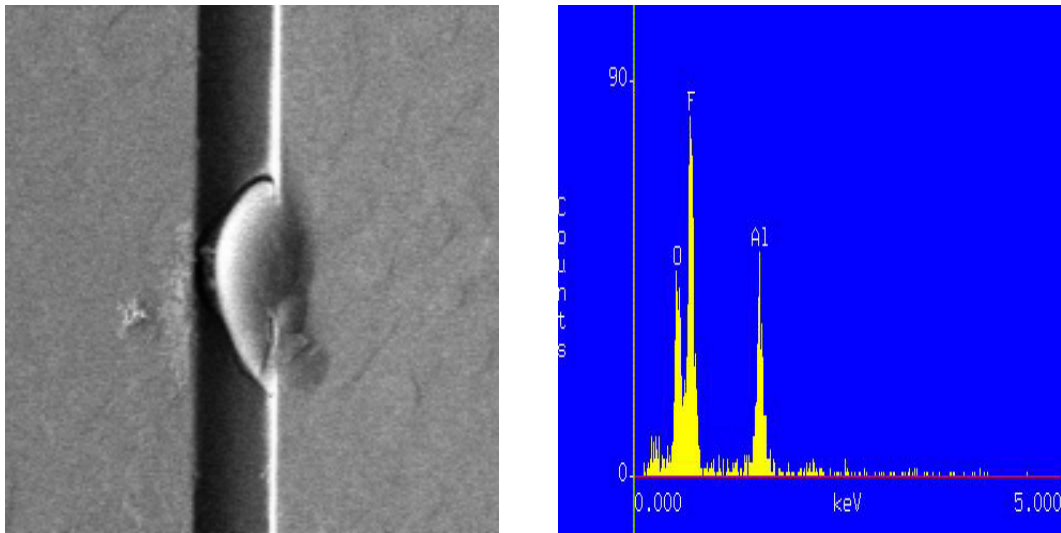
At the first step, it is necessary to identify corrosion come from fluoride or chlorine residues. Figure 2.4 shows the corrosion metal was composed of aluminum, oxygen and fluorine by EDX. Figure 2.5 shows the corrosion wasn't eliminated after metal etching back again. Therefore, the mechanism of corrosion must come from fluorine residues but where the fluorine residues come from?

Fig 2.4 Corrosion metal was composed of aluminum, oxygen and fluorine by EDX

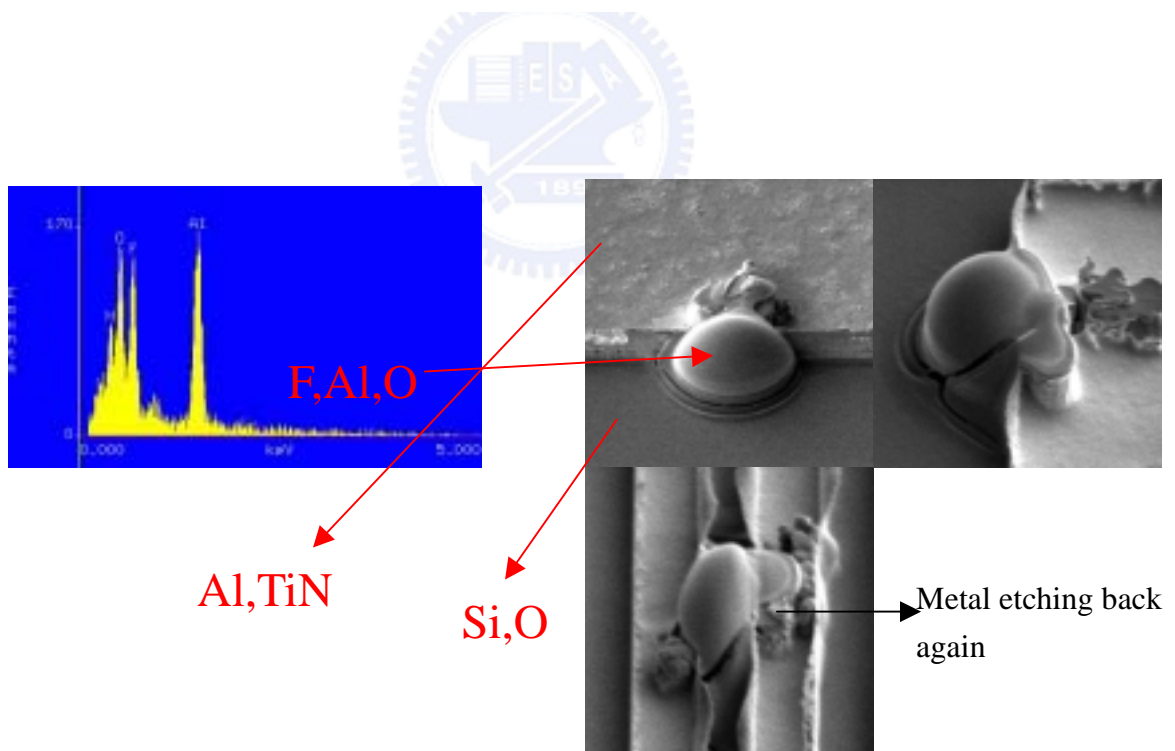
AlF_3 has very low volatility. Under normal etch conditions, ~100 mTorr, <60 °C, AlF_3 is a solid. This can be proven by figure 2.5 shows the corrosion wasn't eliminated after metal etching back again. In order to confirm that HF is existence on box, the litmus test is a must. Preparing contaminated box with decomposition of SF_6 and injecting a little water, the color of litmus paper was changed and showed the water is acid.

Fig 2.5 Corrosion metal wasn't eliminated after metal etching back again

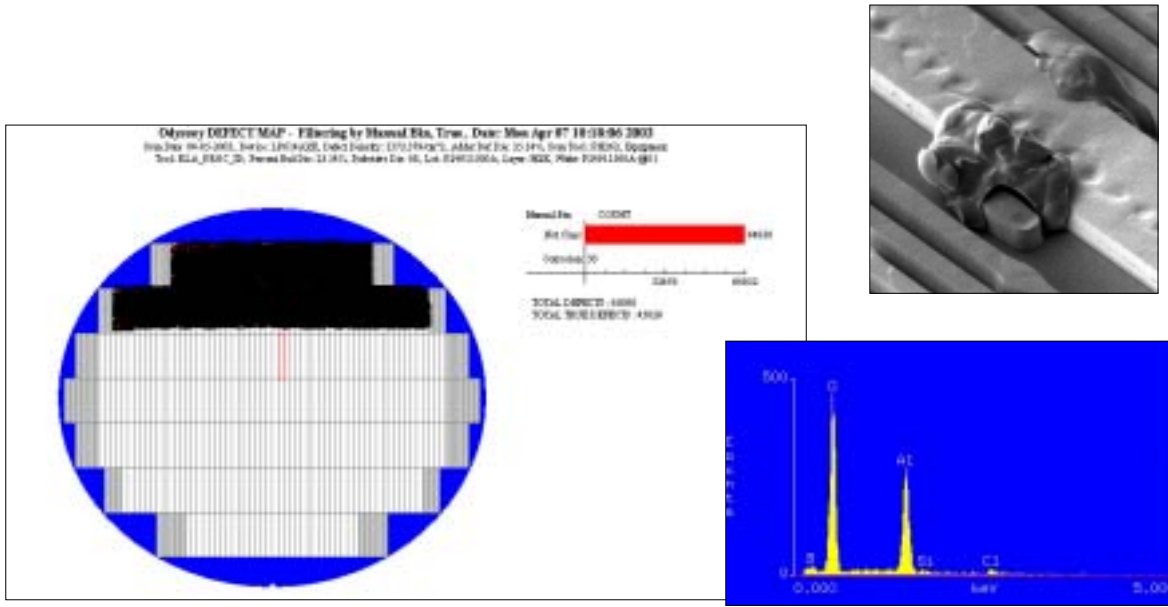
The film structure was formed by Al-Cu metal line and did post clean by dSP. All of wafers had been placed in boxes exceed 12 hours. Figure 2.6 shows “wafer A – just metal etch and didn't asher”, the KLA map appeared metal corrosion on All wafer. This type corrosion metal was composed of chlorine, oxygen and aluminum; also inspected by SEM (second electron microscope). Figure 2.7 Shows the KLA maps of “wafer B – wafer held with cassette in open area” and “wafer C – wafer held with cassette in clean box”. Didn't find corrosion metal on all wafers. Fig 2.8 shows “wafer D – wafer held with cassette in contaminated

Fig 2.6 Wafer A – just metal etched and didn't asher, the KLA map appeared metal corrosion on All wafer. This type corrosion metal was composed of chlorine, oxygen and aluminum; also inspected by SEM (second electron microscope)

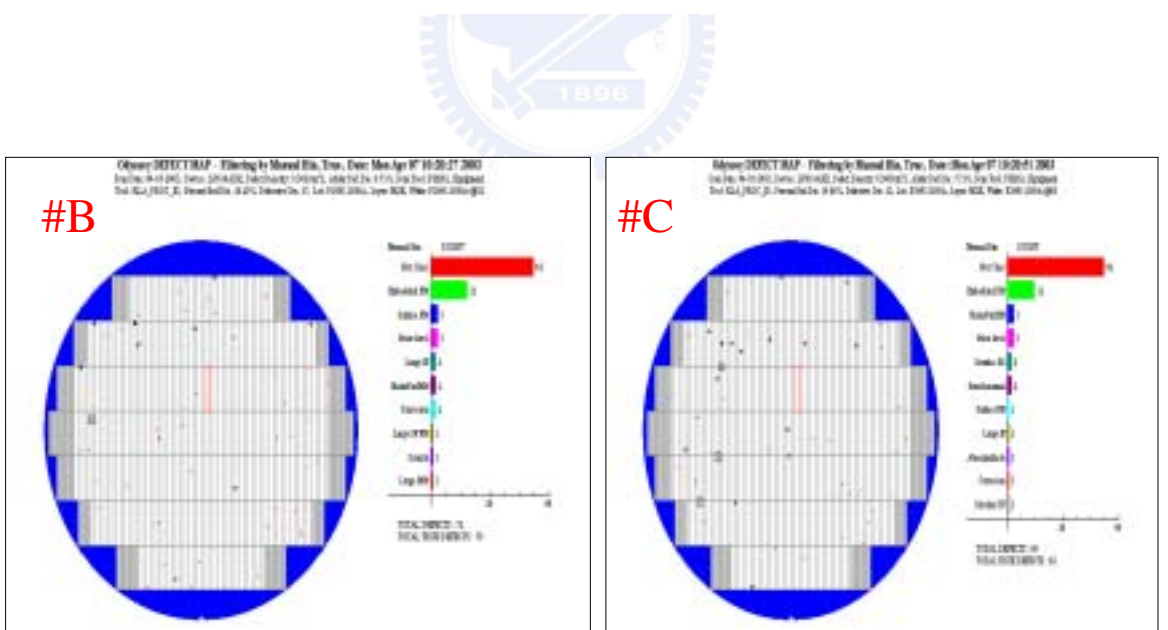
Fig 2.7 The KLA maps of “wafer B – wafer held with cassette in open area” and “wafer C – wafer held with cassette in clean box”. Didn't find corrosion metal on all wafers

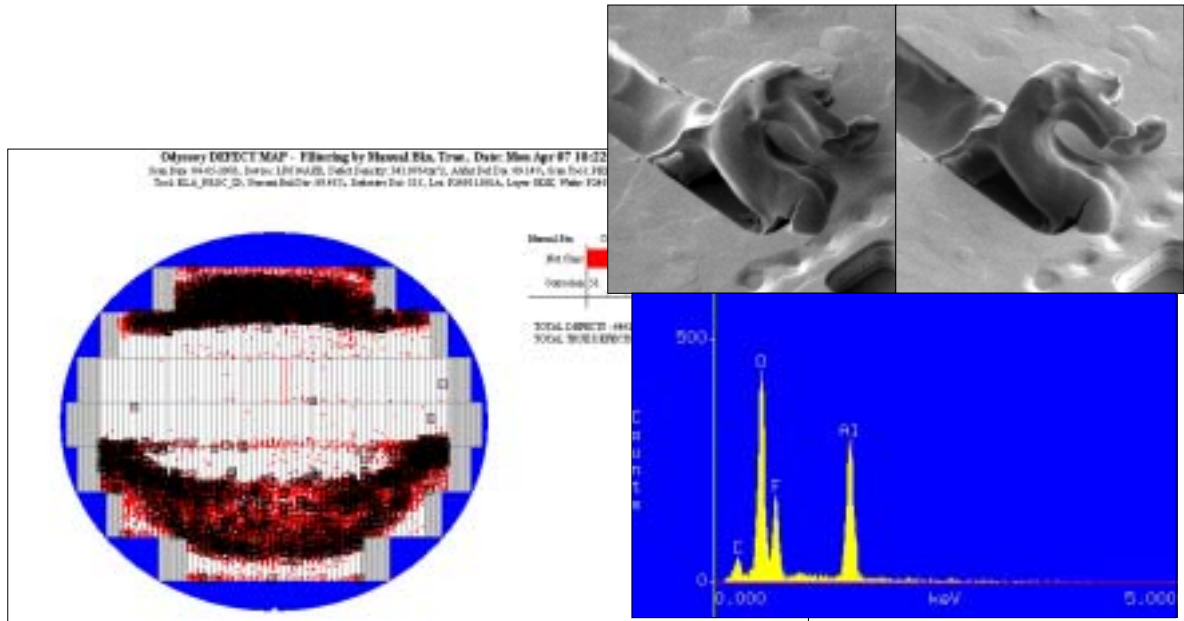
fluoride box”, the KLA map appeared metal corrosion on top/bottom of wafer. This type corrosion metal was composed of fluorine, oxygen and aluminum; also inspected by SEM (second electron microscope).

Fig 2.8 Wafer D – wafer held with cassette in contaminated fluoride box, the KLA map appeared metal corrosion on top/bottom of wafer. This type corrosion metal was composed of fluorine, oxygen and aluminum; also inspected by SEM (second electron microscope)

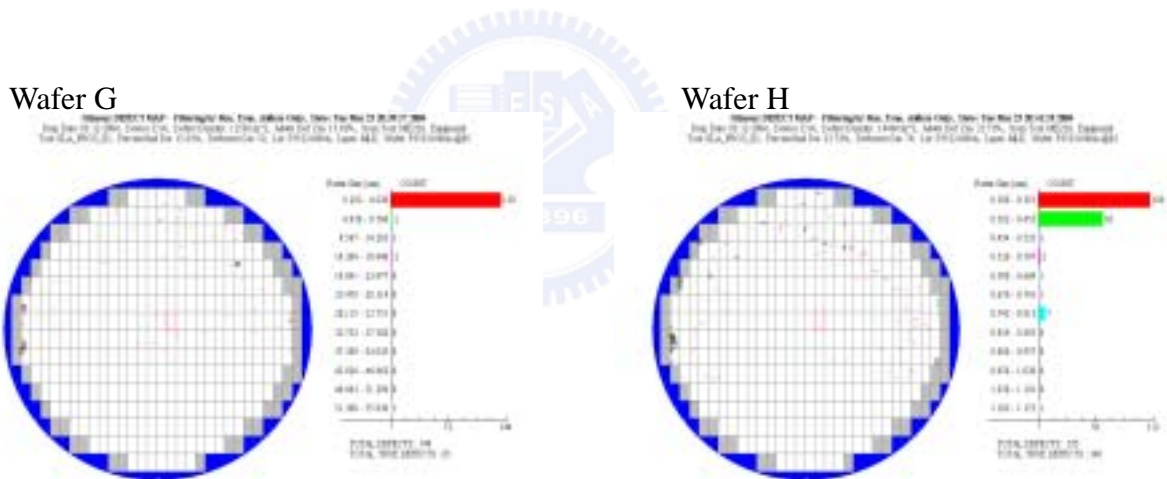
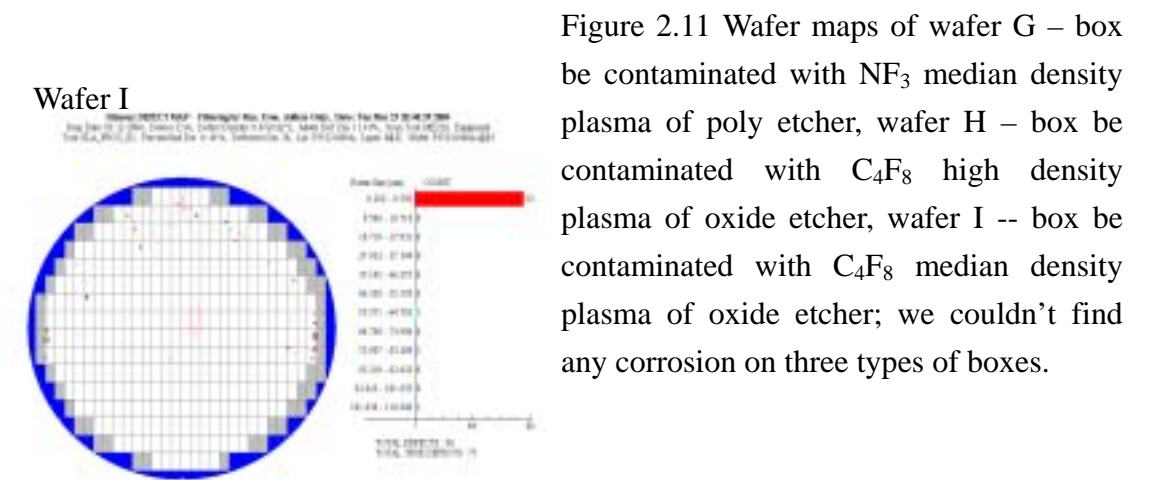
Figure 2.11 Wafer maps of wafer G – box be contaminated with NF_3 median density plasma of poly etcher, wafer H – box be contaminated with C_4F_8 high density plasma of oxide etcher, wafer I -- box be contaminated with C_4F_8 median density plasma of oxide etcher; we couldn't find any corrosion on three types of boxes.

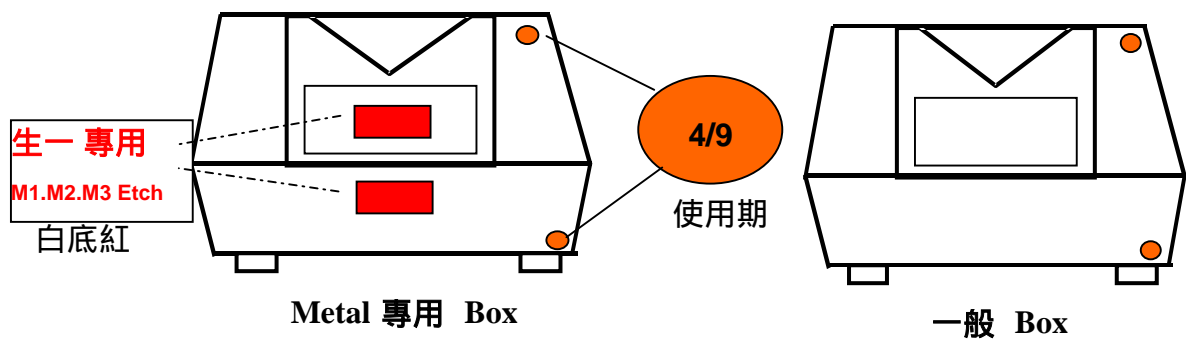
Fig 2.12 In order to avoid contamination of metal, dedicated special boxes for metal wafer transport is a must.

The root cause of corrosion Al-Cu film happened irregularly was found, decomposition of SF_6 in DPS poly etcher was the key. In order to eliminate corrosion metal, it is necessary to setup a new production rule. Figure 2.12 shows two kinds of boxes for metal layers and non-metal layers, dedicated metal boxes can avoid contamination by decomposition of fluoride.

Since the dedicated metal boxes was implemented in mass production, have never seen corrosion metal that contaminated by fluorine. It is important to solve corrosion problem, because corrosion with fluorine have appeared in our Fabrication for several years. Not only get more up-time of tools, but also improve quality of product.

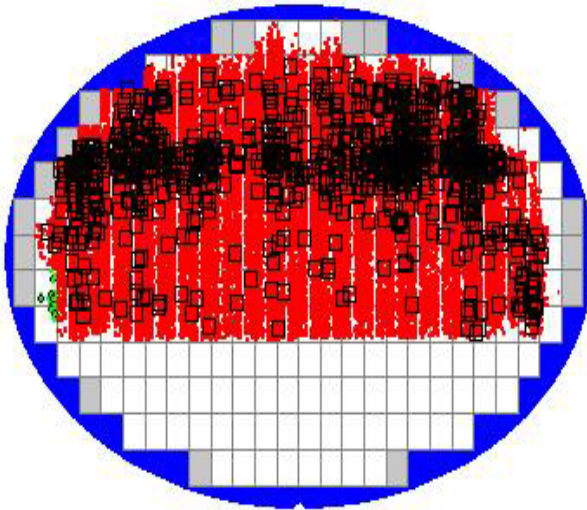
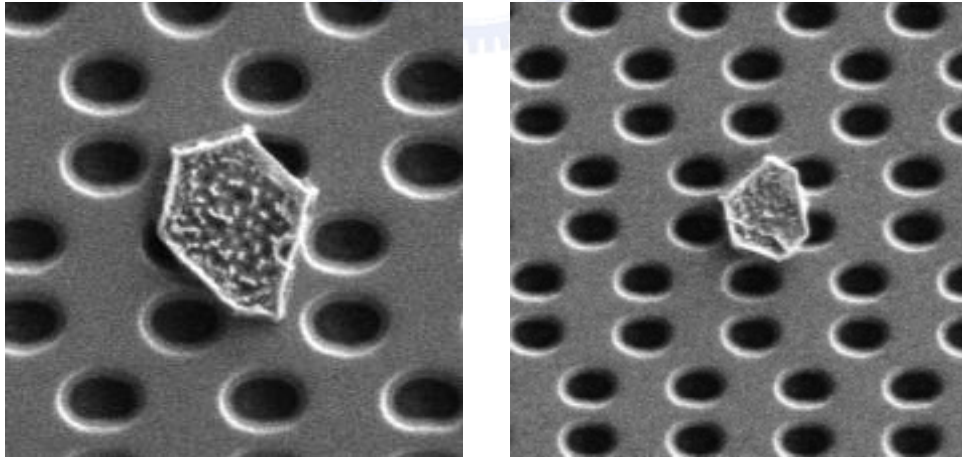
Figure 3.3 in this step, appeared semi-translucent hexagonal defects on the wafer by KLA inspected. If put the high level defect wafer in cassette box for 2, 24, 48 hours; the defect level is still high on the wafer. But take the high level defect wafer out cassette box for 2 hours, the defect level is down to half quickly. Therefore, the part of semi-translucent hexagonal defect is volatile in air sometime and remains in box. We have tried to remove they with popular clean skills, can reduce defect counts but can't remove completely.

Fig 3.3 Semi-translucent hexagonal defect on the wafer by KLA inspected

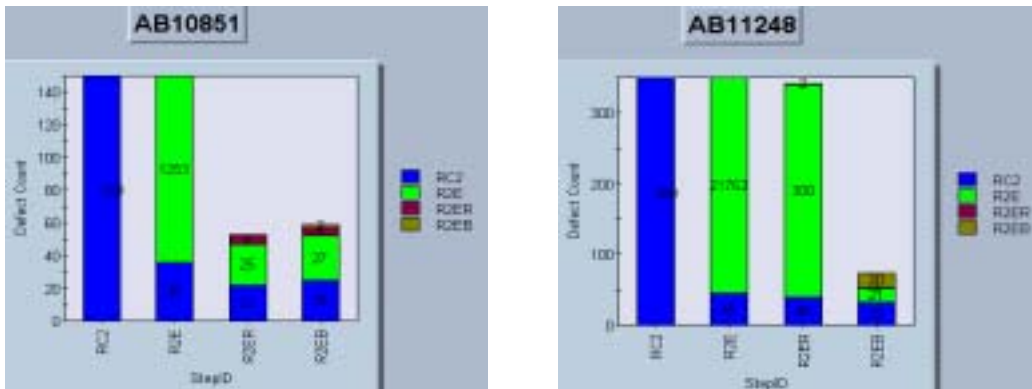
Fig 3.4 The efficiency of particle reduction with SPM + APM. The left lot – defect counts reduce from 1253 to 25 at 1st time clean. The right lot – defect counts reduce from 21762 to 300 at the 1st time and to 21 at the 2nd time clean.

- (a) SPM and APM clean: “SPM” means sulfuric acid (H_2SO_4) and (H_2O_2) on ratio 7:1. “APM” means ammonia (NH_4OH) and (H_2O_2) on ratio 1:4. SPM used to dehydrate the organic particle (like photo-resist) and APM used to remove particle on silicon or oxide surface. Figure 3.4 shows the efficiency of SPM and APM. The left lot – defect counts reduce from 1253 to 25 at the 1st time clean. The right lot – defect counts reduce from 21762 to 300 at the 1st time clean and to 21 at the 2nd time clean. Figure 3.5 shows another experiment.

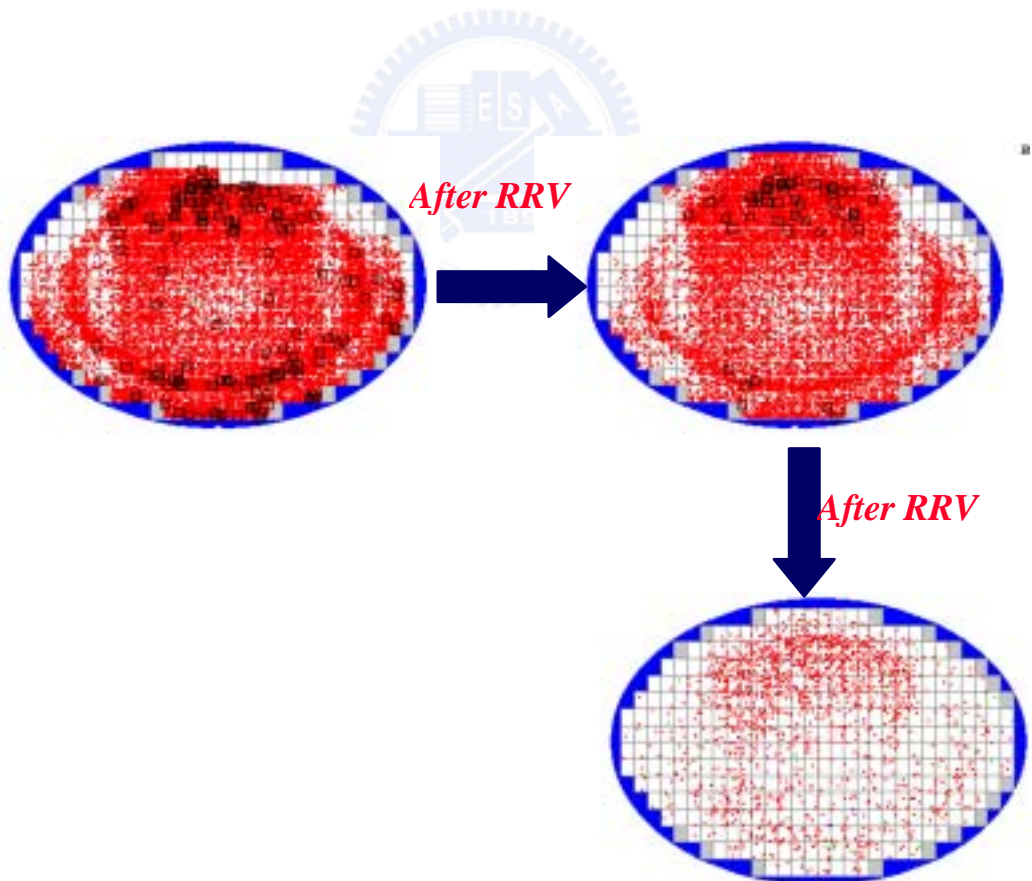
Fig 3.5 The efficiency of particle reduction with SPM +APM once and twice.

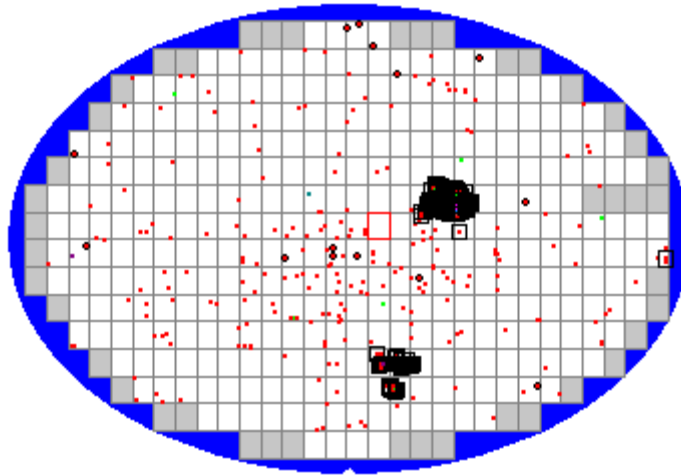
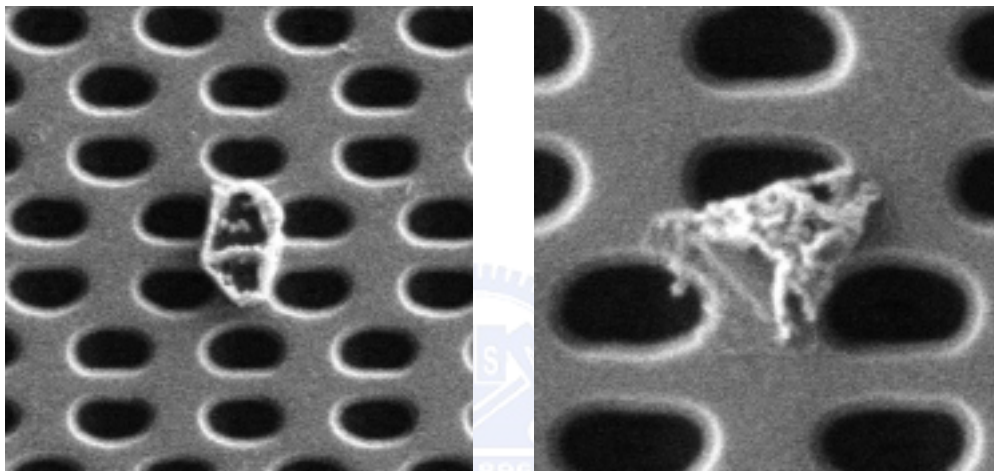
Fig 3.6 The result of adding N_2 plasma treatment in the end of poly etching.

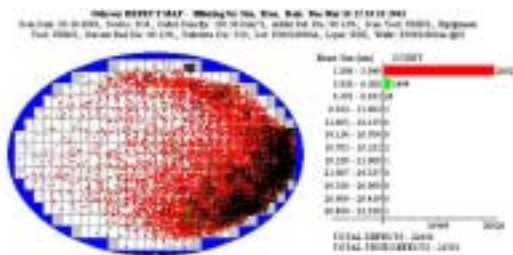
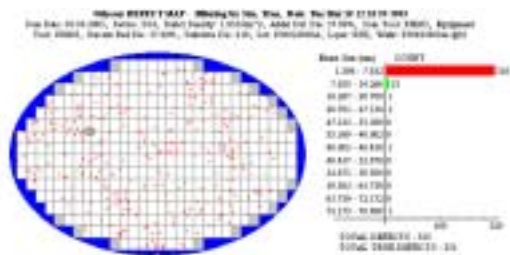
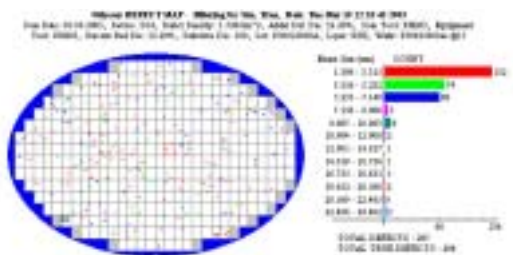
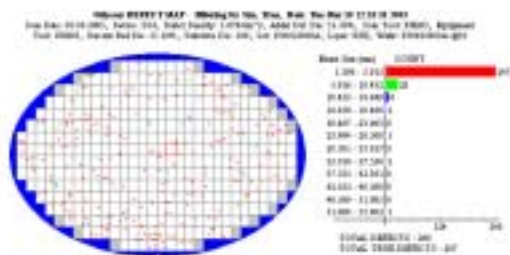
Fig 3.7 The result of adding O_2 plasma treatment in the end of poly etching. The removed efficiency is good for treatment 5, 10, 15 seconds.

O₂ plasma treatment can decrease of SF₅, and then decrease of F₁₁NS₂. According the

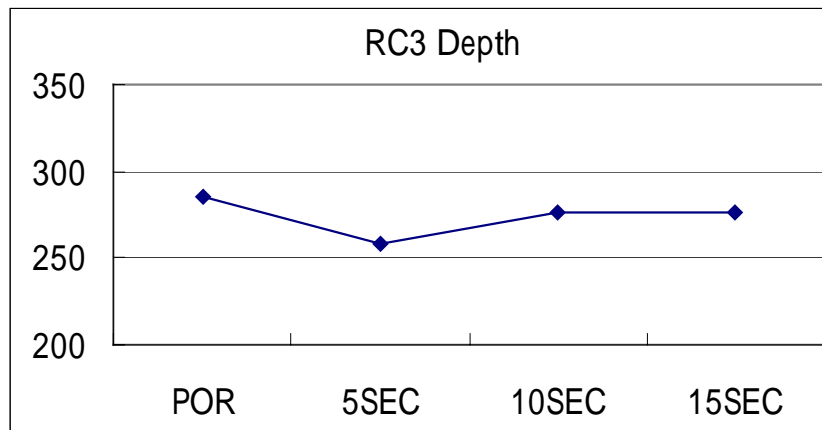
Fig 3.8 The O₂ plasma treatment don't influence poly etching performance. The depth is stable in different treatment time.
