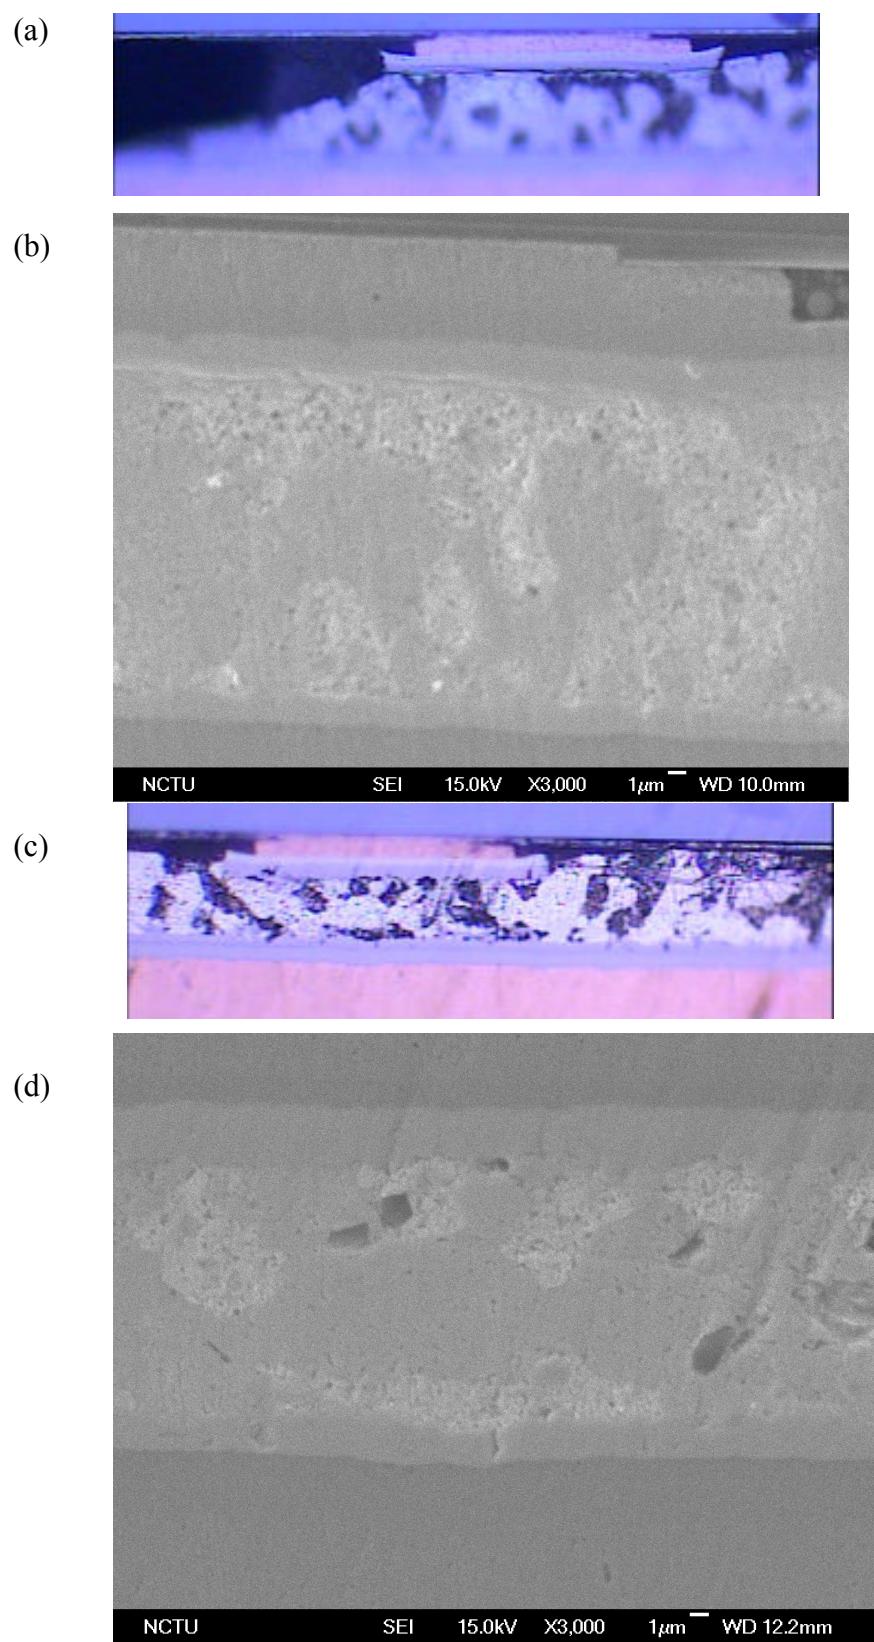
Fig. 4.5 Aging at 150°C (a) aging 1000hr OM (b) aging 1000hr SEM (c) aging 1500hr OM (d) aging 1500hr SEM

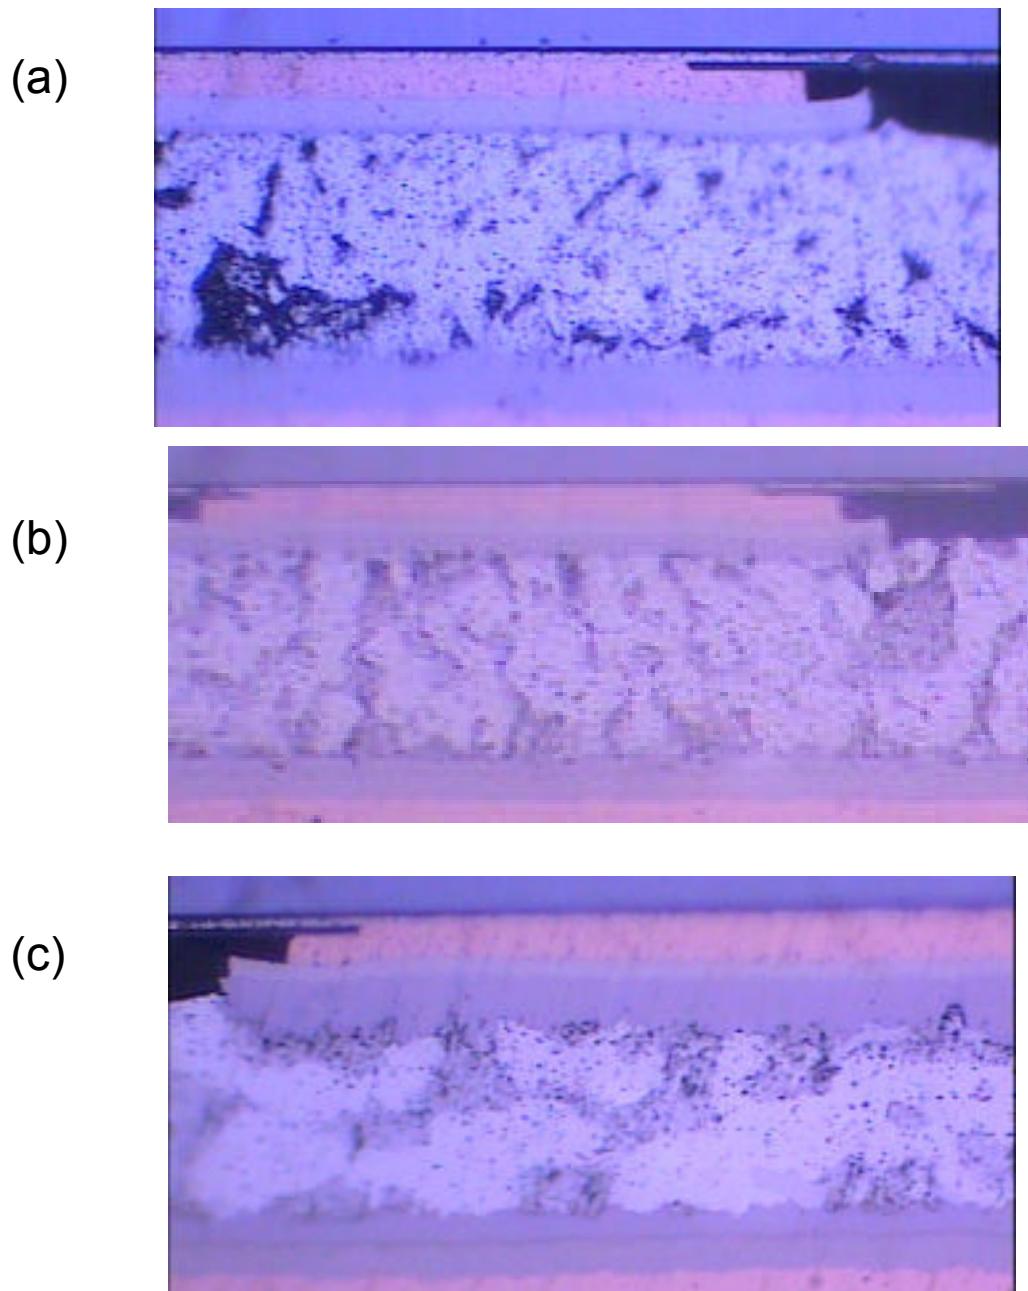
Fig. 4.6 Thick-film bump IMC thickness and aging time under 170°C (a)0hr(b)
25hr(c)50hr

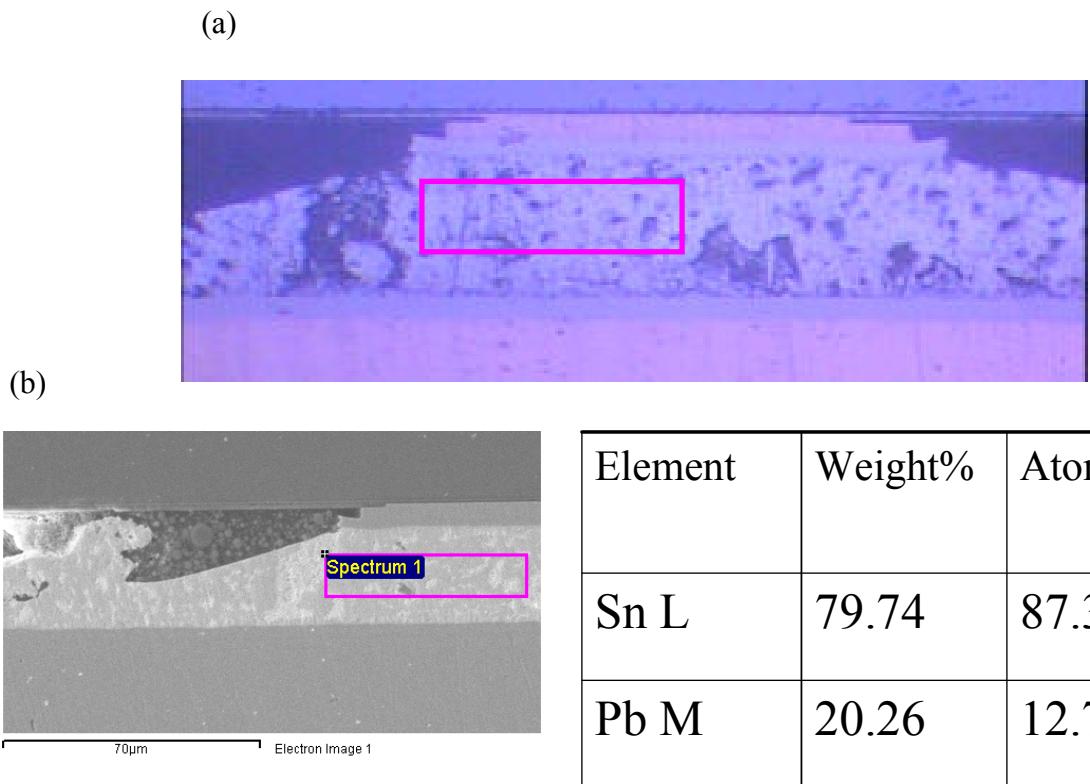
Fig. 4.7 No aging solder bump composition(a)OM image(b) SEI image

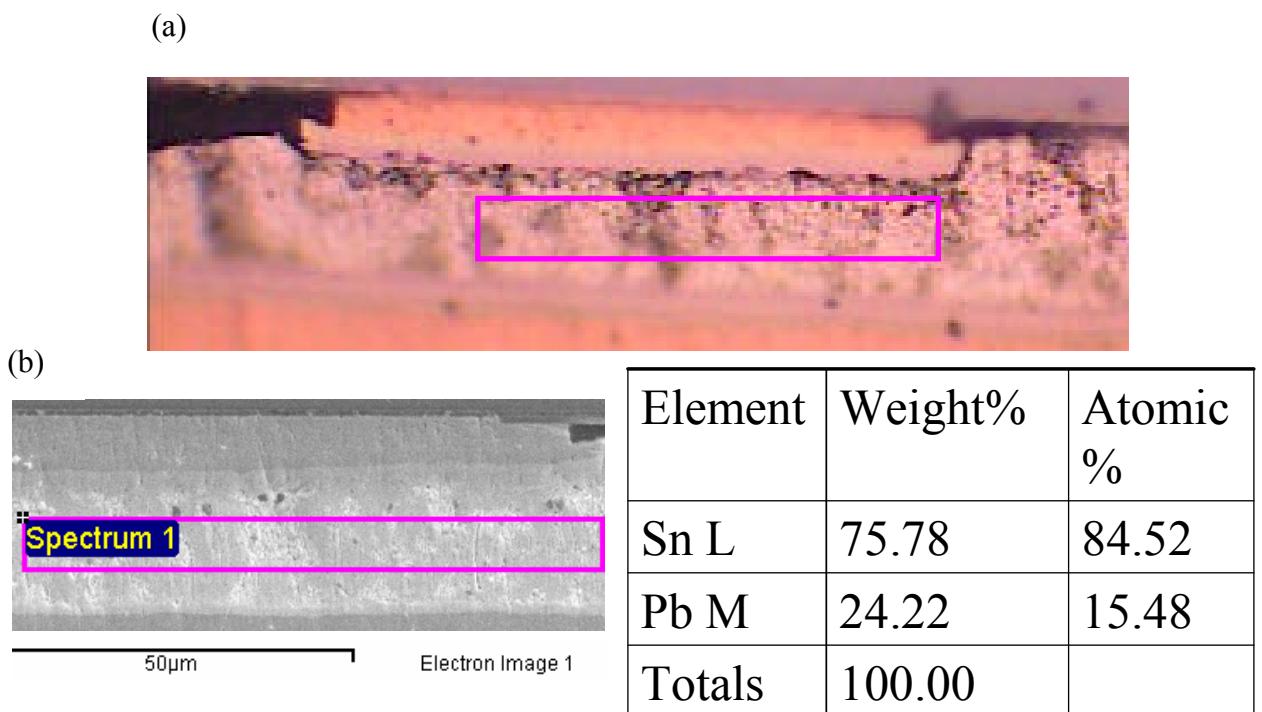
Fig. 4.8 Aging 25hr solder bump composition (a)OM image(b) SEI image

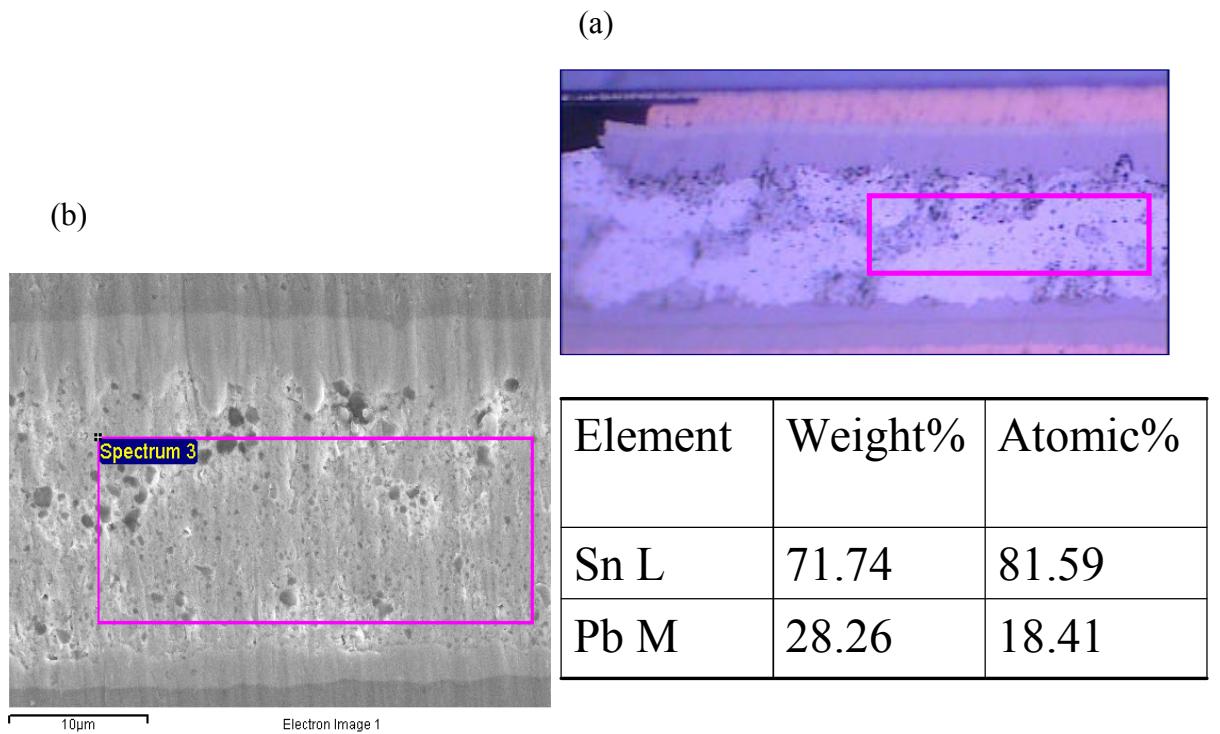
Fig. 4.9 Aging 50hr solder bump composition (a)OM image(b) SEI image

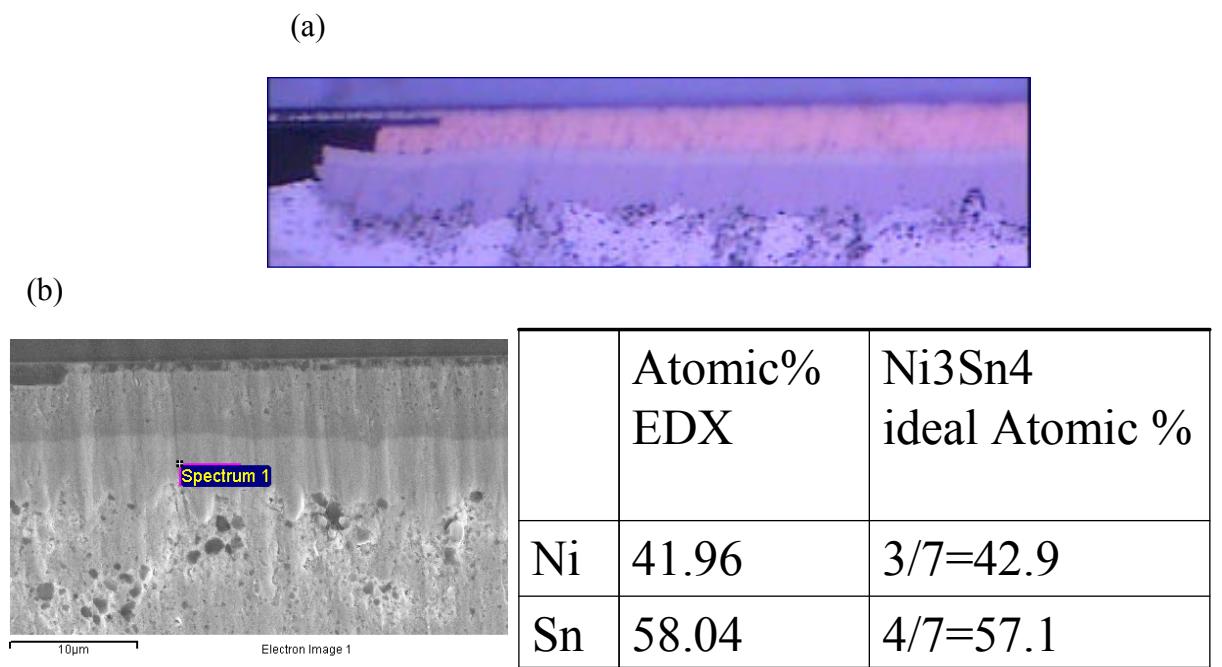
Fig. 4.10 Chip side IMC (a)OM image(b) SEI image

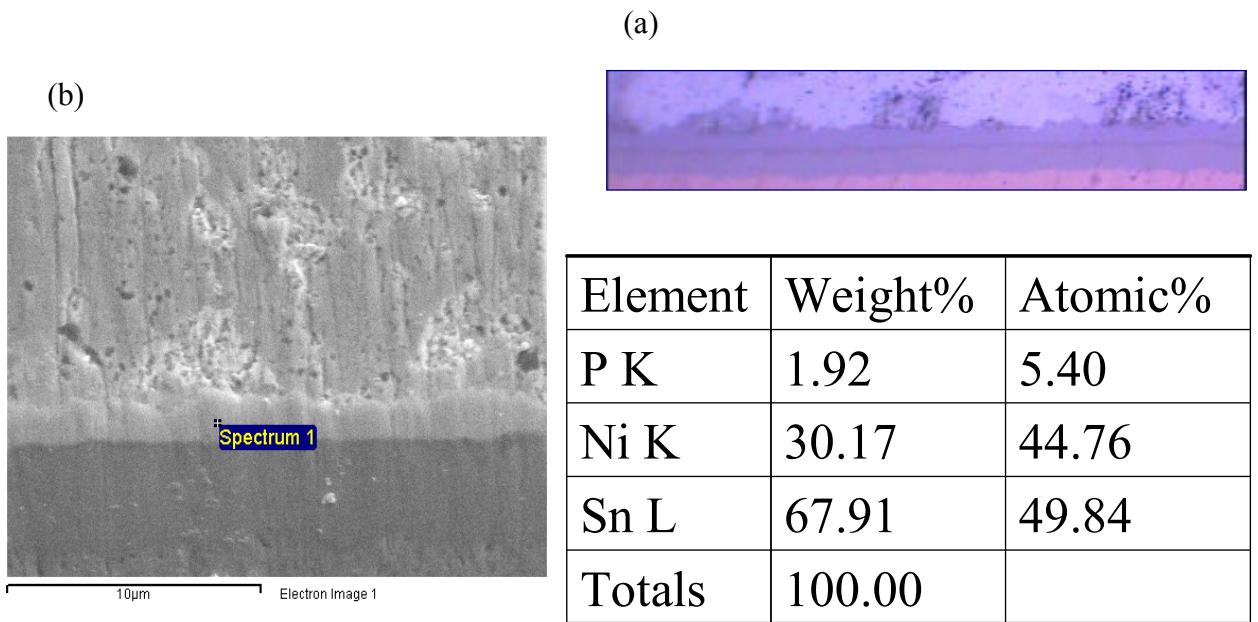
Fig. 4.11 board side IMC (a)OM image(b) SEI image

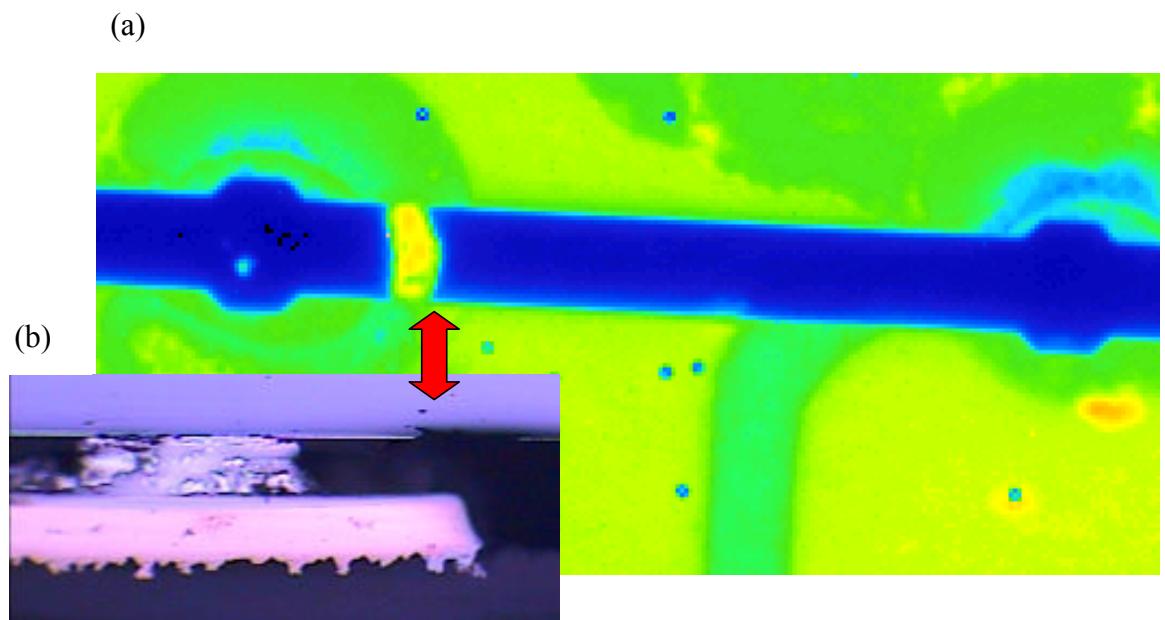
Fig. 4.12 Electromigration test fail at Al line instead of solder bump(a)IR image(b)OM image

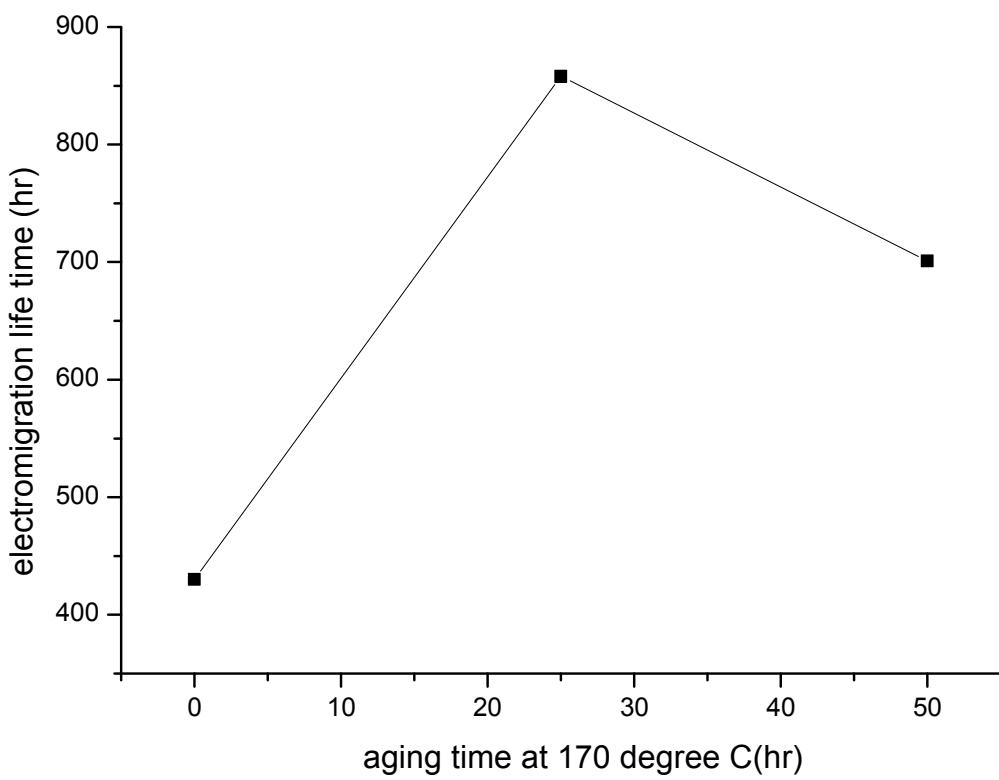
Fig. 4.13 Electromigration life time and under 170°C aging time in thick-film UBM

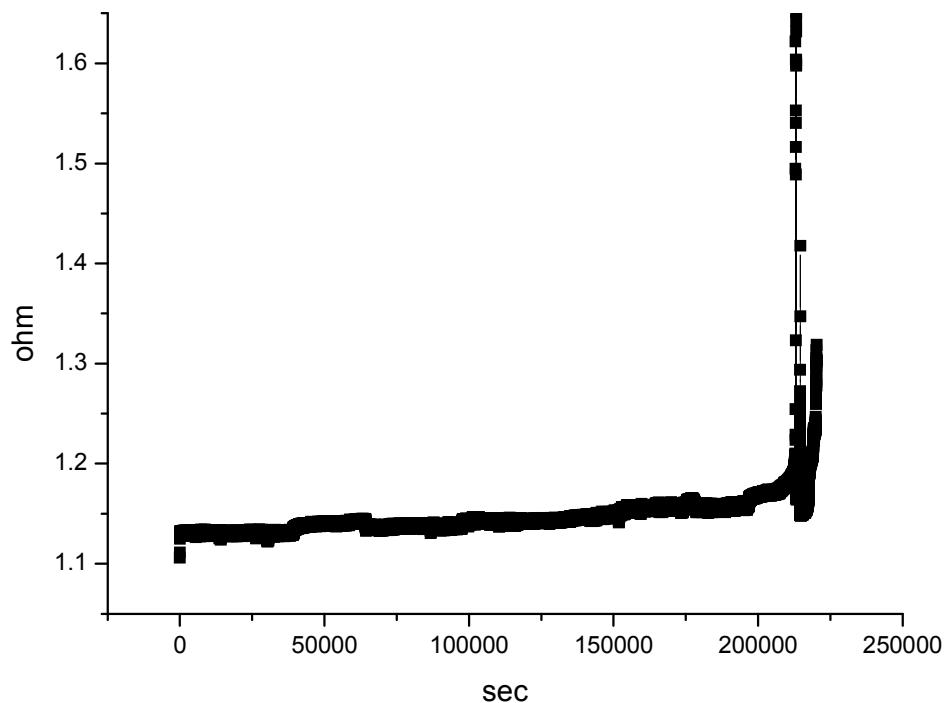
Fig. 4.14 All resistance of sample change before fail 61hr(total life time 385hr)

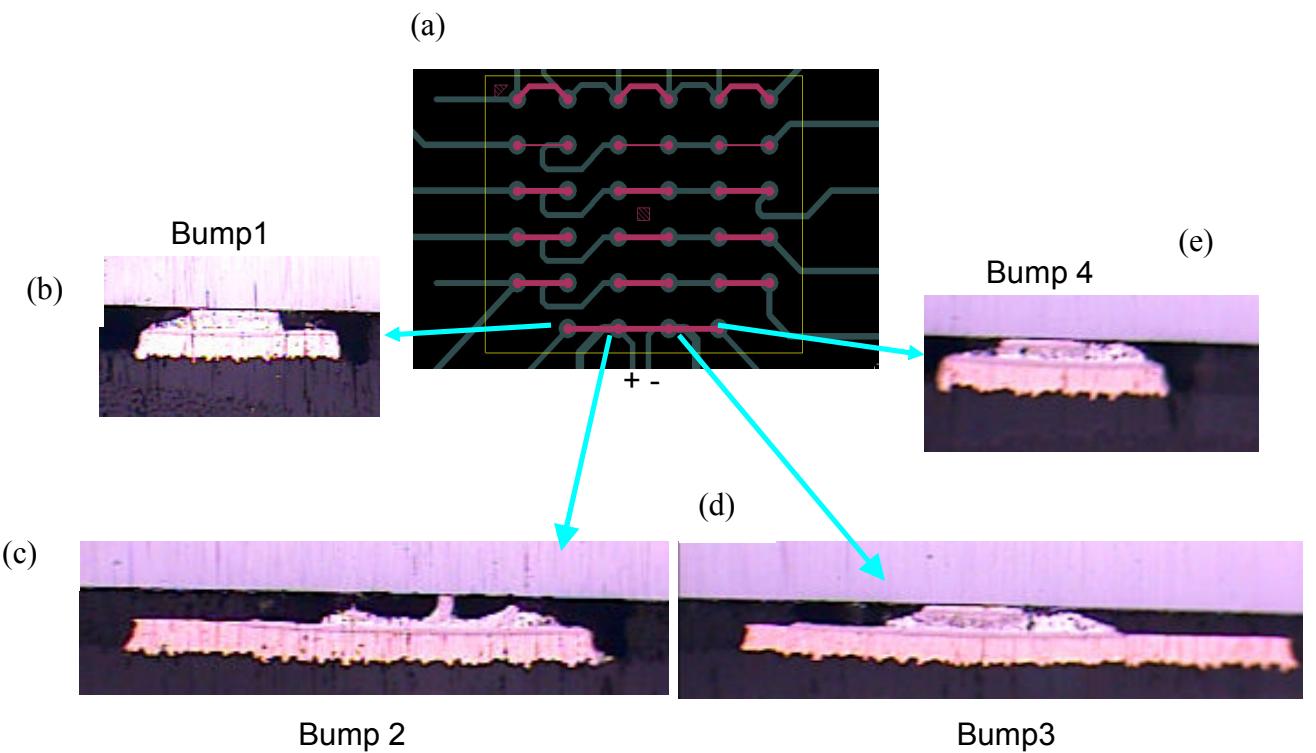
Fig. 4.15 Aging 0hr (failed at 385hr) OM image (a)chip side bump and Al distribution (b) bump1 (c)bump2 (d)bump3 (e)bump4

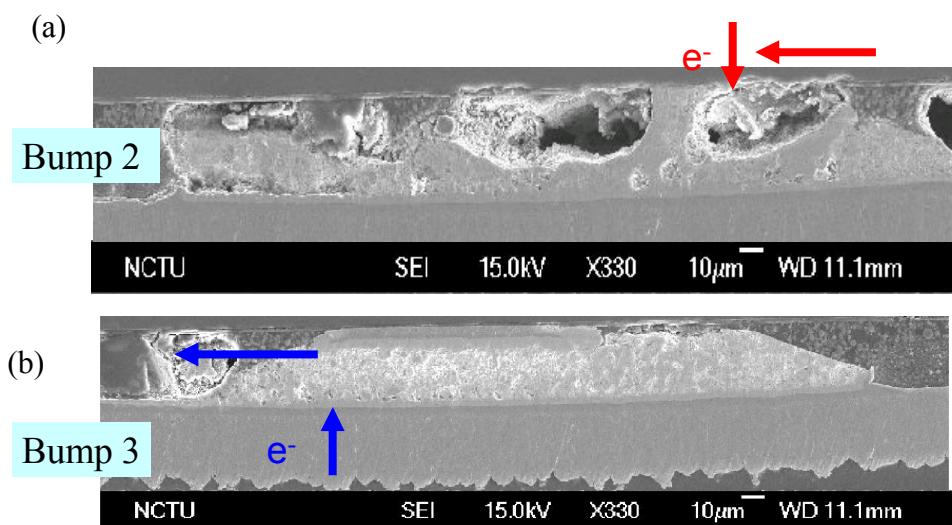
Fig. 4.16 Aging 0hr (failed at 385hr) SEM image(a)bump2 (b)bump3

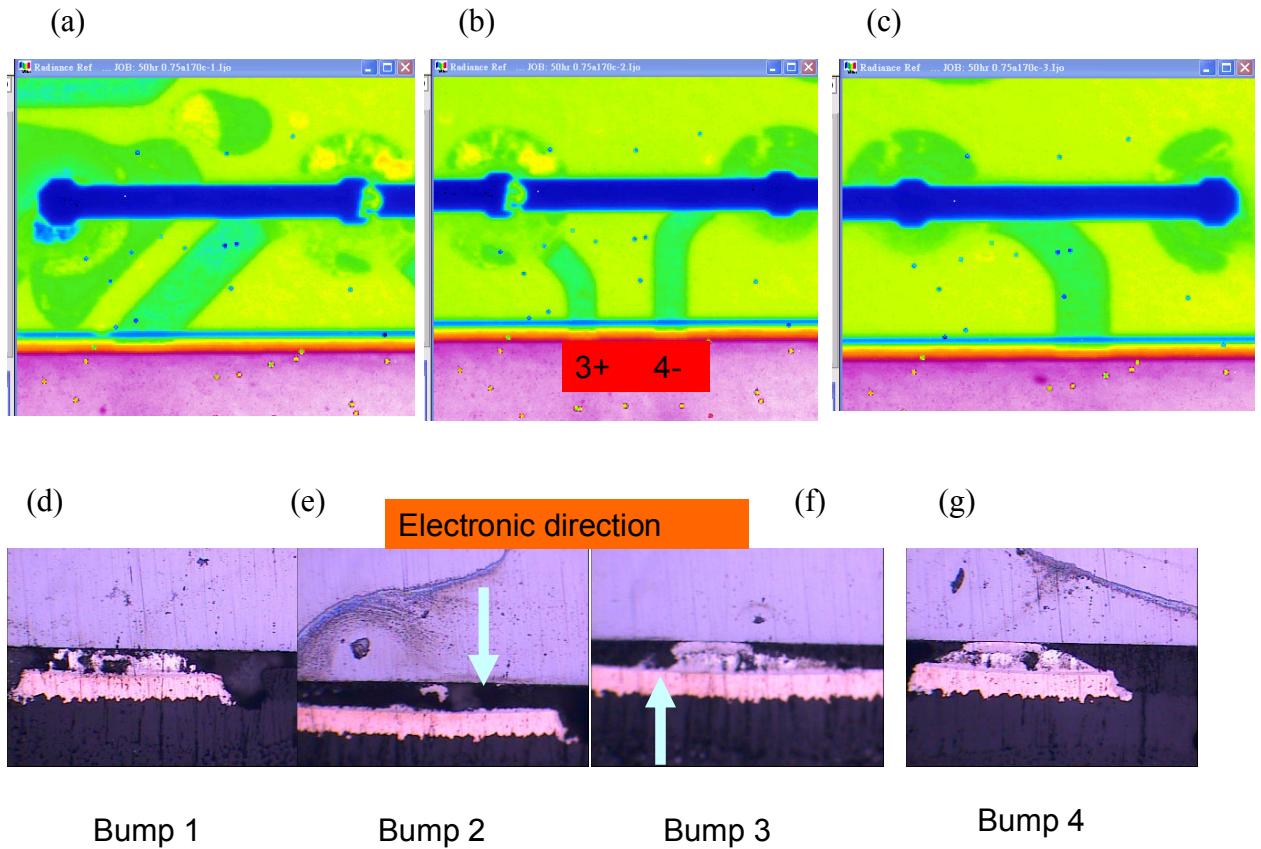
Fig. 4.17 Aging50hr (failed at 701hr) IR result and OM image(a)IR image of bump1 and bump 2(b) IR image of bump 2 and bump 3(c) IR image of bump 3 and bump 4(d)OM image of bump1(e) OM image of bump 2 (f) OM image of bump 3 (g) OM image of bump 4

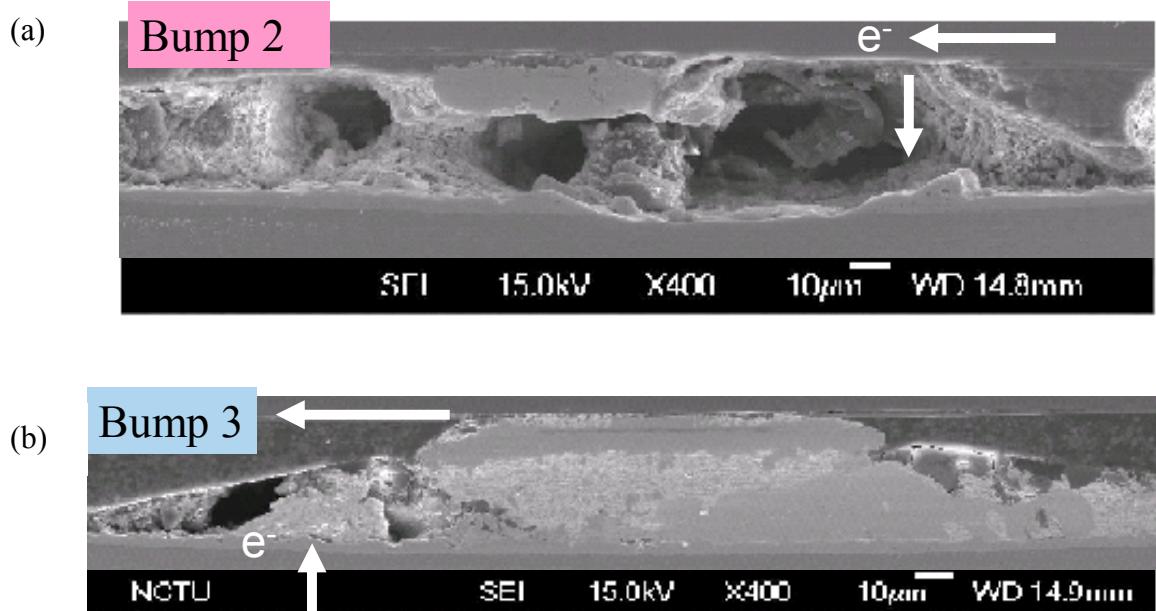
Fig. 4.18 Aging 50hr (failed at 701hr) SEM image(a) bump 2(b) bump 3
