# Microstructure evolution during electromigration in eutectic SnPb solder bumps

C.M. Lu, T.L. Shao, C.J. Yang, and Chih Chen<sup>a)</sup>

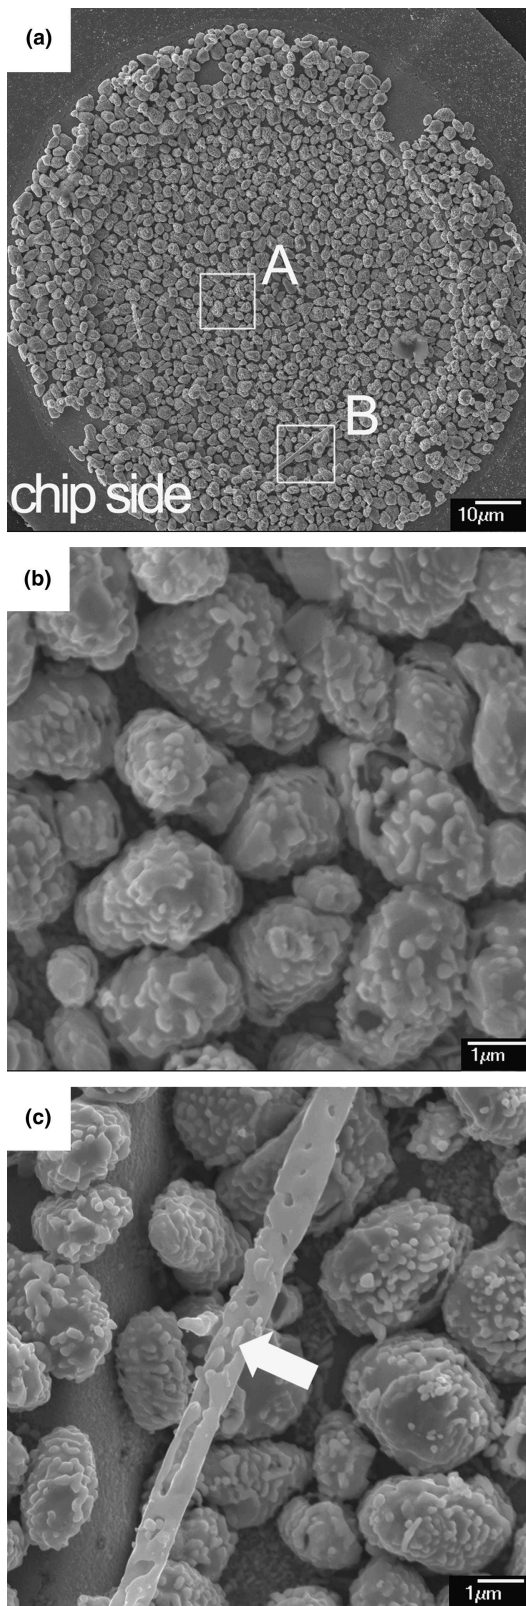
FIG. 2. Plan-view SEM images showing IMC morphology on the chip side (a) Panoramic view of the contact opening and  $\text{Cu}_6\text{Sn}_5$  IMCs. (b) Magnified SEM image of the rectangle area in (a). (c) Enlarged SEM image of IMC of the rectangular area in (a). The rod-type IMC indicated by the arrow is  $(\text{Cu}_y\text{Ni}_{1-y})_6\text{Sn}_5$ , in which a small percentage of Ni atoms was detected.

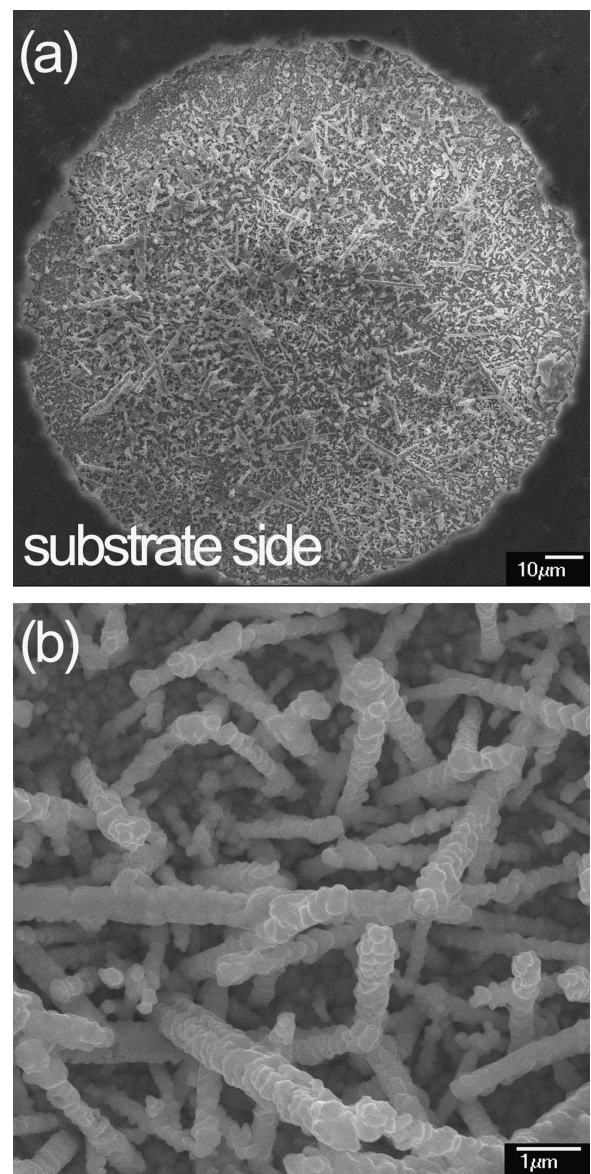
FIG. 3. Plan-view SEM images showing IMC morphology on the substrate side. (a) Panoramic view of the contact opening and  $(\text{Cu}_y\text{Ni}_{1-y})_6\text{Sn}_5$  IMCs. (b) The magnified SEM image of the rectangle area in (a), showing the morphology of  $(\text{Cu}_y\text{Ni}_{1-y})_6\text{Sn}_5$  IMCs.

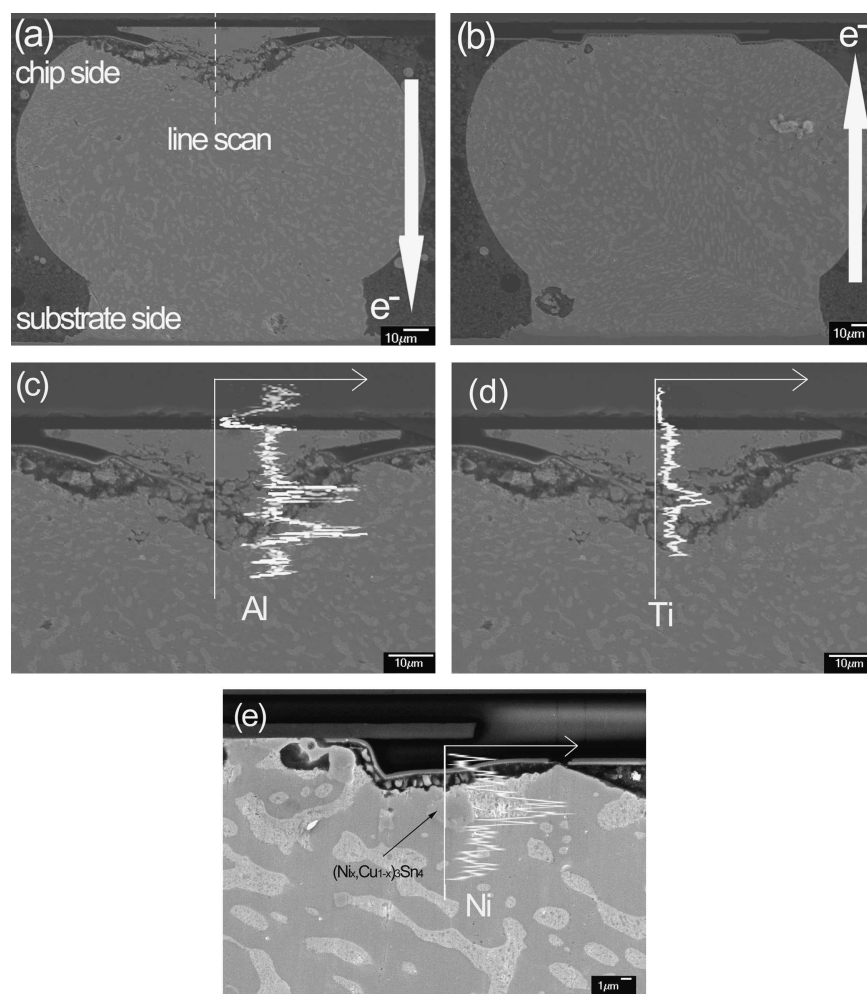
FIG. 6. Cross-sectional SEM images of bump pairs after stressing by  $5 \times 10^3 \text{ A/cm}^2$  at 150  $^\circ\text{C}$  for 216 h. (a) For the bump in which the direction of electrons drifted from chip to substrate end. (b) For the bump in which the direction of electrons was opposite to that in (a). The solder joints failed on the cathode/chip side. (c) Line-scan analysis for Al on the failed chip/cathode side. (d) Line-scan analysis for Ti on the failed chip/cathode side, showing the Al pad and that the UBM had migrated into the solder bump. (e) Line-scan analysis for Ni on the IMC near the anode/chip side.

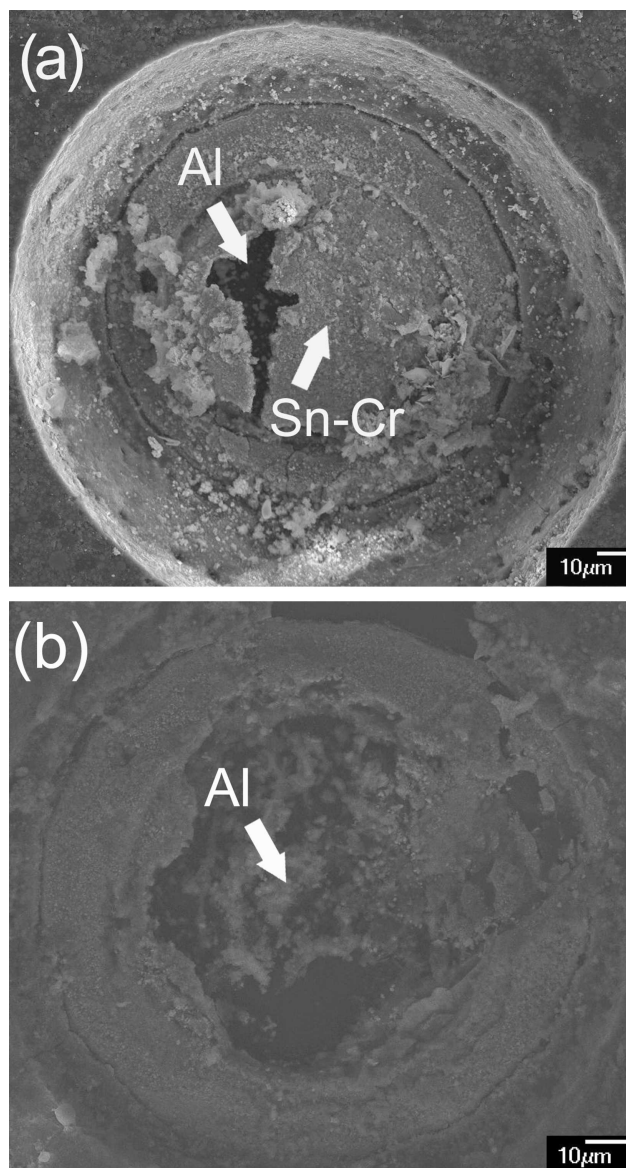
FIG. 7. Plan-view of SEM images on the cathode/chip side showing the damage caused by the electromigration under  $5 \times 10^3 \text{ A/cm}^2$  at  $150^\circ\text{C}$  for (a) 216 h, (b) 224 h.
