# A case of rapid rock riverbed incision in a coseismic uplift reach and its implications

Ming-Wan Huang, Yii-Wen Pan\*, Jyh-Jong Liao

Department of Civil Engineering, National Chiao Tung University, 1001, University Road, Hsinchu, 30010, Taiwan

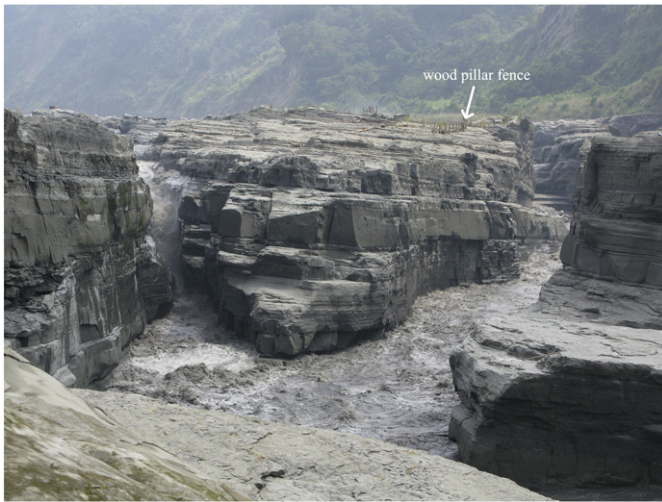
**Fig. 7.** The gorge-like channel with steep cliff banks. A branch in the left side created a knickpoint near the junction. For reference, the height of the wood pillar fence is 1 m.

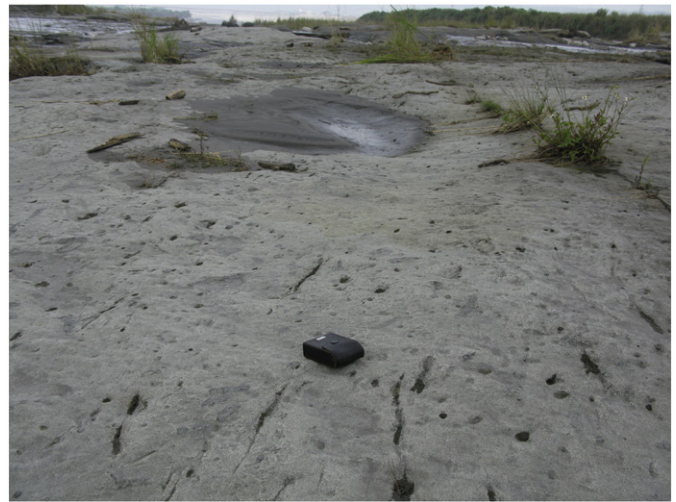
**Fig. 8.** A massive sandstone preserved the notches of abrasion by bedload saltation.

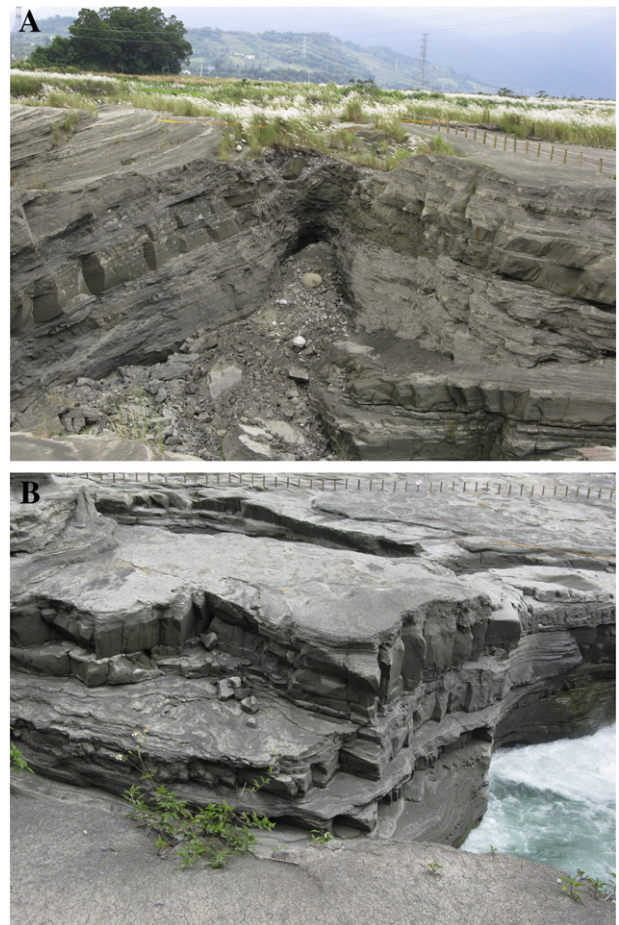
**Fig. 9.** Heavily jointed rock masses arise from coseismic uplift. (A) The anticline axis and the hinge of the west limb. (B) Horizontal rocks near the anticline axis. For reference, the height of the wood pillar fence is 1 m.

or massive sandstone) were overstressed and fractured (Fig. 9). Surficial flat fragments or small pieces of shale and thin interlayered shale/sandstone were easily removed by river flow (Fig. 10A). Moreover, broken sandstone blocks that were as large as a meter may lose support and stability after the underlying weaker rock layer is eroded (Fig. 10B). Relative to weathering and abrasion, plucking of rock blocks was the most effective process for large quantities of bedrock erosion in a short time. Joint spacing in this reach was generally in the scale of submeters. Erosion by plucking was common in the uplift reach. Therefore, plucking was considered the dominant erosion mechanism in the reach.

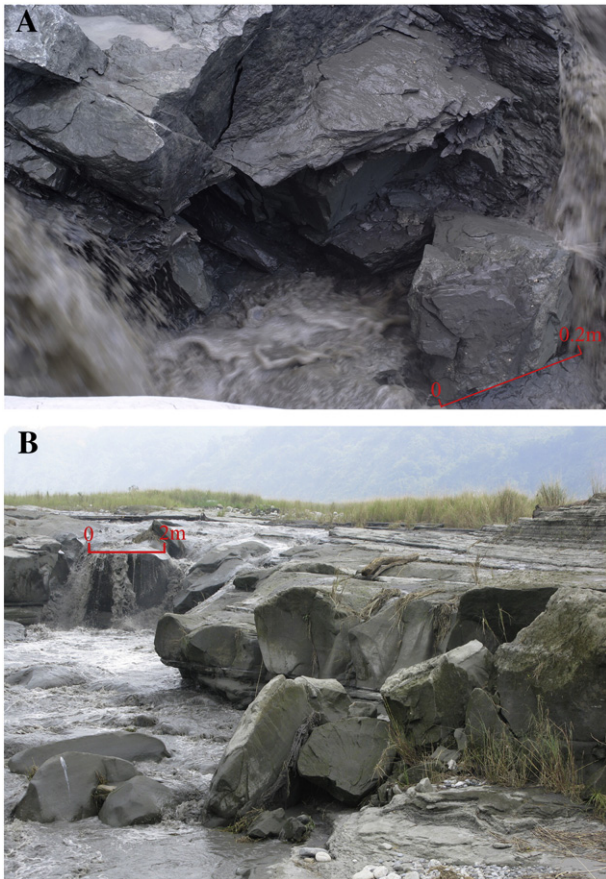
**Fig. 10.** Plucking process in the reach on (A) interlayered shale and sandstone; (B) massive sandstone.

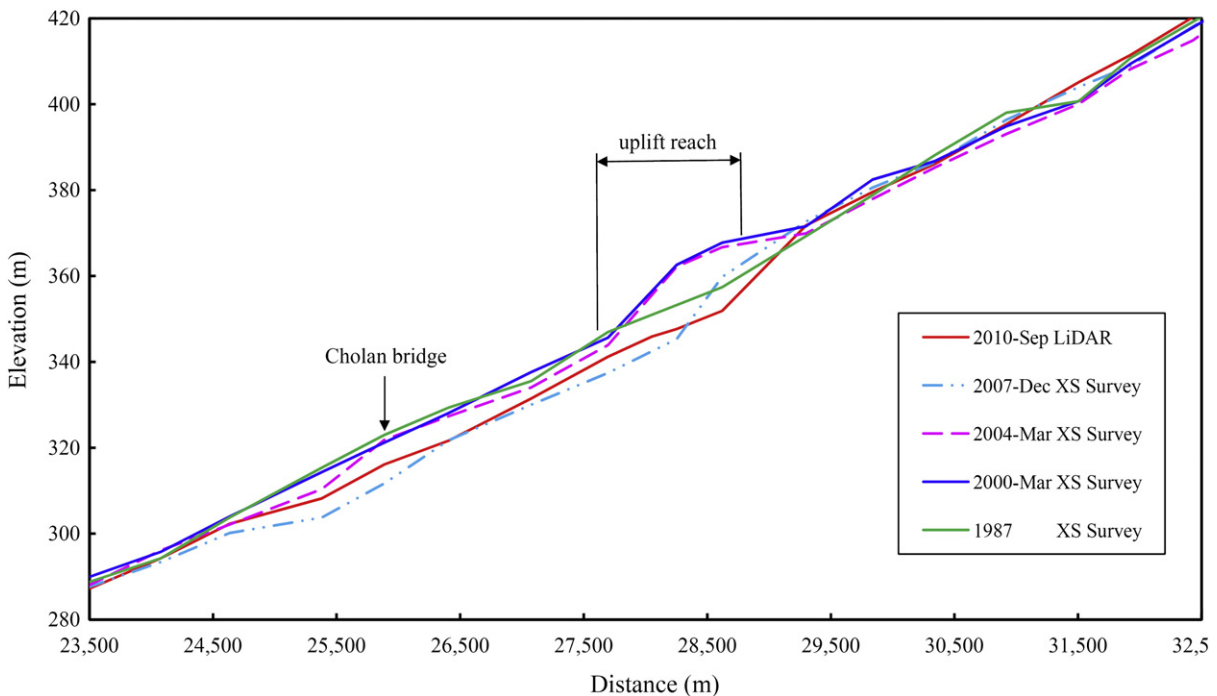
**Fig. 13.** The chronological longitudinal profiles between 23,500 and 32,500 m from the estuary. These profiles, in consecutive periods, show the multistaged variations of incision/deposition from upstream to downstream of the uplift reach.

Before the 1999 Chi-Chi earthquake, the Taan River was a typical graded stream with a smooth longitudinal profile (Fig. 13, 1987 profile). The coseismic uplift disturbed the original equilibrium state of the river system; it caused deposition upstream and incision downstream. The affected region in the river is ~5 km (Fig. 13, distance 24,500–29,500 m). Because of the bedrock incision in this reach for approximately a decade,

As shown in Fig. 13, the range of river affected severely by the uplift was a total of 5 km: 1 km in the uplift reach and 4 km in the downstream reach. The reason for a longer affected range in the downstream
