Journal of Constructional Steel Research 61 (2005) 1–21

Cyclic behaviour of unreinforced and rib-reinforced moment connections

This study investigates the cyclic behaviour of the beam-to-column welded moment connections used in steel moment-resisting frames. Two unreinforced welded connections were tested initially to elucidate the behaviour and failure mode. Test results showed that both specimens failed by the brittle fracture of the beam flange, initiated from the root of the weld access hole. Nonlinear finite element analysis was used to identify the causes of the failure. The stress concentration in the weld access hole region has the potential to cause the beam flange to fracture. Analytical results also demonstrated that reinforcing the connection with a single rib can reduce the concentration of stresses at the root of the weld access hole. Further tests of two specimens whose beam flanges were each reinforced by a single rib revealed that the single rib effectively prevents beam flange fracture in the weld access hole region.

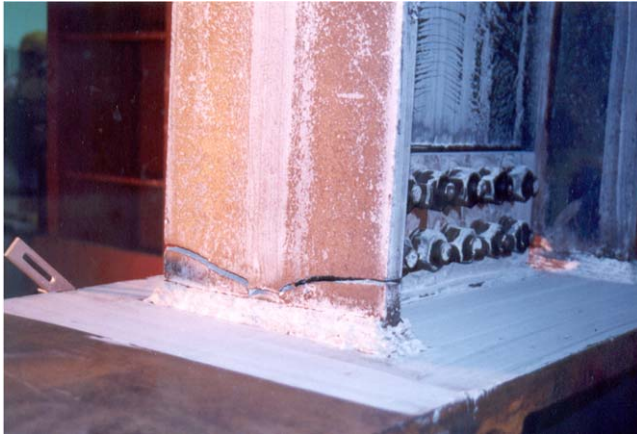
Fig. 6. Yielding and fracture of the beam flange of specimen S6.

The beam flanges close to the column in both specimens developed moderate inelastic behaviour. The yielding pattern of the beam flange of specimen S6 can be observed in Fig. 6. No sign of local buckling of the beam was observed before failure. Fig. 7 plots the maximum moment in the beam versus the total plastic rotation for both specimens. The moment was computed at the column face based on the load obtained from the actuator. The moment, M , was also normalized by the plastic flexural strength of the beam, M_p , according to material strengths measured in the tensile coupon test. The total plastic

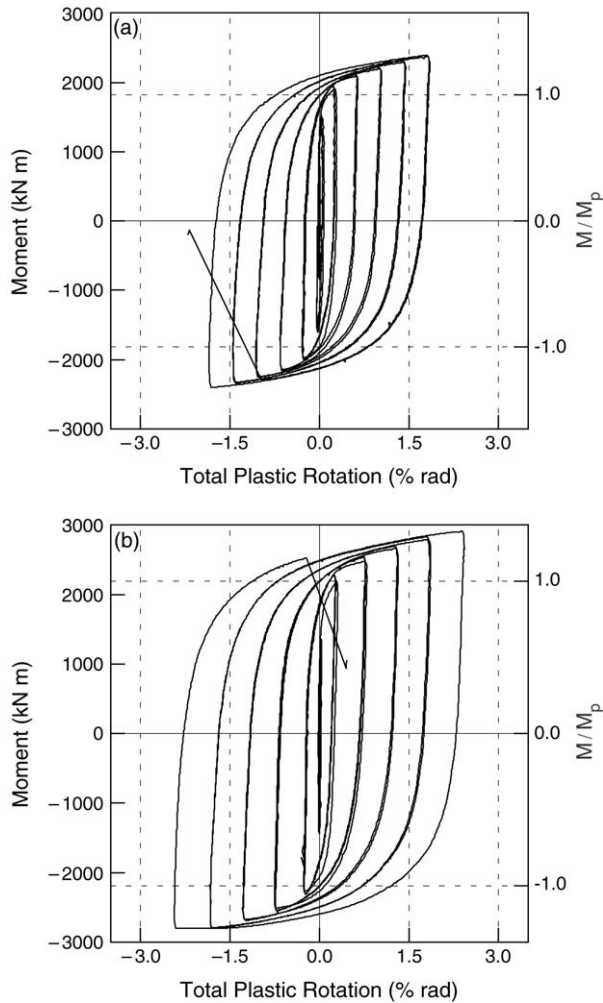
Fig. 7. Hysteresis curves of unreinforced connection specimens: (a) specimen S6; (b) specimen S7.

where K_θ is the elastic rotational stiffness of the specimen. Neither hysteresis curve in the figure reveals degrading of strength. Specimen S6 exhibited a total plastic rotation of only 1.9% rad corresponding to a maximum storey drift of 3.15% rad, while specimen S7 exhibited a total plastic rotation of 2.4% rad corresponding to a maximum storey drift of 3.6% rad. However, both specimens developed flexural moments greater than the plastic flexural strengths of the beam section.

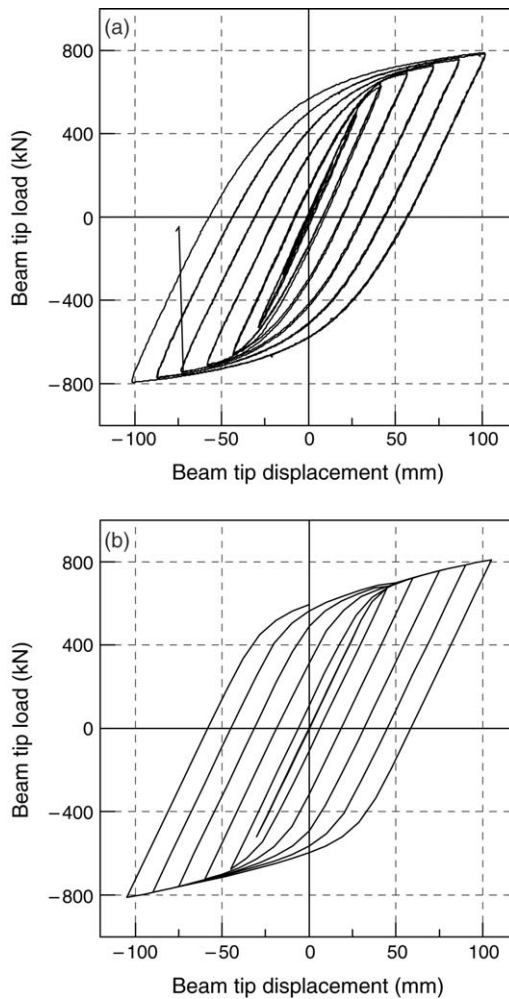
Fig. 10. Experimental and analytical hysteresis curves for specimen S6: (a) experiment; (b) finite element analysis.

The predictions of the finite element analysis were compared with the experimental results in terms of load and deformation relations to verify the analytical model. Fig. 10

plots the beam tip load versus the displacement for specimen S6, as determined by finite element analysis and experimentally. The results are consistent with each other. The analytical results are also plotted in the form of a stress distribution to elucidate the yielding and plasticization of the connection. Fig. 11 displays the von Mises stress distribution in the beam-to-column joint and the adjacent beam section at a plastic rotation of 3% rad because SAC [16] recommended a 3% rad minimum plastic rotation capacity for the connection of the moment frames. The beam flange yielded near the column face because the critical section through which the beam forces were transferred to the joint was the joint–beam interface. Localized stress concentrations were observed in the beam-to-column interface and in the weld access hole region, owing to the geometric discontinuity at the joint.

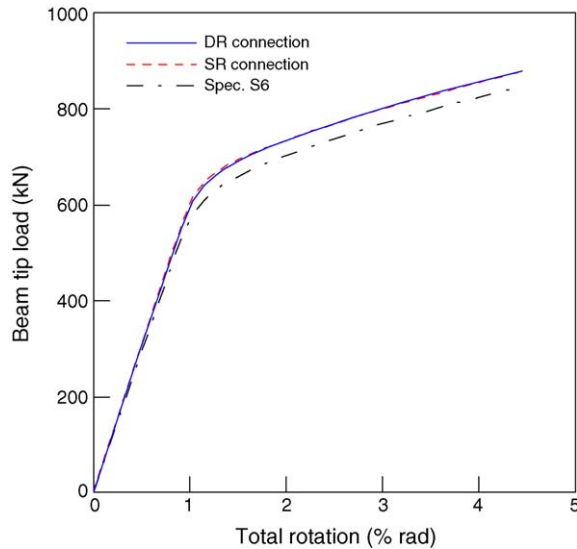
Fig. 14. Load versus total rotation relations for various connections.

Fig. 14 presents the beam tip load versus total rotation for specimen S6, DR and SR connections, to examine the global behaviour of the connections. The curves for DR and SR connections were virtually identical because both connections formed plastic hinges in the beam beyond the rib tip. Both DR and SR connections exhibited a higher ultimate capacity than specimen S6, but had the same elastic stiffness, because both connections were shorter from the beam tip to the plastic hinge than in specimen S6.

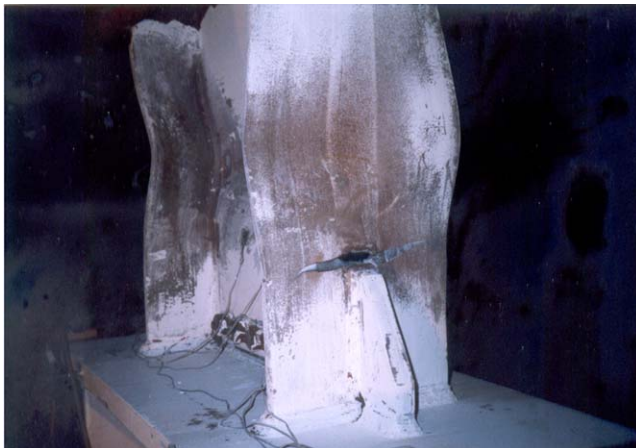
Fig. 19. Specimen SR30 after failure.

cycles of 1% rad storey drift. The beam flanges underwent slight local buckling at a storey drift of 2.3% rad. A minor crack in the bottom flange of the beam at the rib tip was detected at a storey drift of 2.8% rad. This crack grew slowly but propagated toward the base metal of the beam flange. This ductile tearing of the base metal gradually reduced the strength of the connection. Fig. 19 shows the fracture of the beam flange at a storey drift of 4.1% rad; the test was terminated during these cycles because of a great loss of strength.

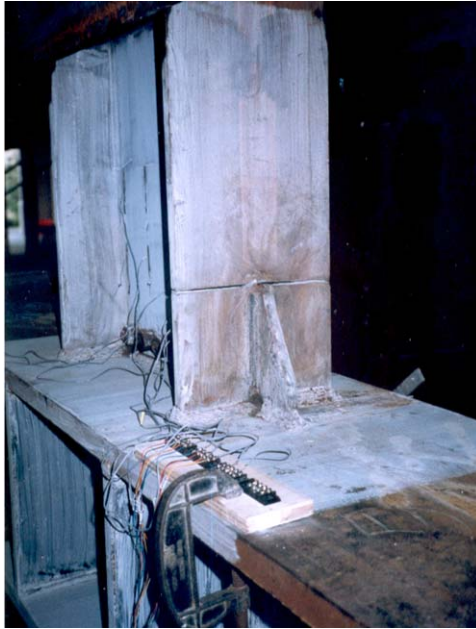
Fig. 20. Specimen SR20 after failure.

Before the cycles associated with 2.3% rad storey drift, the behaviour of specimen SR20 was quite similar to that of specimen SR30. The top flange of the beam cracked at the rib tip at a storey drift of 2.3% rad. Unlike the crack in specimen SR30, this crack did not grow. In contrast, specimen SR20 failed with a very loud bang caused by the fracture of the beam top flange at a storey drift of 2.8% rad. This brittle crack led to complete fracturing of the top flange of the beam, as displayed in Fig. 20.
