## Evaluation of reinforced connections between steel beams and box columns

### Abstract

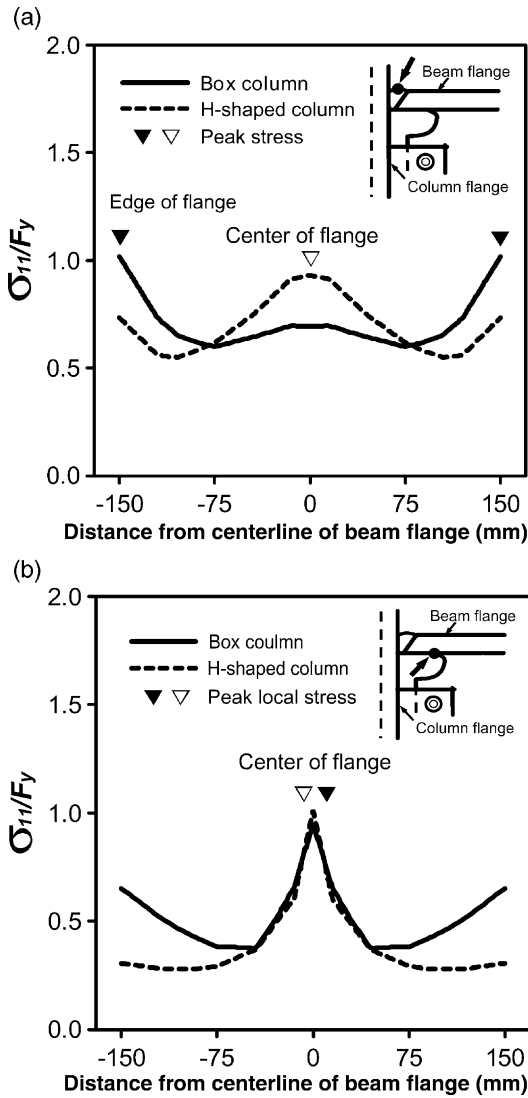
Fig. 3. Distributions of normalized longitudinal stresses along beam flange width at 0.5% story drift angle: (a) at CJP weld; (b) at root of weld access hole.

The elementary analyses presented herein emphasize the distribution of elastic stresses and the plastic equivalent strains in the joint at the CJP weld and the WAH region because the presence of the WAH greatly affects the fracture of the beam flange [2,19,20]. Distributions of normalized longitudinal stresses at 0.5% story drift angle and PEEQ indices at 4% story drift angle, along the beam flange width at the locations of the CJP weld and the root of the WAH, are plotted in Figs. 3 and 4, respectively. The normalized longitudinal stress is defined as the normal stress,  $\sigma_{11}$ , normalized by the yield stress,  $F_y$ . The PEEQ index is defined as the plastic equivalent strain, which represents local strain demand, divided by the yield strain,  $\varepsilon_y$ . Moreover, the story drift angle of 0.5% was selected to study the elastic behaviour of the connection, while the story drift angle of 4% indicates that the connection undergoes required inelastic deformation. The stresses exhibited by the connection with the box column were concentrated at both edges of the beam flange groove weld. However, the connection with the H-shaped column exhibited peak local stress streaming into the center of the beam flange at the CJP weld, as shown in Fig. 3(a). Similar analytical results were observed by Kim et al. [15]. The distinct distributions of the stresses at the CJP weld are attributed primarily to the stiffness provided by the column web, because the box column has two webs on both sides whereas the H-shaped column has only one web through the center of its cross section. PEEQ indices at 4% story drift angle shown in Fig. 4(a) demonstrated identical distribution as that of longitudinal stresses. Distributions of the longitudinal stresses along the beam flange width at the root of the WAH are shown in Fig. 3(b), and PEEQ indices are plotted in Fig. 4(b). Both connections, with the box

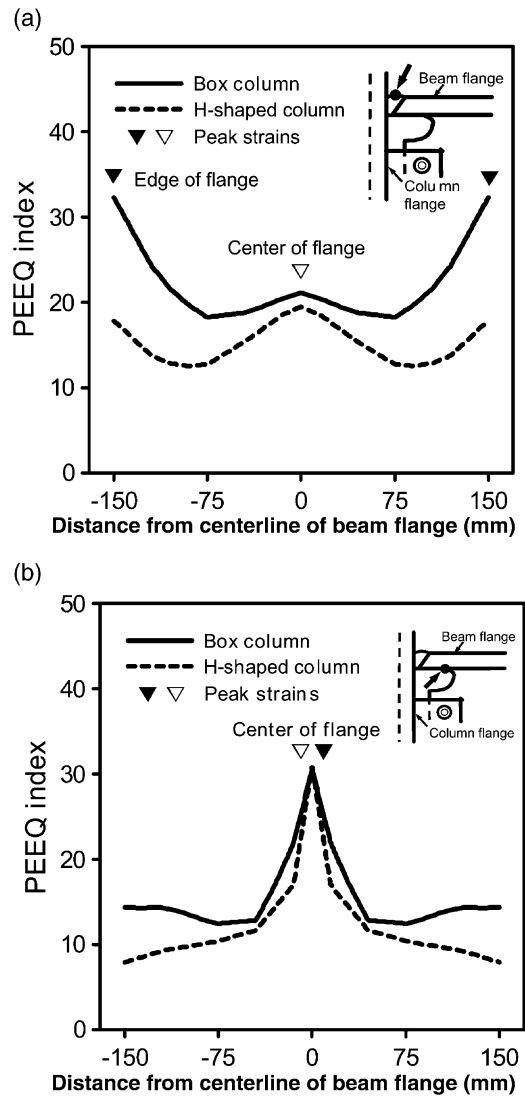
Fig. 4. Distributions of PEEQ indices along beam flange width at 4% story drift angle: (a) at CJP weld; (b) at root of weld access hole.

4.1.2.1. Specimen BR115SB. Extensive yielding was observed in beam flanges and the web within the region of the rib extension. This observation is consistent with the objective of the design of the lengthened flange rib. However, cracks were initiated in the CJP weld fusion zone at the edges of the top and bottom flanges of the beam at the first cycle of 3.4% story drift angle. The observation of concentrations of plastic equivalent strains in the finite element analysis, shown in Fig. 4(a),

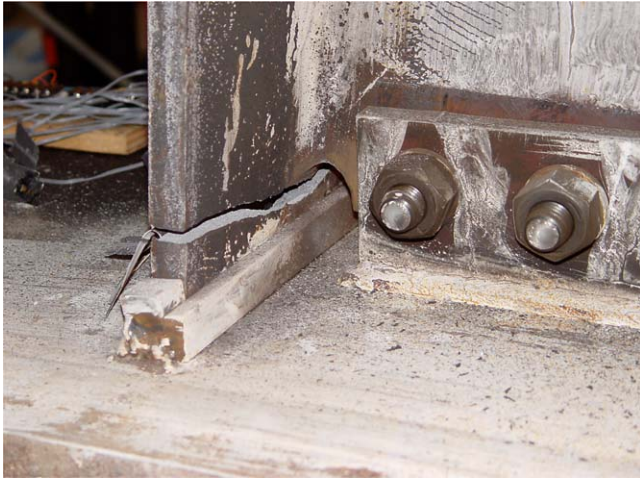
Fig. 14. Fracture of beam top flange of unreinforced specimen BUN.

brittle mode with a rapid drop in beam strength caused by the fracturing of the bottom flange of the beam during the 2.3% story drift angle cycle. The cracks originated in the nicks at the root of the CJP flange welds, and propagated rapidly through the beam flange. After the bottom flange had fractured, reverse monotonic loading was exerted to cause the specimen to fail on purpose, to identify the failure mode in the beam top flange. Eventually, fracturing of the beam top flange was initiated in the toe of the WAH, as presented in Fig. 14. This failure demonstrates clearly that the WAH is an indigenous defect of an unreinforced connection, regardless of the geometry of the cross section of the column.

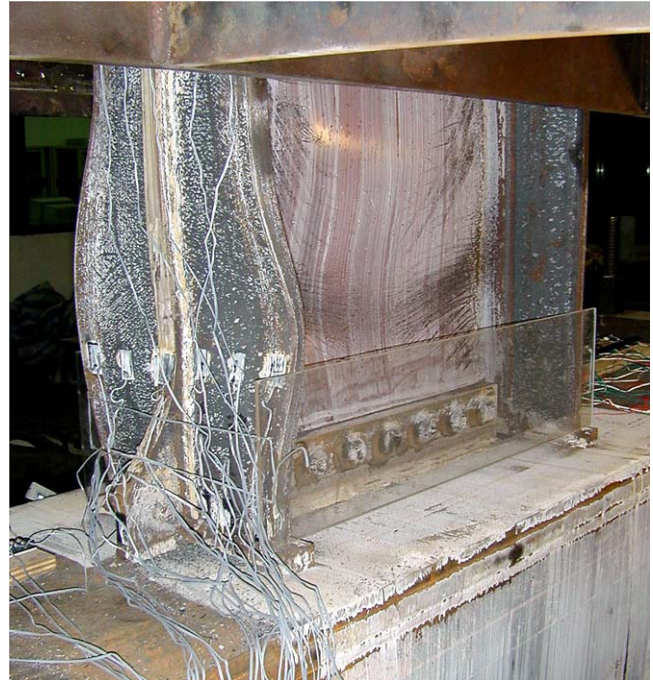
Fig. 16. Local buckling of beam flange and web of specimen BR105SB.

angle, test was terminated due to the excursion limitation of the actuator. No brittle fracture was observed either at the weld joints or in the WAH region during the test. Fig. 16 shows the local buckling in the beam of specimen BR105SB at 5.1% story drift angle.

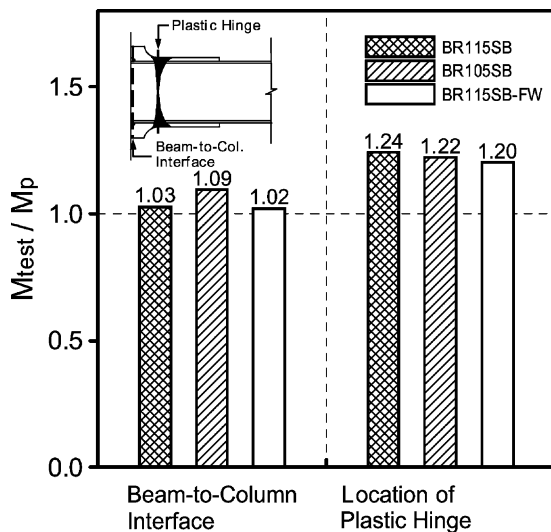
Fig. 21. Ratios of flexural moment to plastic flexural capacity.

Variations of flexural moment along the length of the beam are examined to further verify the efficacy of the lengthened flange rib. The degree of yielding of the beam section can be determined by comparing the test moment to the flexural capacity of the beam. Two critical locations are of interest—the beam-to-column interface and the plastic hinge. Accordingly, the maximum test moment,  $M_{\text{test}}$ , is defined as the maximum testing load multiplied by the distance from the beam tip to either the beam-to-column interface or the location of the plastic hinge. Fig. 21 plots the ratios of the maximum test moment to the plastic flexural capacity of the beam, including the rib plates,  $M_{\text{test}}/M_p$ , for the three flange rib-reinforced specimens. The ratios at the interface are in the range 1.02–1.09, implying

that the test moments barely reach the plastic flexural capacity of the beam at the beam-to-column interface. Meanwhile, the ratios at the location of the plastic hinge range from 1.20 to 1.24, indicating that the beam yielded at the location of the plastic hinge and the beam sections were stressed into the strain-hardening range. These limited test results imply that specimens
