# Seismic Rehabilitation of Welded Steel Beam-to-Box Column Connections Utilizing Internal Flange Stiffeners

This work investigates the seismic performance of rehabilitated steel moment connections using internal flange stiffeners (IFSs) welded to the face of a built-up box column and a beam flange inner side. The objective is to provide a rehabilitation scheme that excludes interference from the composite slab and story height limitation in an existing steel building. Five rehabilitated moment connections with different IFSs were tested according to AISC (2005) loading protocol to validate their cyclic performance. Two rehabilitated moment connections had excellent performance; no welded joint fractures were found in the connections with a drift in excess of 4%. The specimens were modeled using the computer program ABAQUS to further verify the effectiveness of the IFSs in transferring beam moments to a column and to investigate potential sources of connection failure. Design guidelines for the rehabilitation scheme are provided based on test and analytical results. [DOI: 10.1193/1.3480275]

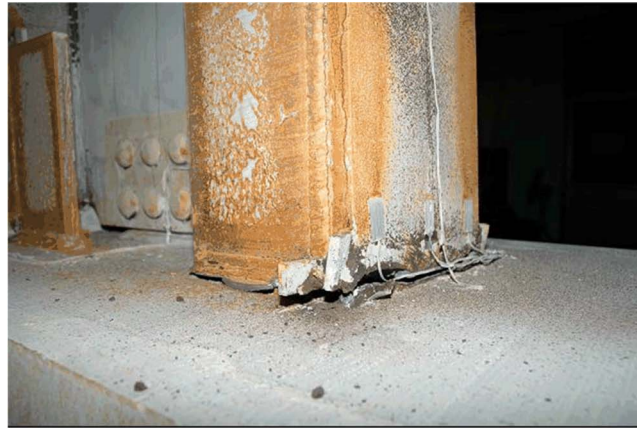
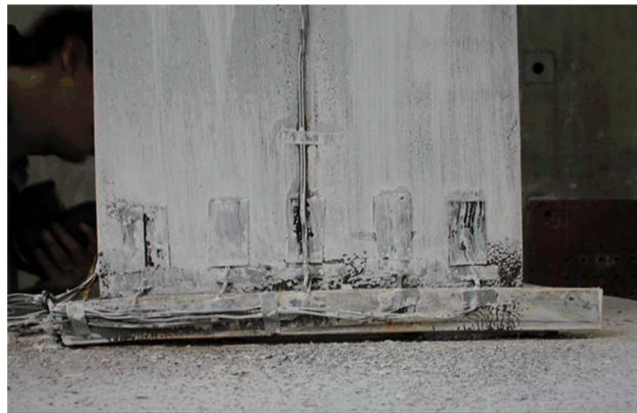
(a) Specimen IFS1 (Top Flange)

(b) Specimen IFS2 (Bottom Flange)

**Figure 6.** Specimens IFS1 and IFS2 weld fractures.

Figures 4b and 4d show the hysteretic responses of Specimens IFS1 and IFS3, respectively. These two specimens sustained inelastic cycles of loading up to a 3% drift before a brittle fracture occurred in the top flange weld. The fracture passed completely through the groove-welded metal connecting the top flange to the column (Figure 6a). Specimen IFS2 had a brittle fracture in the bottom flange weld, causing complete separation of the beam bottom flange from the column face (Figure 6b). Further investigation after the beam was removed from the column indicated that the fracture was within the

column face, immediately adjacent to the groove weld. Specimens IFS1 and IFS2 had a similar deformation capacity irrespective of whether the flange groove welds were made in the field or laboratory. This finding suggests that using high-toughness electrodes is highly beneficial to connection behavior. Even when toughness is reduced due to improper welding conditions (field versus laboratory), a very high level of toughness can remain. However, such a connection still fails to satisfy the stringent [AISC seismic provisions \(2005\)](#). These specimen failures suggest that reinforcement, which corresponds to low beam capacity-demand ratios (Table 2), does not reduce the stress concentration in groove welds, and considerable reinforcement is needed to improve connection behavior.

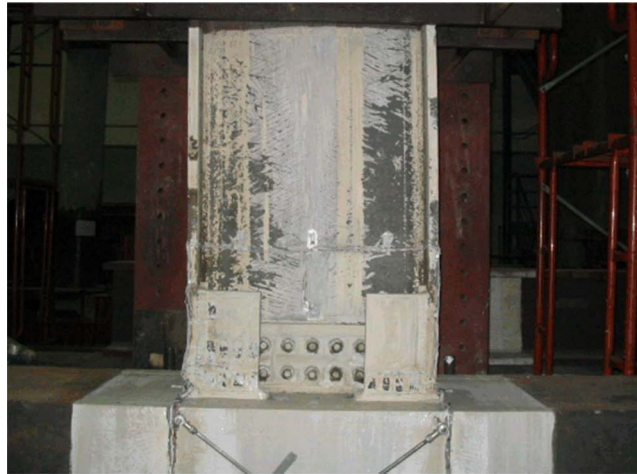
(a) First Test

(b) Second Test

**Figure 7.** Yielding and buckling in Specimen IFS4 (4.4% drift).

Since beam local buckling was minor and no strength degradation was observed after the first cyclic test, Specimens IFS4 and IFS5 were retested using the same [AISC loading protocol \(2005\)](#). The hysteretic responses in the first and second tests were similar (Figures 4e and 4f). However, at an interstory drift of 3%, beam local buckling accompanied by beam twisting caused a small reduction in beam flexural strength for both specimens. At the end of the second test for Specimen IFS4 (4.4% drift), flange and web buckling amplitudes increased to 27 mm and 52 mm (Figure 7b), respectively, reducing strength by 6% compared with that in the first test (Figure 4e). Because beam residual deformation of Specimen IFS5 was large after the first test, this specimen was re-loaded to an interstory drift between  $-4$  and 3.6%. A minor tearing of the beam flange at the end of the stiffener was observed at an interstory drift of 2%. However, this tearing (Figure 8a), caused by flange local buckling, had no adverse effect on specimen strength throughout the second test. Figure 8b shows the yielding and buckling pattern of Specimen IFS5 after the second test; flange and web buckling amplitudes were 21 mm and 32 mm, respectively. The hysteretic loop had a slight reduction in strength (Figure 4f).

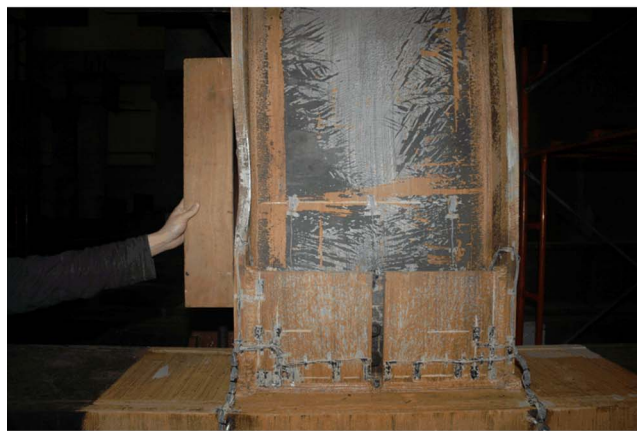
(a) Crack at IFS End

(b) Buckling Pattern

**Figure 8.** Specimen IFS5 after second test.

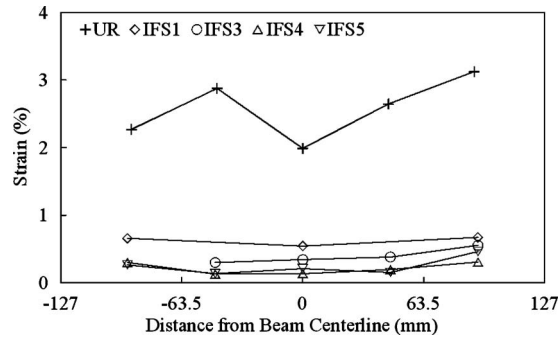
Figure 9. Strain profiles across the beam bottom flange width (3% drift).

The ability of the IFS to decrease beam flange tensile strain was observed from measured strains at 60 mm from the column face (Figure 9). At an interstory drift of 3%, tensile strains in the beam bottom flange of non-rehabilitated Specimen UR were in the range of 2–3%, much higher than those of rehabilitated specimens. The tensile strains in Specimen IFS3 were lower than those in Specimen IFS1, suggesting that the IFS located close to the side plate of the welded box column effectively reduced tensile strain. Furthermore, failed

Specimens IFS1 and IFS3 had higher tensile strains than successful Specimens IFS4 and IFS5, indicating that the IFS with adequate strength and stiffness effectively reduced strains and thereby prevented flange groove-weld fracture. Maximum tensile strain for successful Specimens IFS4 and IFS5 at an interstory drift of 4% was about 0.8%, equaling  $5.6\varepsilon_y$ , where  $\varepsilon_y$  is yield strain.

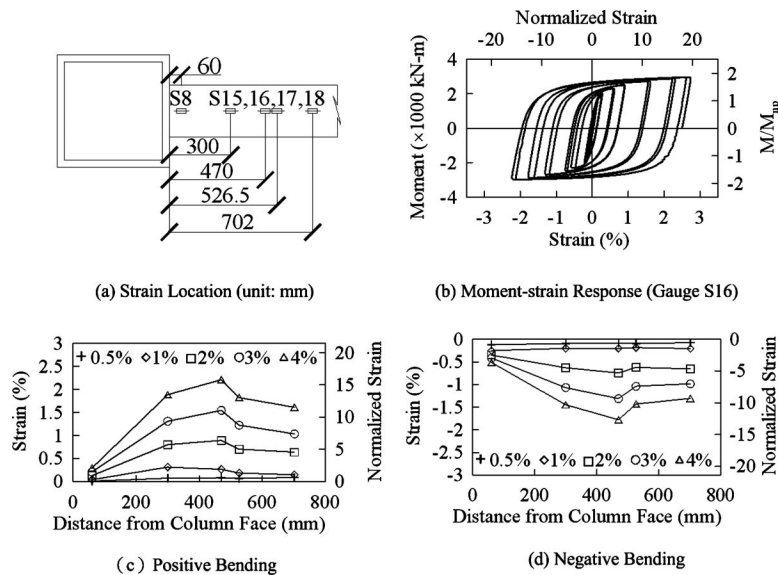
Figure 10. Bottom flange strain profiles along a beam axis (Specimen IFS5).

Flange strain along the beam axis of Specimen IFS5 was highest beyond the IFS (Figure 10). At an interstory drift of 4%, maximum strain (gage S16) at the assumed location of the beam plastic hinge was about  $16\varepsilon_y$  in tension (Figure 10c) and  $13\varepsilon_y$  in compression (Figure 10d), demonstrating successful relocation of the plastic hinge from the column face.

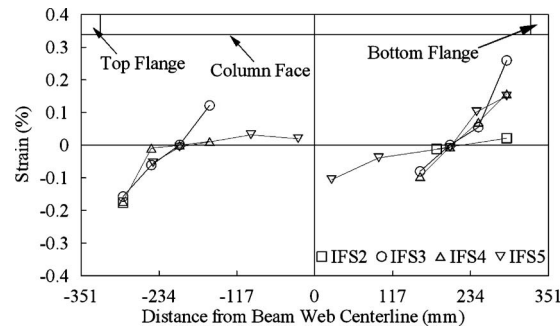
**Figure 11.** IFS strain profiles (beam positive bending at a 2% drift).

Figure 11 presents the measured longitudinal strains along the stiffener depth, 35 mm from the column face. Longitudinal strains beyond the neutral axis of the IFS have values that are opposite those of the side of the IFS connecting the beam flange, and longitudinal strains near the beam flange are greater than yield strain. Because Specimen IFS3 has weaker stiffeners than Specimens IFS4 and IFS5, tensile strain of the IFS near the beam bottom flange of Specimen IFS3 is highest among these specimens. For Specimen IFS2, in which the stiffener is located far from the box column side plate, the stiffener shows low

tensile strain, indicating poor efficiency. The maximum tensile strains measured at an inter-story drift of 4% were roughly  $2.4\varepsilon_y$  for Specimen IFS4 and  $2.2\varepsilon_y$  for Specimen IFS5.
