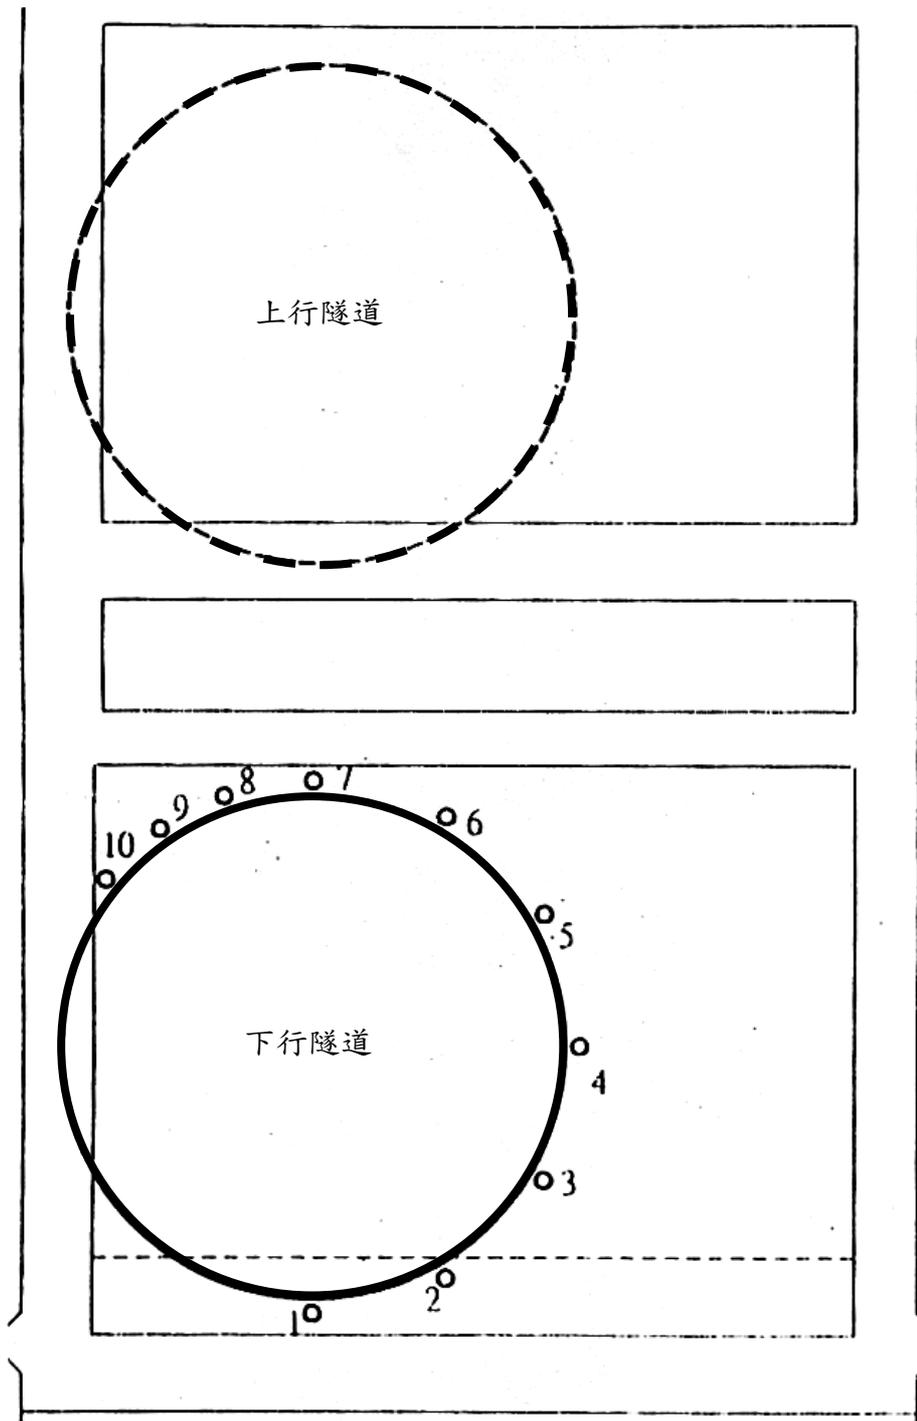
圖 5-11 下行隧道試水位置
(摘自 大陸工程，2003)

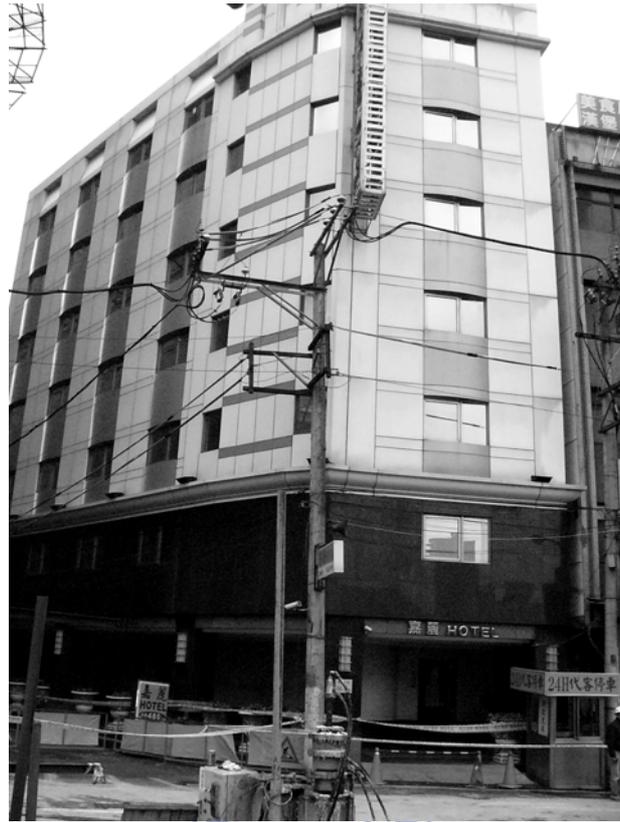
(a) 嘉麗旅館

圖 5-13 CD266 意外事故造成(a)(b)建築物產生沉陷與傾斜

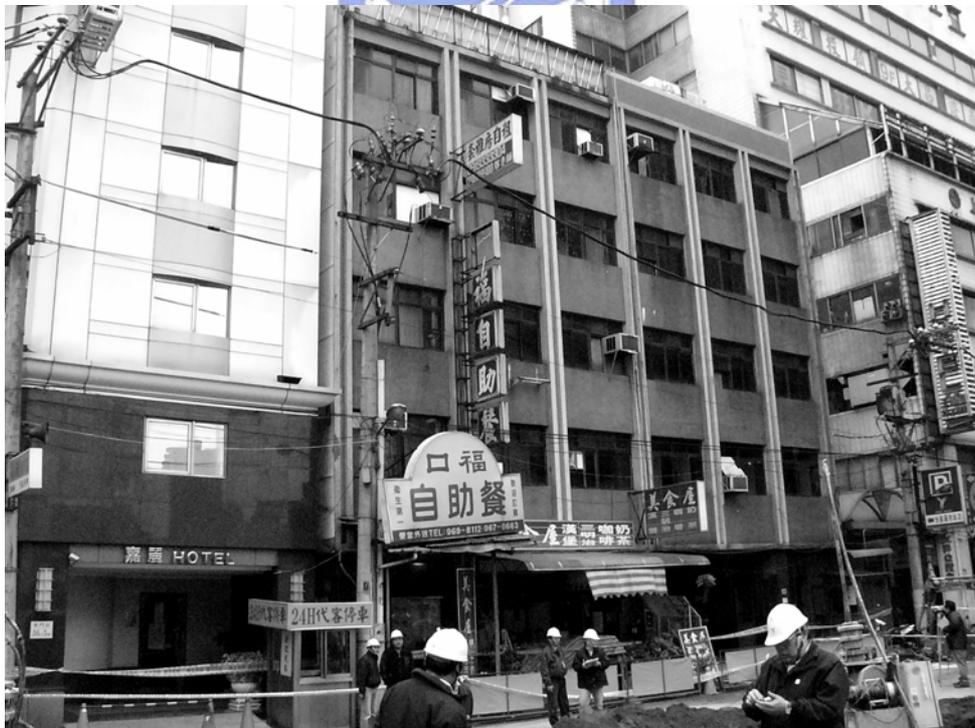
(b) 東門街 32-36 號五樓公寓
