Chapter 4

Investigation of Hot-carrier Degradation Using a Novel Test Structure

4.2 Fabrication and operating principle of HCTFT

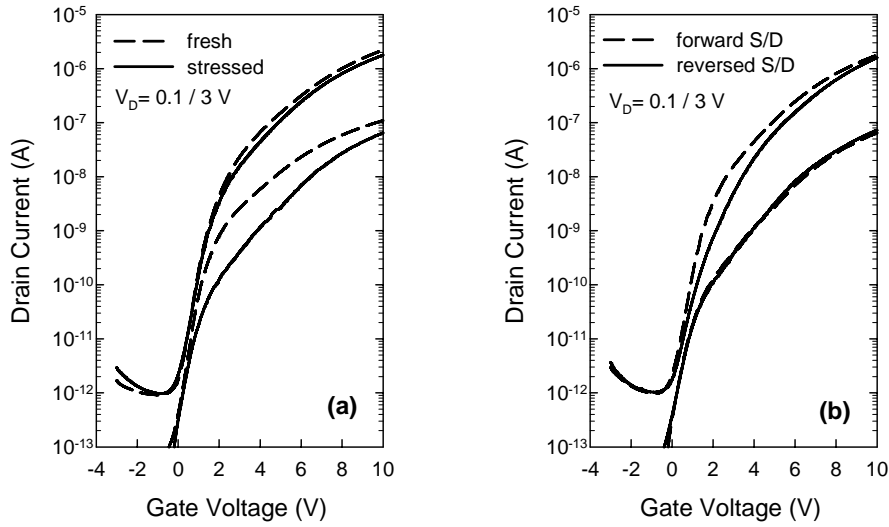
Fig. 4-4 (a) Subthreshold characteristics of the test transistors before and after the hot-carrier stressing at V_G/V_D of 10 V/20 V for 1000 sec. (b) Subthreshold characteristics which are measured under reversed S/D mode.

As can be seen in Fig. 4-4(b), defects which were originally screened out in the forward S/D mode will now be exposed when the device is operated in reversed S/D mode, so the device will exhibit obvious degradation in subthreshold I-V characteristics even at higher drain bias.

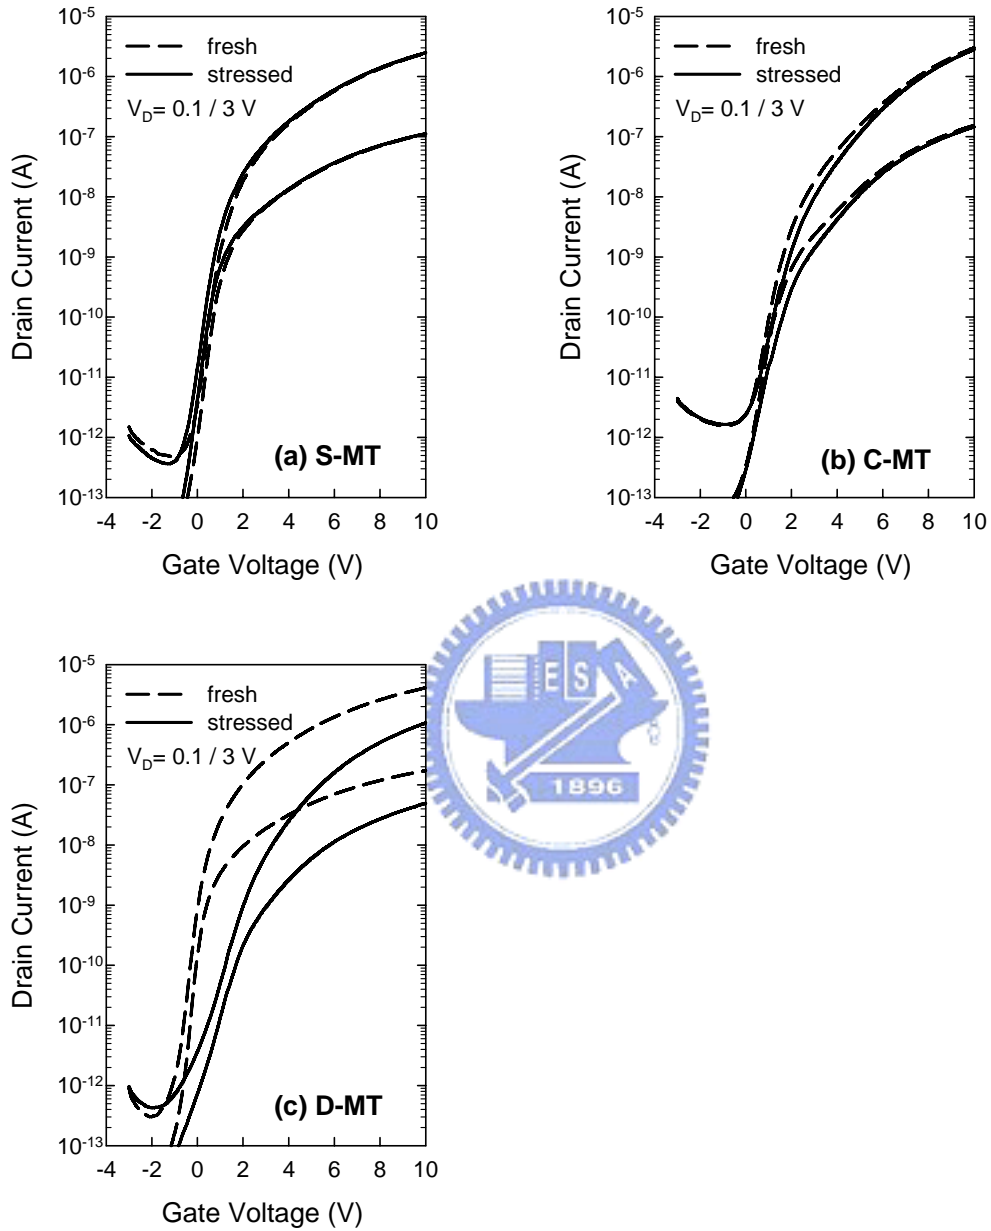
Fig. 4-5 Subthreshold characteristics of (a) S-MT, (b) C-MT, and (c) D-MT transistors in the same test structure characterized in Fig. 4-4 before and after the hot-carrier stressing at V_G/V_D of 10 V/20 V for 1000 sec.

high V_D bias (e.g., 3 V), indicating that the induced traps are uniformly distributed along the entire channel of the D-MT. This observation confirms the inference made above in analyzing the results of Fig. 4-4. However, the remaining two MTs exhibit some interesting results that are not explicitly revealed in Fig. 4-4. First, the C-MT shows degraded subthreshold swing, albeit the on-current does not seem to be affected. This implies that the generation of interface states at oxide/channel interface is mainly responsible for the degradation. Second, the S-MT shows negative parallel shift in subthreshold characteristics, indicating that positive hole trapping is preponderant in the oxide near the source side of test transistor after stressing. These holes are generated by the impact ionization during the hot-carrier stressing of test transistor. Since no substrate contact is present in the TFT structure, these holes tend to drift toward the grounded source, and some of them with sufficient energy may surmount the barrier and be injected into the oxide. Based on the results shown in Fig. 4-5, major degradation mechanisms occurring at different channel sections could be clearly distinguished and identified by the proposed novel test structure.

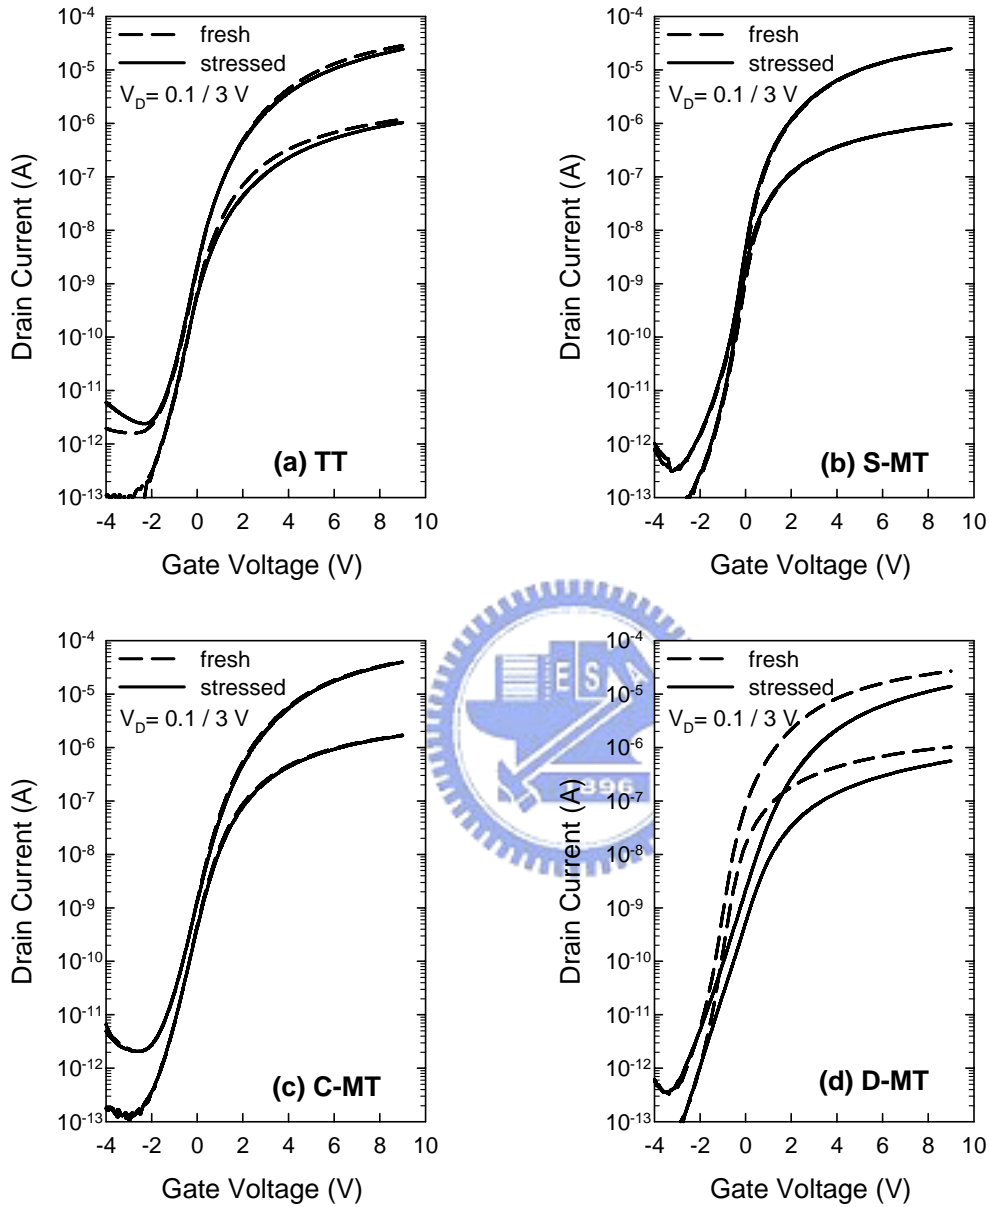
Fig. 4-6 Subthreshold characteristics of (a) TT, (b) S-MT, (c) C-MT, and (d) D-MT transistors in a test structure with a SPC poly-Si channel before and after the hot-carrier stressing at V_G/V_D of 9 V/18 V for 1000 sec.

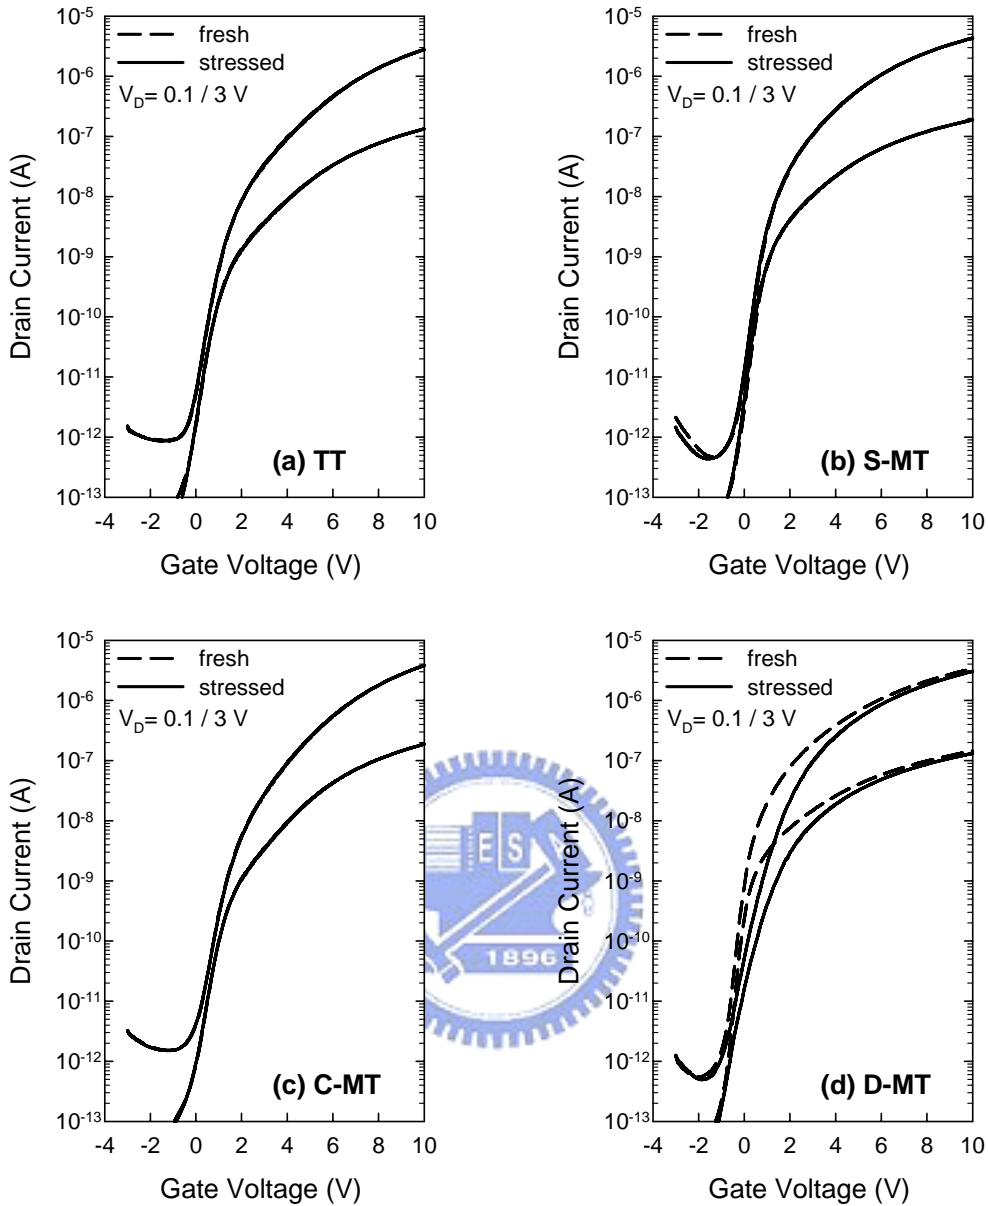
Fig. 4-7 Subthreshold characteristics of (a) TT, (b) S-MT, (c) C-MT, and (d) D-MT transistors in a test structure with an as-deposited poly-Si channel before and after the hot-carrier stressing at V_G/V_D of 6 V/12 V for 1000 sec.

condition. This will call for a very long stress time for TT to yield detectable degradation. However, the associated D-MT shows visible degradation, as shown in Fig. 4-7(d). Like that using as-deposited poly-Si, the sample using SPC poly-Si as the channel material also shows similar trends in sensitivity enhancement. Similar results for SPC samples are shown in Fig. 4-8.

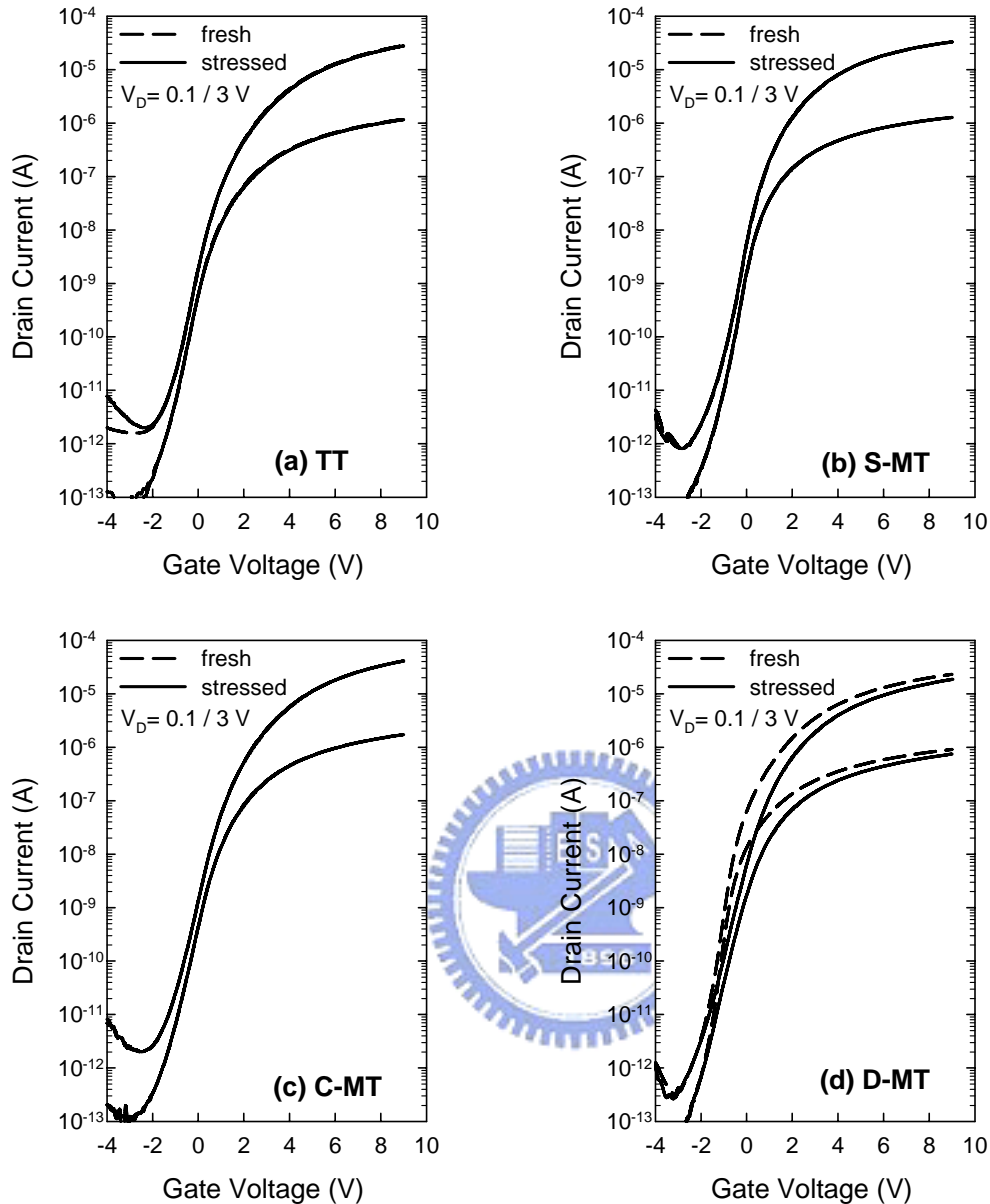
Fig. 4-8 Subthreshold characteristics of (a) TT, (b) S-MT, (c) C-MT, and (d) D-MT transistors in a test structure with a SPC poly-Si channel before and after the hot-carrier stressing at V_G/V_D of 6.5 V/13 V for 1000 sec.

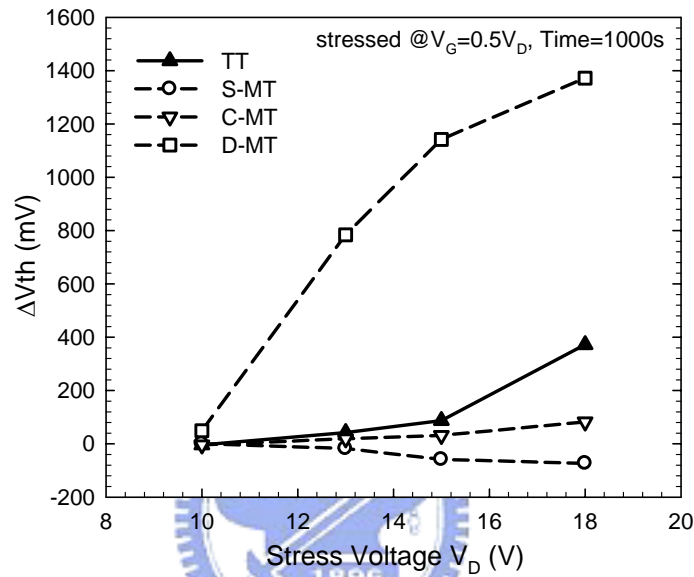
Fig. 4-9 Threshold voltage shift of test structures under various hot-carrier stress conditions with constant V_G/V_D ratio of 0.5.

Figure 4-9 and Fig. 4-10 show the shift in threshold voltage (ΔV_{th}) and subthreshold swing (ΔSS), respectively, as a function of stress V_D with $V_G = 0.5 V_D$ for 1000 sec. Testers in these figure employ SPC poly-Si as the channel material. As expected, the degradation increases with increasing V_D . When V_D is less than 15 volt, TTs depict threshold voltage shift of less than 100mV, and negligible change in subthreshold swing.

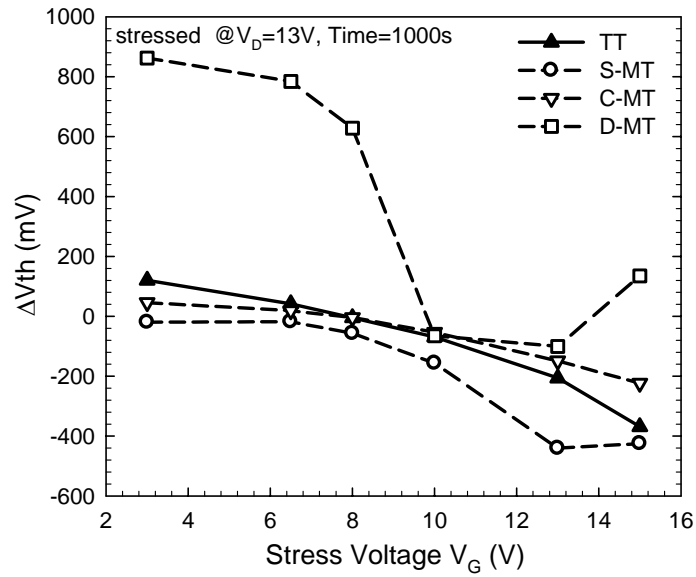
Fig. 4-11 Threshold voltage shift of test structures under various hot-carrier stress conditions at a fixed V_D of 13 V.

the result reported in Fig. 4-11 and Fig. 4-12. The detailed mechanism will be described in the next section.

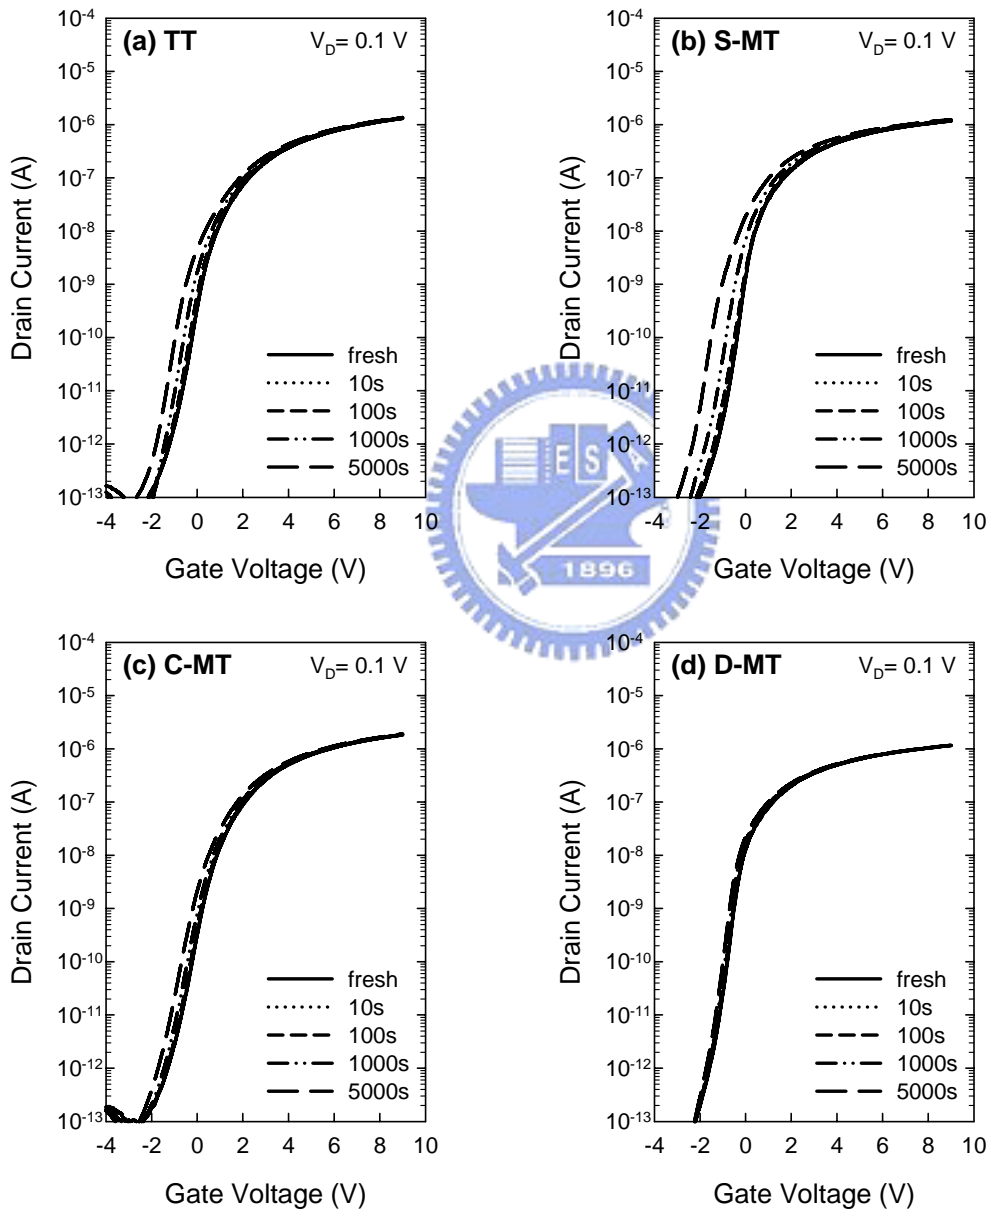
Fig. 4-18 Evolution of subthreshold characteristics of (a) TT, (b) S-MT, (c) C-MT, and (d) D-MT in a test structure with a SPC poly-Si channel during hot-carrier stressing under $V_G/V_D=13V/13V$.

Temporal evolution analyses for devices under $V_G = V_D$ stress mode are presented in Fig. 4-18 to Fig. 4-20. It is seen that all four sub-transistors depict negative threshold voltage shift, implying that generation of positive charges is mainly responsible for the degradation. Moreover, among these devices, S-MT exhibits the largest shift. It should be noted that, although the S-MT characterized in Fig. 4-15 under $V_G = 0.5V_D$ stress mode

Fig. 4-17 alone cannot account for the observation shown in Fig. 4-18, and some other mechanisms should be responsible for the degradation. It is likely that the oxide field between gate and channel play an important role, as a high gate voltage (e.g., 13V) applied during stressing exerts an oxide field ($\sim 3.7\text{MV/cm}$) above the channel near the source side. It has been pointed out previously [4.19] that such field may lead to the generation of positive charges in oxide. The schematics of such process are illustrated in Fig. 4-21. This phenomenon can consistently explain the results observed in this stress mode.

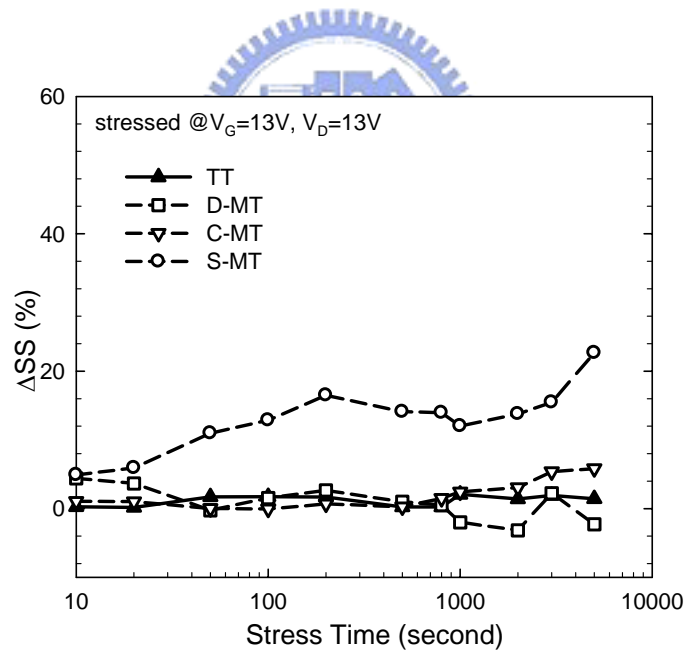
Fig. 4-20 Evolution of subthreshold swing degradation of a test structure during hot-carrier stress under $V_G/V_D=13V/13V$.

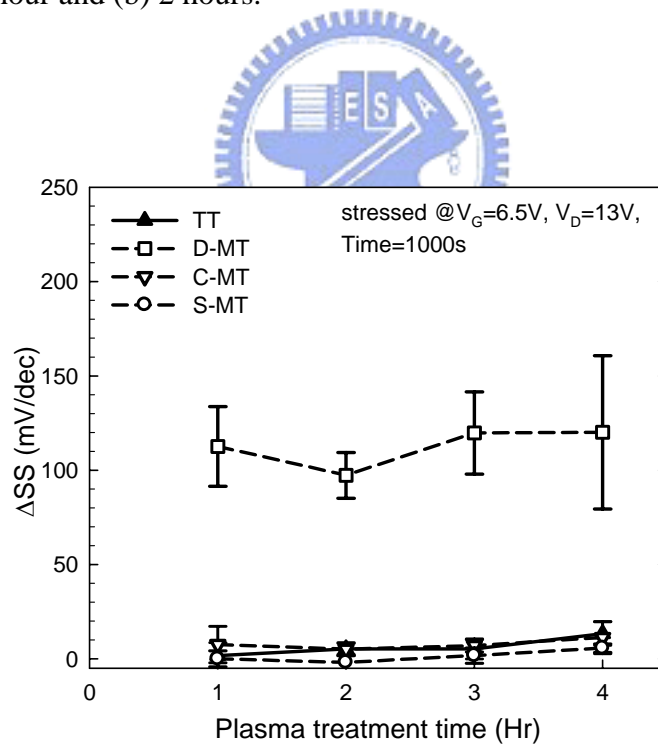
Fig. 4-25 Subthreshold swing shift of testers as a function of NH_3 plasma treatment time. The shift represents the difference of the SS measured before and after hot-carrier stressing.

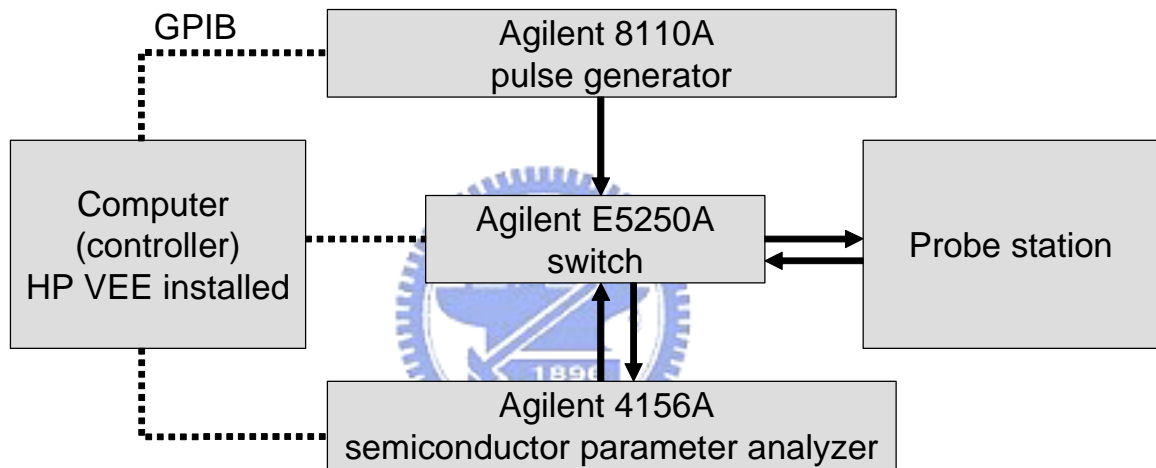
Fig. 5-1 Schematic illustration of the measurement setup.

acted as the controller, and coordinated all the equipments via GPIB bus. The schematics of the setup are illustrated in Fig. 5-1. The AC stress waveforms used in this work are illustrated in Fig. 5-2. During AC stress, a train of voltage pulses is applied to the gate using Agilent 8110A pulse generator. Rising time (t_r) is defined as the time that the voltage signal rises from 10% to 90% of the amplitude ($V_{G_high} - V_{G_low}$), and vice versa for falling time (t_f). It should be noted that the total stress time is defined as the summation of t_{high} under the stress condition. In this work, V_{G_low} is set at 0 V and duty cycle is set at 50%. The pulse gate voltage (V_{G_high}) of 6.5 volt and 13 volt were tested in this work.

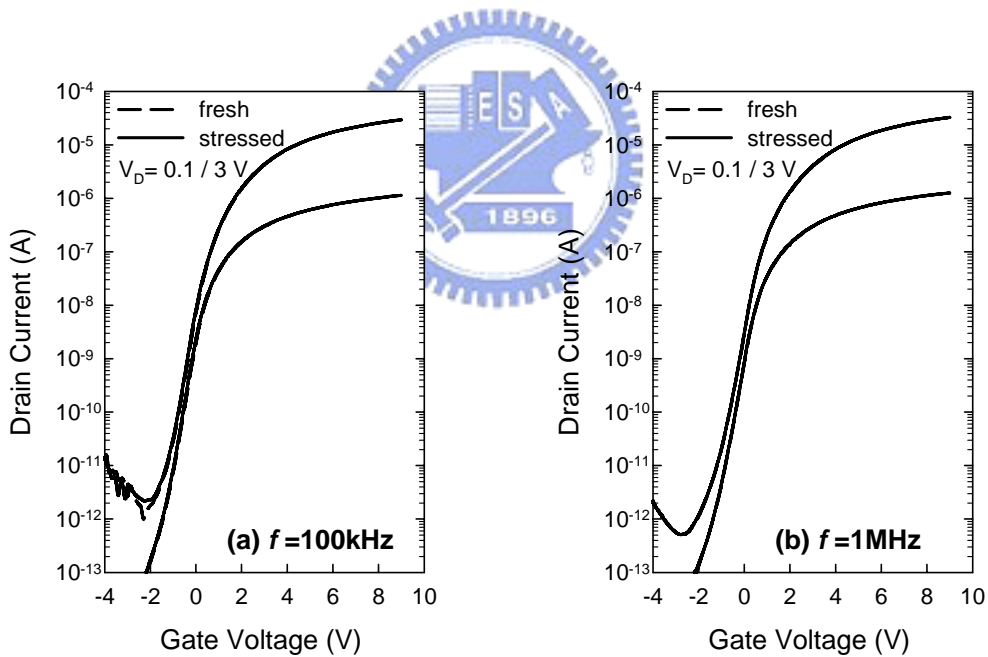
Fig. 5-5 Subthreshold characteristics of S-MTs before and after AC stress for 1000 seconds with the frequency of (a) 100kHz and (b) 1MHz.

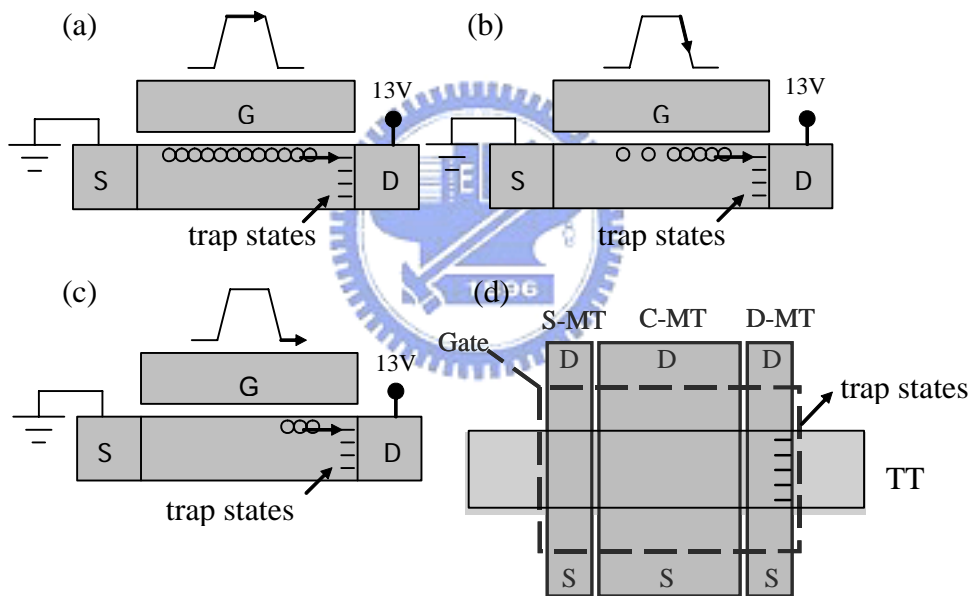
Fig. 5-8 Mechanism of AC stress induced degradation.

Possible damage schemes of the tester under AC stress are illustrated in Fig. 5-8. The

waveform of the stress can be divided into four bias conditions: (1) on-state hot-carrier stressing, (2) transient state when gate voltage raises up from V_{G_low} to V_{G_high} , (3) transient state when gate voltage falls down from V_{G_high} to V_{G_low} , (4) off-state stressing caused by localized electric field. In addition to the on-state hot-carrier degradation shown in Fig. 5-8(a), the testers receive transient hot-carrier stressing when elections move rapidly from the inversion layer to the drain (Fig. 5-8(b)). Since for different frequency, the total time under V_{G_high} is the same, the transient stages (t_r and t_f) are the reasonable cause of damage. Most of the generated trap states are located near the drain side of TT, and can be easily detected by D-MT (Fig. 5-8(d)).

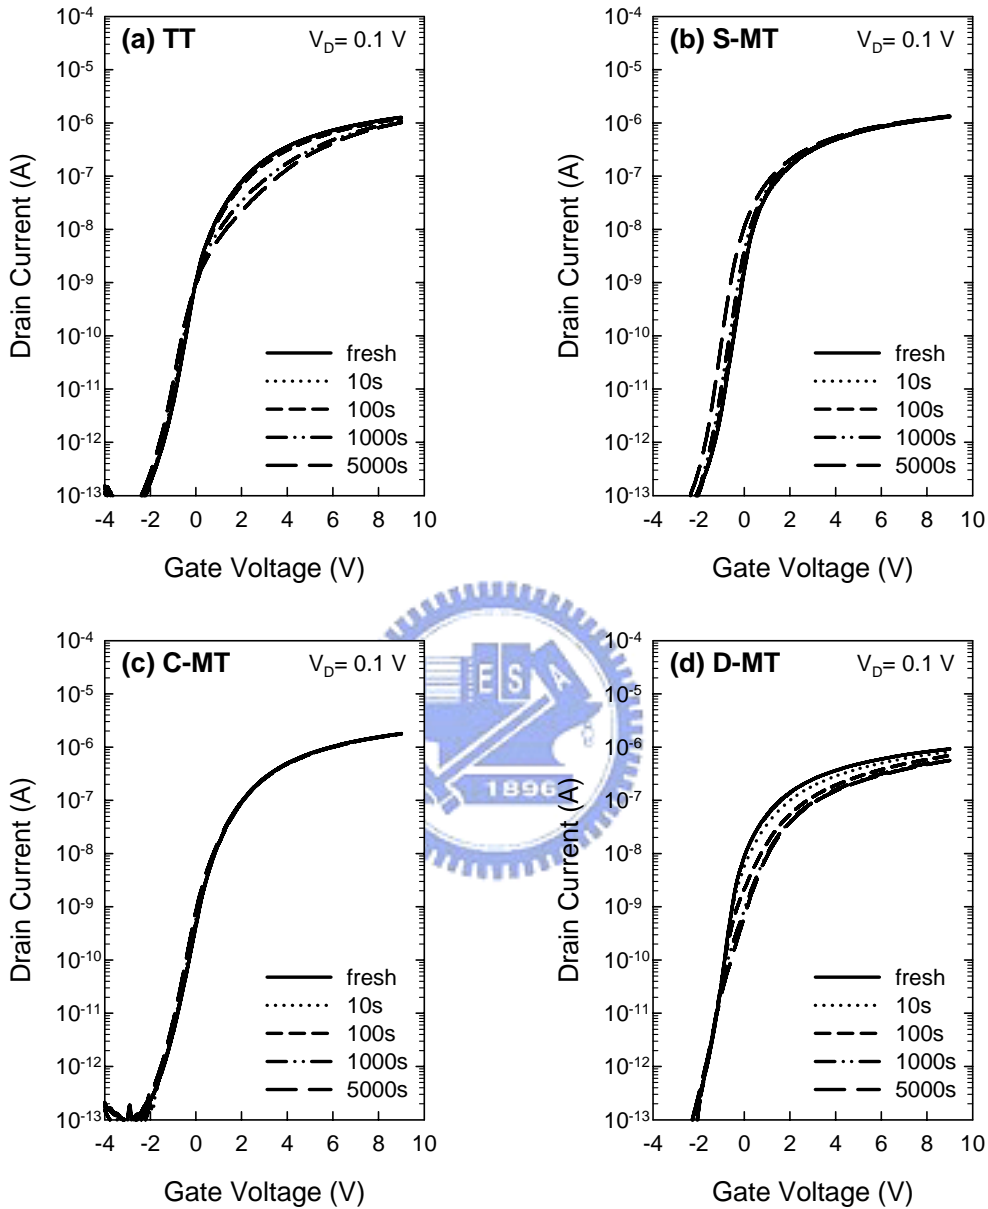
Fig. 5-17 Evolution of subthreshold characteristics of (a) TT, (b) S-MT, (c) C-MT, and (d) D-MT in the tester during hot-carrier stressing under $V_{G_high}/V_D=13V/13V$, freq. = 500 kHz, $t_r = t_f = 100ns$.

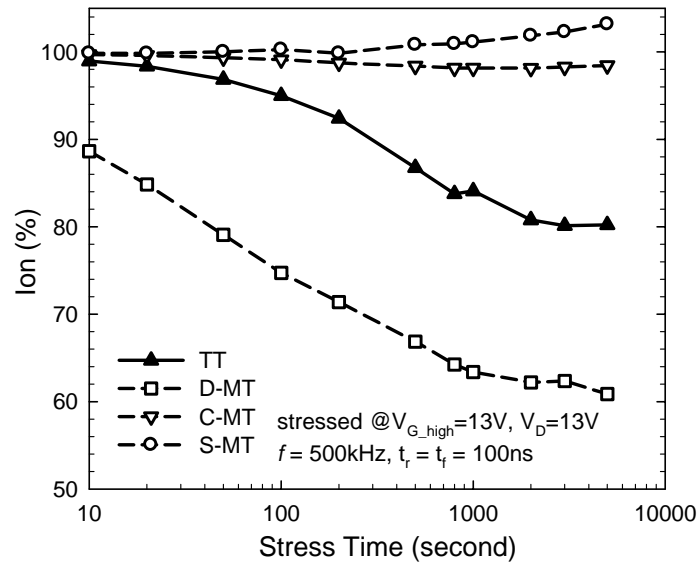
Fig. 5-20 Evolutions of on-current degradation of the same tester shown in Fig. 5-17.
