Engineering Geology 71 (2003) 157–179

The influence of surface ruptures on building damage in the 1999 Chi-Chi earthquake: a case study in Fengyuan City

Keywords: Hangingwall; Building damage; Chi-Chi earthquake

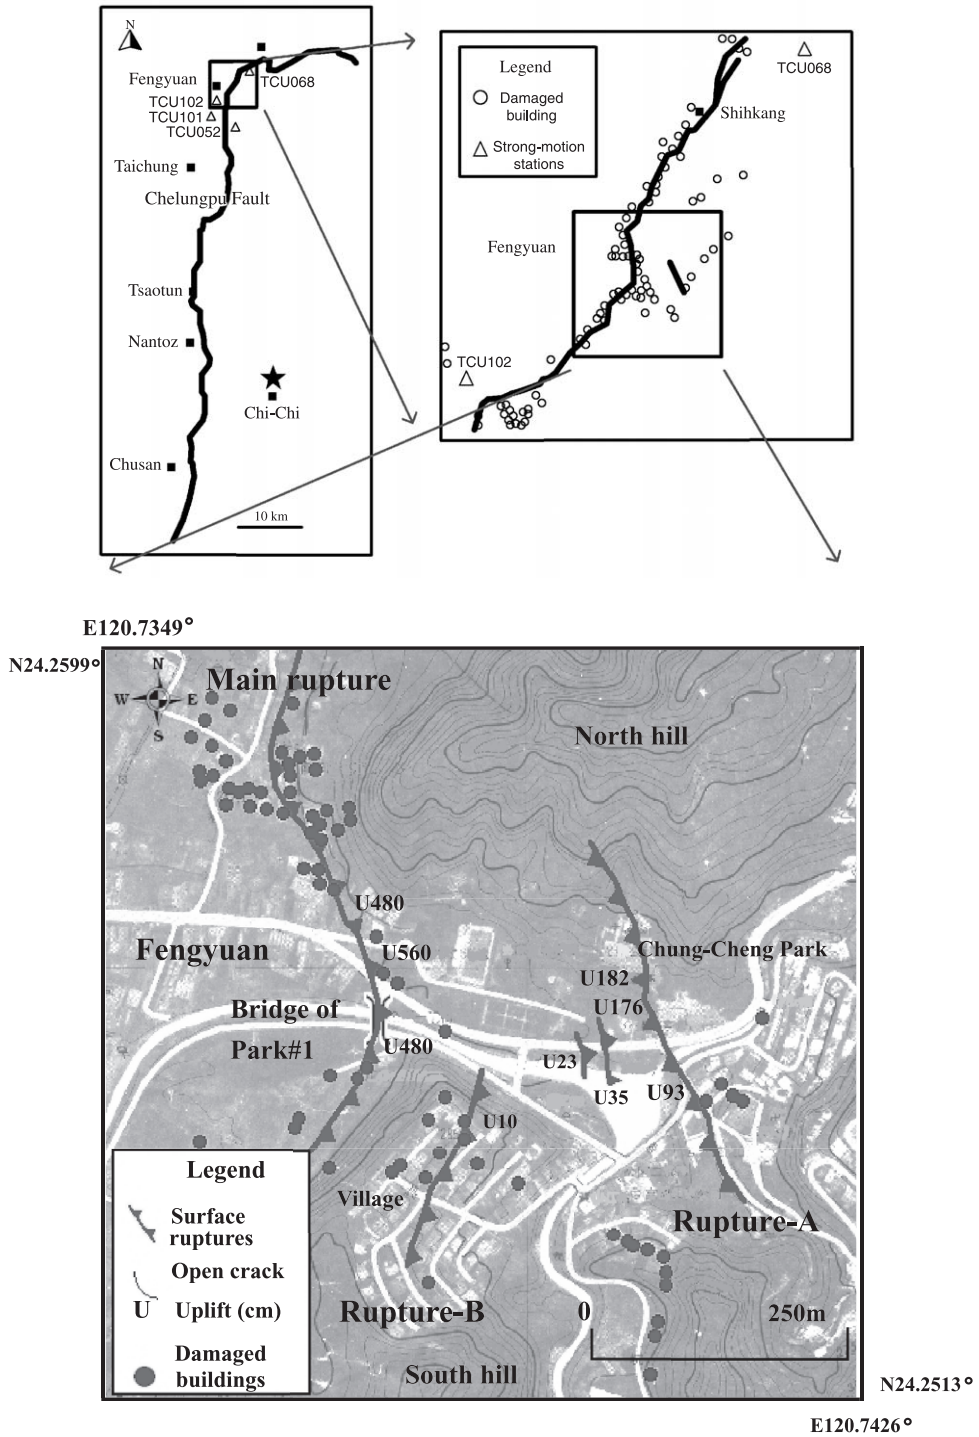
Fig. 1. The surface ruptures (uplift is illustrated as U560, in cm) and distribution of damaged buildings in Chi-Chi earthquake (redrawn from NCREE, 2000).

As shown in Fig. 1, most of the damaged buildings in the studied area distribute along the main surface rupture as well as the secondary surface ruptures on the hangingwall. The main surface rupture damages most of its adjacent buildings near the Chung-Cheng Park. The main rupture, with a 4–5 m uplift on the hangingwall, damage nearby buildings. A building astride the main-rupture is seriously titled as shown in Fig. 20. Nevertheless, the structure remains intact. Fig. 21 shows that the building on the hangingwall is damaged while the one on foot-wall remains intact. The influence of ground deformation on structure's survivability is obvious. The effect of surface deformation on hangingwall near

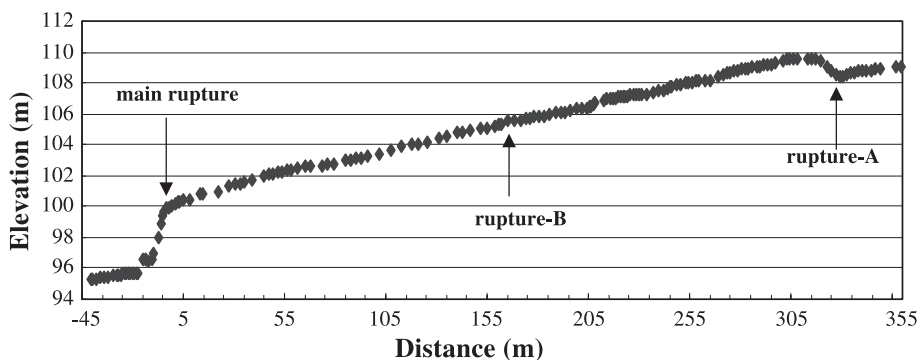
Fig. 2. The measured profile of surface deformation along the valley near the Chung-Cheng Park after Chi-Chi earthquake (redrawn from Lee et al., 2000).

secondary ruptures (rupture-A and rupture-B). Minor surface ruptures and open cracks are also observed. The measured profile after the Chi-Chi earthquake along the valley is shown in Fig. 2 (Lee et al., 2000). Lee et al. (2000) interpreted the deformation pattern

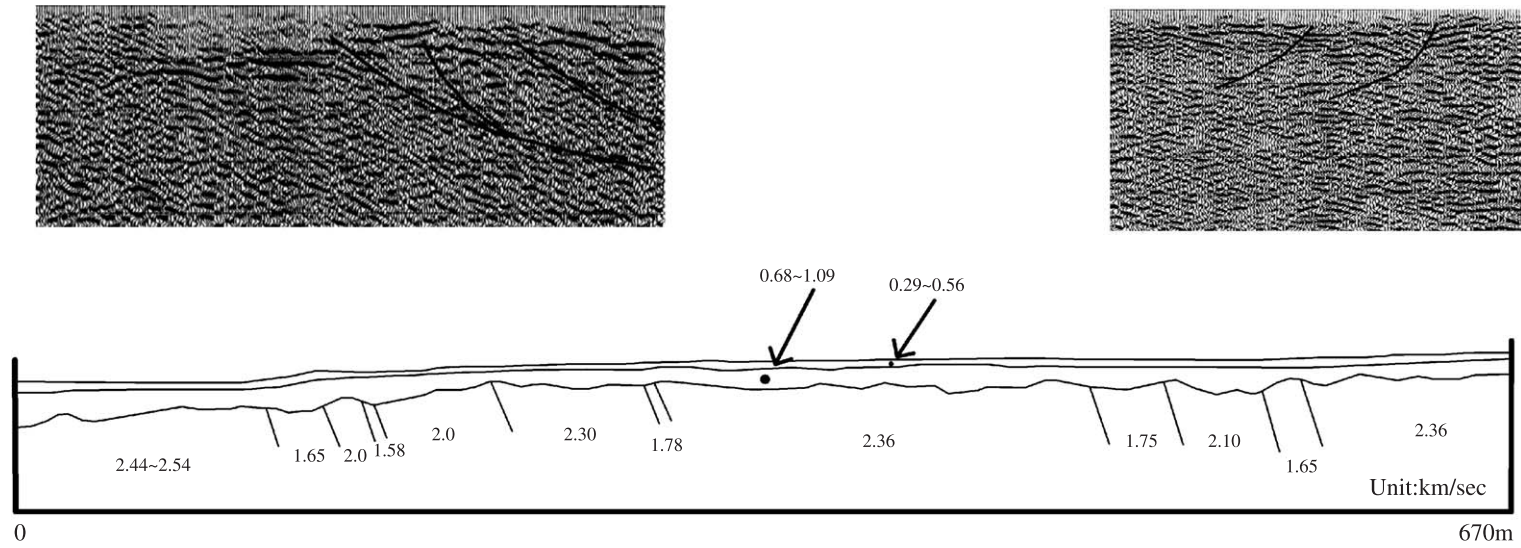
Fig. 13. Results of seismic prospecting in the valley. The lower graph shows the results of seismic refraction R1 (670 m); the upper graph shows the results of seismic reflection L1-1 (243 m) and L1-2 (138 m). The fracture zones around main rupture and rupture-A can be clearly identified.

Three faults are identified from the results of seismic reflection (Figs. 13 and 15). The fracture zones around the main rupture and rupture-A under the ground surface can be clearly identified in Fig. 13 (fracture zone around the main fault on the left side; fracture zone around rupture-A on the right side). There are more than one strong reflection can be observed in Fig. 13 around both fracture zones. It indicates that fracture zones are formed rather than a single slip surface. Fracture zone around rupture-B across the uphill village is also noticeable in Fig. 15. As a minor surface rupture, the fracture zone around rupture-B is not as obvious as the fracture zones around the main rupture and rupture-A.

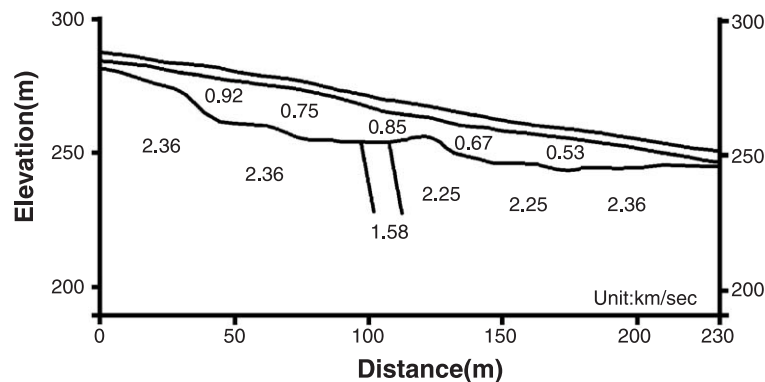
Fig. 14. Results of seismic refraction R-2 (230 m long) in the south hill. The band of low velocity indicates the fracture zone around rupture-B across the village.

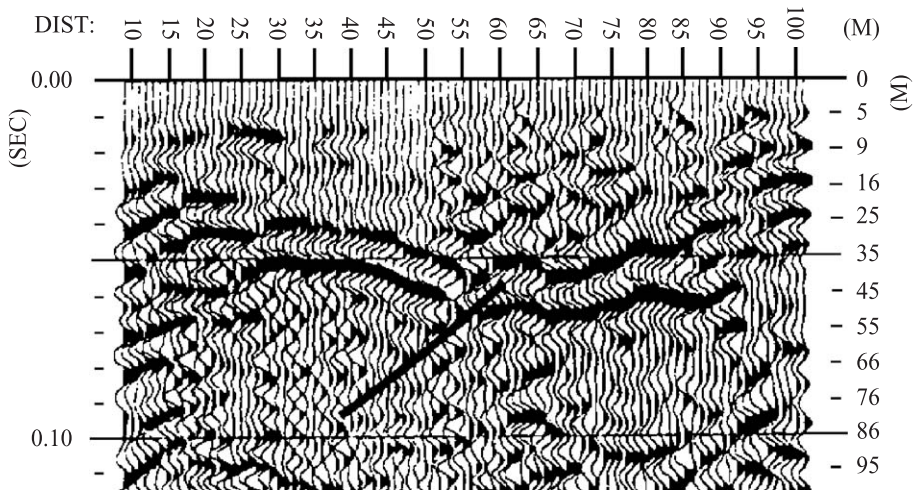
Fig. 15. Results of seismic reflection L-2 (102 m) in the south hill. The black line marks the fracture zone around rupture-B across the village.

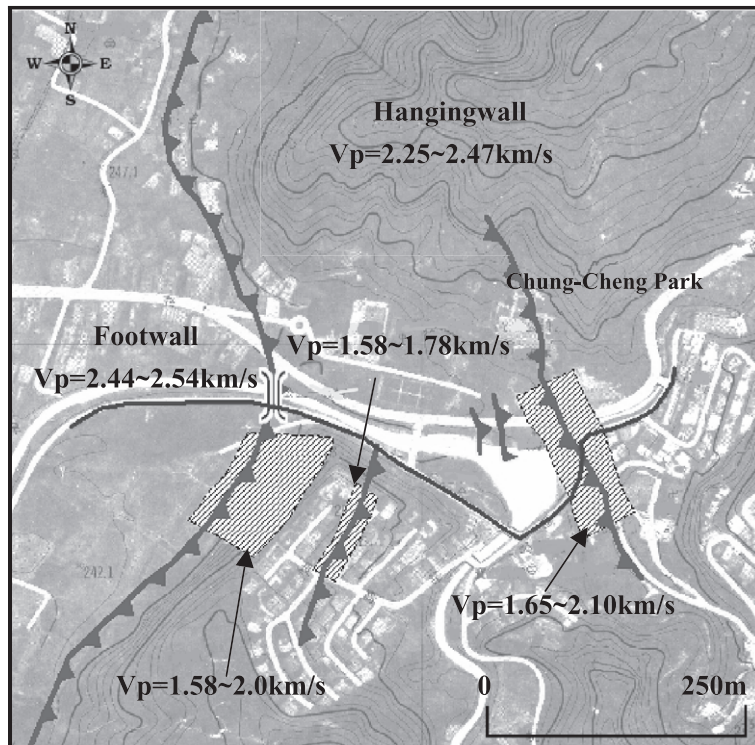
Fig. 16. Zones of P-wave low velocities near surface ruptures.

s. There are two distinct areas bisected in Fig. 16. The zones of P-wave low velocities are around the surface rupture. The widths of the zones of P-wave low velocities are nearly 90–100 m around the main rupture and rupture-A. The width of the zone of P-wave low velocities in the hangingwall is about 70 m. It appears that the fracture zone is wider in the

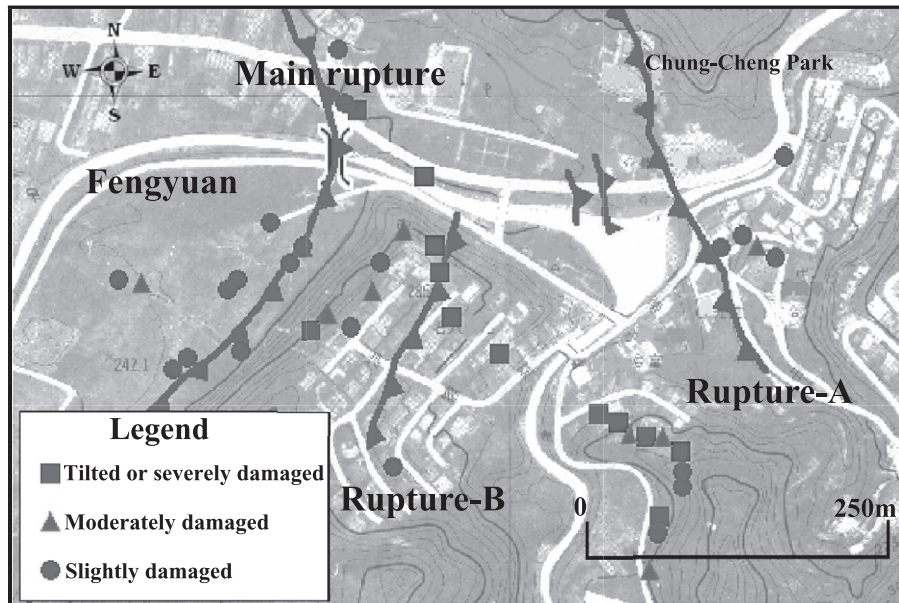
Fig. 22. Distribution of damaged buildings in the Chi-Chi earthquake near the Chung-Cheng Park (redrawn from NCREE, 2000).

Fig. 22 shows the buildings on hangingwall near the Chung-Cheng Park are damaged to various extents. Five buildings in the valley distributed to the east of rupture-A are lightly to moderately damaged as shown in Fig. 22 (the vertical uplift is about 0.9–1.8 m). Buildings in the uphill of village astride of rupture-B (the vertical uplift is about 10 cm) are also severely damaged as shown in Fig. 22. In this region, 11 buildings are damaged to various extents. Among them, two of them are seriously tilted. Between rupture-A and rupture-B, there are also 11 damaged buildings. Five of them are tilted or severely damaged. There are a few minor secondary surface ruptures to the north of these buildings. The effect of surface deformation on hangingwall appears evident on the buildings' damage. From Fig. 22, the following phenomena are noted.

Comparing Figs. 1, 16 and 22, it is found that many damaged building in the studied area are located in zones of P-wave low velocities. On hangingwall of a thrust fault, it is always with potential that certain displacement of a secondary fracture may take place in a relatively weak zone. Hence, the zones of P-wave low velocities near the thrust and backthrust may be considered as a good reference to regulation development adjacent to an active fault.
