# Electromigration Study in SnAg<sub>3.8</sub>Cu<sub>0.7</sub> Solder Joints on Ti/Cr-Cu/Cu Under-Bump Metallization

This paper investigates the electromigration-induced failures of SnAg<sub>3.8</sub>Cu<sub>0.7</sub> flip-chip solder joints. An under-bump metallization (UBM) of a Ti/Cr-Cu/Cu trilayer was deposited on the chip side, and a Cu/Ni(P)/Au pad was deposited on the BT board side. Electromigration damages were observed in the bumps under a current density of  $2 \times 10^4$  A/cm<sup>2</sup> and  $1 \times 10^4$  A/cm<sup>2</sup> at 100°C and 150°C. The failures were found to be at the cathode/chip side, and the current crowding effect played an important role in the failures. Copper atoms were found to move in the direction of the electron flow to form intermetallic compounds (IMCs) at the interface of solder and pad metallization as a result of current stressing.

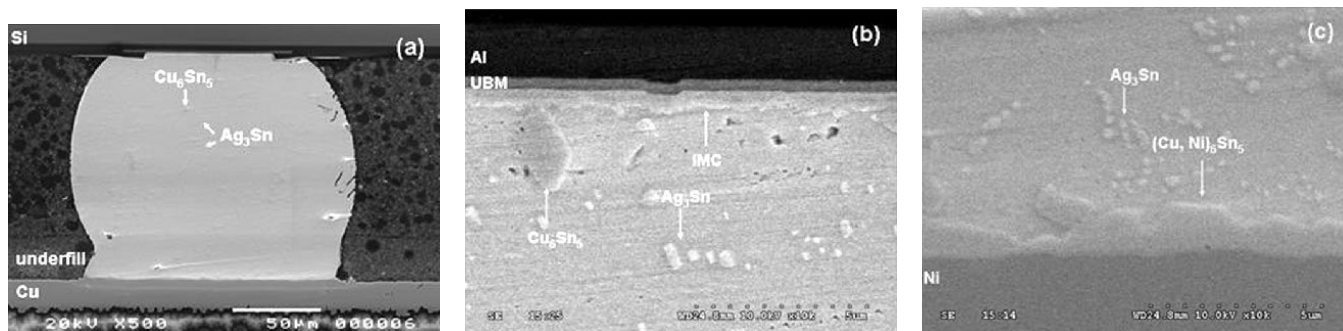
Figure 3a illustrates the cross-sectional SEM image of the SnAgCu solder bump before current stressing. In the bulk solder, the composition of the IMC was identified to be  $\text{Cu}_6\text{Sn}_5$  with dissolution of 2–4 at.% of Ni. The  $\text{Ag}_3\text{Sn}$  particles were also found in the solder bump. Figure 3b and c shows the

Fig. 3. The cross-sectional SEM images of a solder bump before current stressing: (a) whole bump view, (b) enlarged image on the chip side, and (c) enlarged image on the board side.

enlarged SEM images of the chip side and the BT board side, respectively. A layer of IMC with a thickness of  $0.7\ \mu\text{m}$  was formed between the solder and UBM interface at the chip side. On the BT board side, the IMC of  $\text{Cu}_6\text{Sn}_5$  with dissolution of 15–20 at.% of Ni was observed.

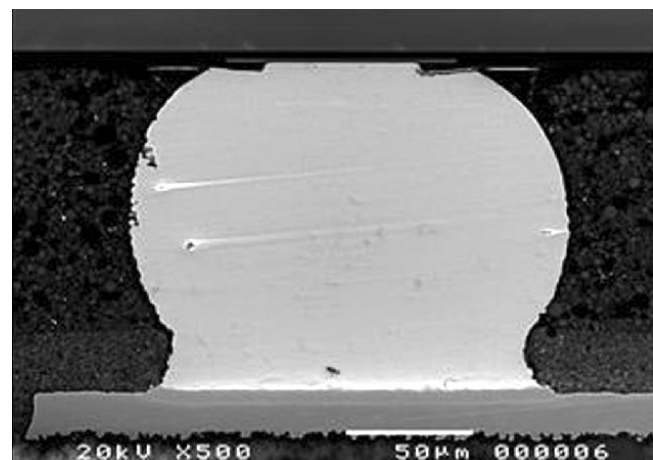
The results for the measured resistance of the stressing circuit as a function of stressing time is shown in Fig. 10. Although the resistance included both the resistance of the conduction lines and that of the bump pair, it was still observed that the failure time depended on the dramatic increase of the resistance. As expected, the bump failed within 42 h of stressing time at 150°C and within 142 h at 100°C because the diffusivity of metal atoms are larger at high temperature. To examine the microstructure changes caused by the thermal effect, reference bumps were employed to undergo a similar thermal history during current stressing. Figure 11 shows the microstructure changes resulting from the thermal effect only. The bump was kept at 150°C for 42 h, and no obvious microstructure change was observed.

Fig. 11. The cross-sectional SEM image of the reference bump. The bump was kept at 150°C for 42 h.
