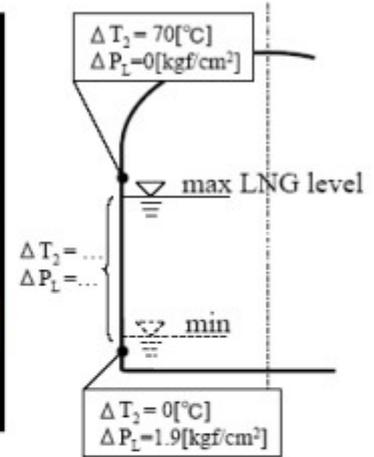
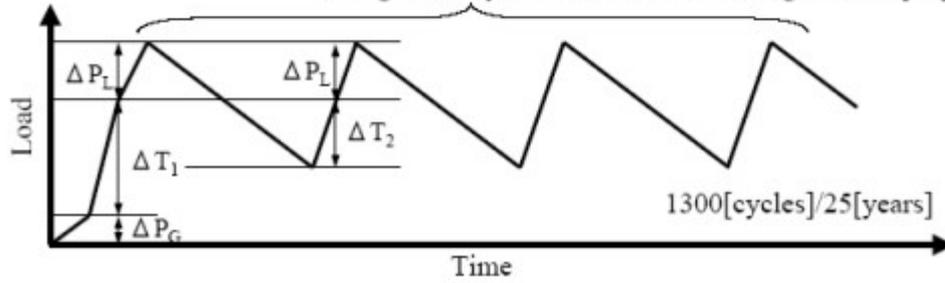
圖 38 LNG 儲存槽運轉期負載狀況

薄膜型LNG儲存槽使用期間負荷週期預估

Operation process	The kind of load					
	Thermal		Gas pressure		Liquid pressure	
	T	ΔT	P_g	ΔP_g	P_L	ΔP_L
Construction	RT	—	0 [kgf/cm ²]	—	0 [kgf/cm ²]	—
Cooldown	-162 [°C]	ΔT_1 = 190[°C]	0.2 [kgf/cm ²]	0.2 [kgf/cm ²]	0 [kgf/cm ²]	—
Loading	-162 [°C]	0	0.2 [kgf/cm ²]	0 [kgf/cm ²]	max 1.9 [kgf/cm ²]	max 1.9 [kgf/cm ²]
Unloading	max θ_2 [°C]	max ΔT_2 = 70[°C]	0.2 [kgf/cm ²]	0 [kgf/cm ²]	min 0 [kgf/cm ²]	max 1.9 [kgf/cm ²]
⋮

Design load cycle \Rightarrow Calculation of fatigue crack propagation
