在高電漿密度蝕刻機中 SF_6 電漿分解產物對產品的影
響與研究

**Study of SF_6 Decomposition Products
of DPS Poly Etcher in IC's
Manufacturing**

研究生：許時齊

National Chiao Tung University
in Partial Fulfillment of the Requirements
for the Degree of
Master of Science
in
Electronics and Electro-Optical Engineering
June 2004
Hsinchu, Taiwan, Republic of China

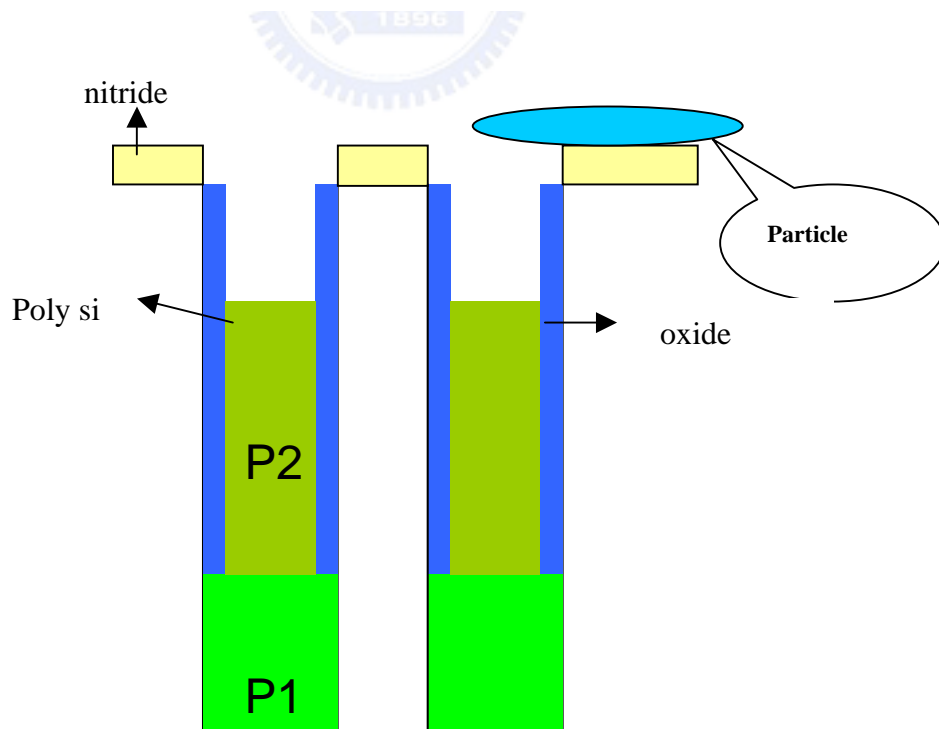
The contamination of fluorine come from DPS poly etcher, figure 3.2 shows wafer structure, the isotropic etching to define poly silicon depth on this step. The plasma chemistry contacts poly silicon film and nitride film at the same time, but only removes poly silicon film and keeps depth to target. The SF₆ is popular gas to etch poly silicon with isotropic etch in DPS poly etcher. The recipe is:

Fig 3.2 wafer structure, isotropic dry etching to define poly 2 depth at this step.
