Seismic rehabilitation performance of steel side plate moment connections

KEY WORDS: rehabilitated steel moment connection; side plate; cyclic test; finite element analysis

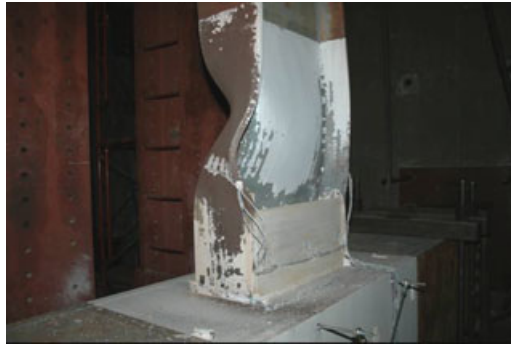
Figure 7. Specimen SP1 beam buckling (4.7% drift).

to the edge of the side plate groove weld. After the beam finished two cycles of a 4.7% drift, testing was stopped due to limitations in the test setup. Fractures as observed in non-rehabilitated Specimen UR were not found in this specimen at the end of testing (Figure 7), indicating that two side plates near the column face can improve seismic performance of the actual connection made by *in situ* welding process prior to 1996.

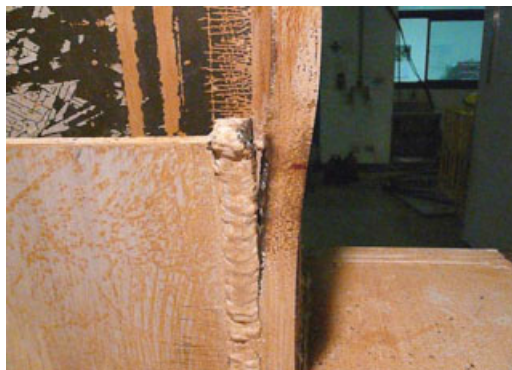
Figure 10. Specimen SP3 test observation (after second test).

when testing to an inter-story drift of 4.8%. Comparison of all rehabilitated specimens showed larger flange and web buckling with larger reinforcement. When Specimen SP3 was retested at an inter-story drift of 1%, a crack, not found in other specimen tests, was observed near the beam-to-column groove-welded joint. This crack did not expand after finishing 3.77% drift cycles. However, the crack, initiated at the edge of the side plate to beam flange inner side groove weld, ran horizontally along the weld due to the beam flange local buckling. The crack length was 70 mm at the end of the second test (Figure 10), and slight strength degradation was also noted in the hysteretic loops (Figure 5(d)). This fracture was not observed in Specimen SP1 and SP2 tests due to sufficient weld length (Table I).

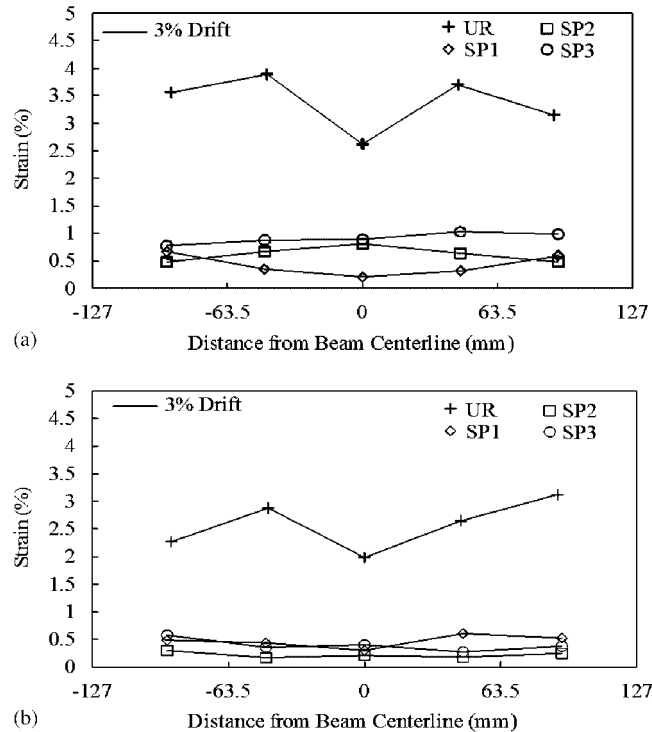
Figure 11. Beam flange tensile strains (3% drift): (a) top flange and (b) bottom flange.

The effectiveness of the side plate in decreasing beam flange tensile strain can be observed from the measured strains at 60 mm from the column face (Figure 11). At an inter-story drift of 3%, the tensile strains in the beam top and bottom flanges of the non-rehabilitated Specimen

UR significantly exceeded those of the rehabilitated specimens. The tensile strains in Specimen SP2 were lower than those in Specimen SP3, indicating that increasing plate thickness effectively reduced tensile strains. Furthermore, modest beam yielding near the column face has no adverse effects on the connection seismic performance. The maximum flange strain at the assumed plastic hinge location, 430 mm from the column face in Specimen SP3, was 2.2% ($=16\varepsilon_y$) at an inter-story drift of 4%, demonstrating successful relocation of the plastic hinge to a quarter beam depth from the end of the side plate.

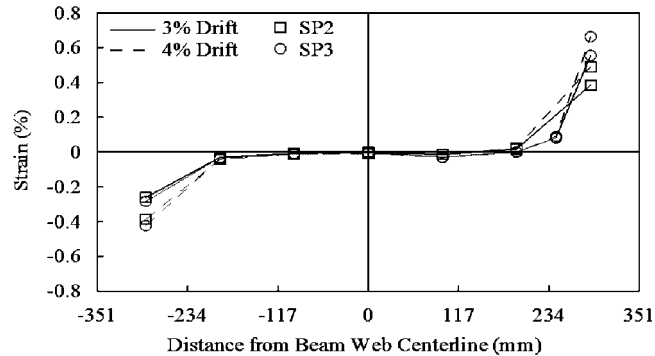
Figure 12. Side plate longitudinal strain profiles (35 mm from the column face).

Figure 12 shows the measured longitudinal strains along the side plate depth, located 35 mm from the column face. The longitudinal strains in the side plate center portion are small, indicating ineffective in transferring beam flange forces to the column. However, the longitudinal strains in the side plate near the beam flanges are greater than the yield strain, indicating effective in transferring beam flange forces. Because Specimen SP3 has thinner side plates than Specimen SP2 (Table I), the tensile strains in the side plate are higher in Specimen SP3 than in Specimen SP2. The maximum measured tensile strains at an inter-story drift of 4% were 0.5% ($2.7\varepsilon_y$) and 0.67% ($3.4\varepsilon_y$) for Specimens SP2 and SP3, respectively. A work [21] utilizing only a small part of side plates near the beam flange inner side to retrofit moment connections also confirmed the effectiveness of the rehabilitation scheme.

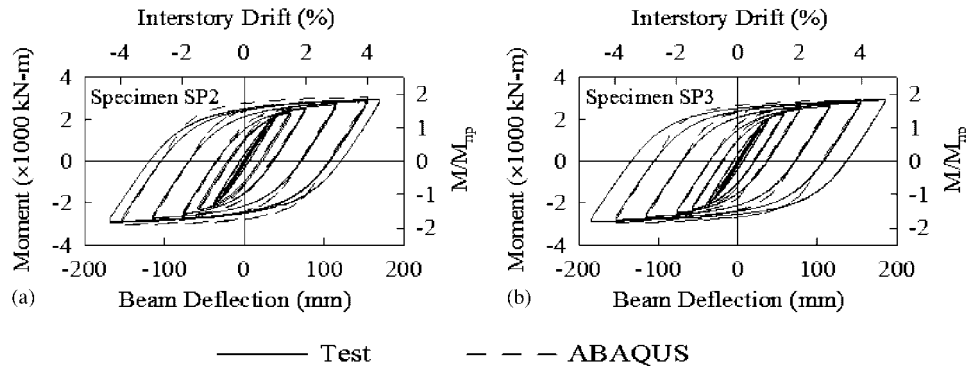
Figure 14. Hysteretic response comparisons between test and finite element model.

Figure 14 compares beam moment-deflection hysteretic responses from testing and analysis. Initial stiffness, post-yield stiffness, and moments at the column face show good agreement. The

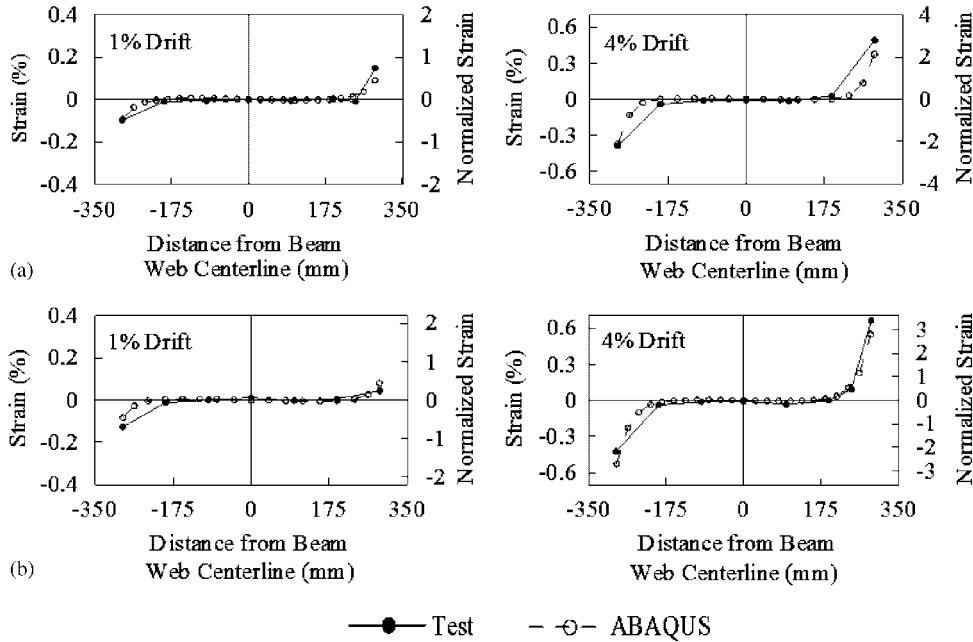
Figure 15. Side plate strain comparisons between test and finite element model:
(a) Specimen SP2 and (b) Specimen SP3.

predicted longitudinal strains along the side plate depth, located 35 mm from the column face, correlate well with the test data (Figure 15). From the finite element model, moment, M_s , transferred through the side plate to the column, was computed based on the longitudinal stresses in the side plate, the respective area along the depth, and the distance to the beam web centerline. The ratio of M_s to the plastic moment strength of the side plate, M_{ps} , increased with drift (Figure 16(a)), and the ratios at an inter-story drift of 4% were 69 and 72% for Specimens SP2 and SP3, respectively. The ratio of M_s to the beam moment, M_{ABA} , computed at the column face, was 36–38% at an interstory drift of 4% (Figure 16(b)), indicating that about one third of the beam moment was transferred to the column through the side plates, and Specimen SP2 utilizing thicker side plates than Specimen SP3 transferred larger beam moments.
