附錄 B 孔內造影資料

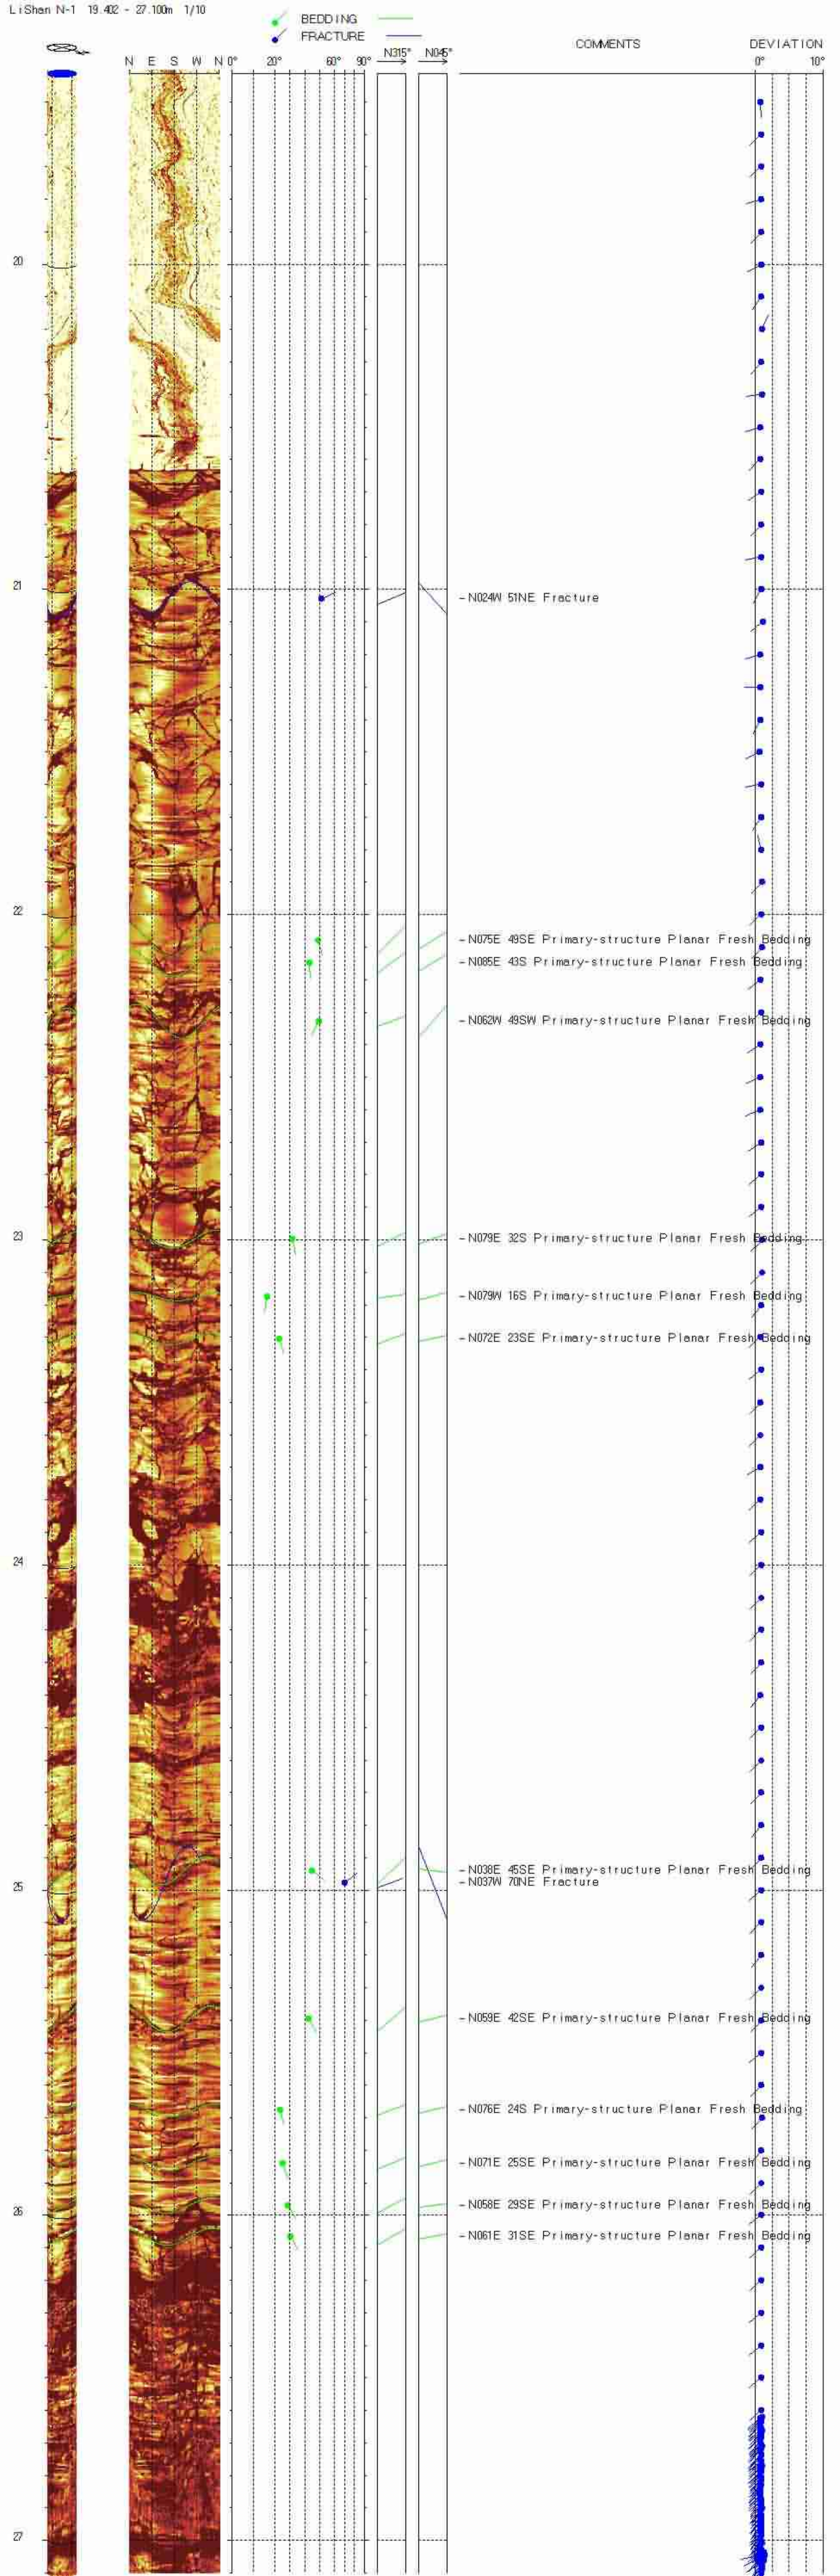
BEDDING FRACTURE GAMMA CPS

COMMENTS DEVIATION

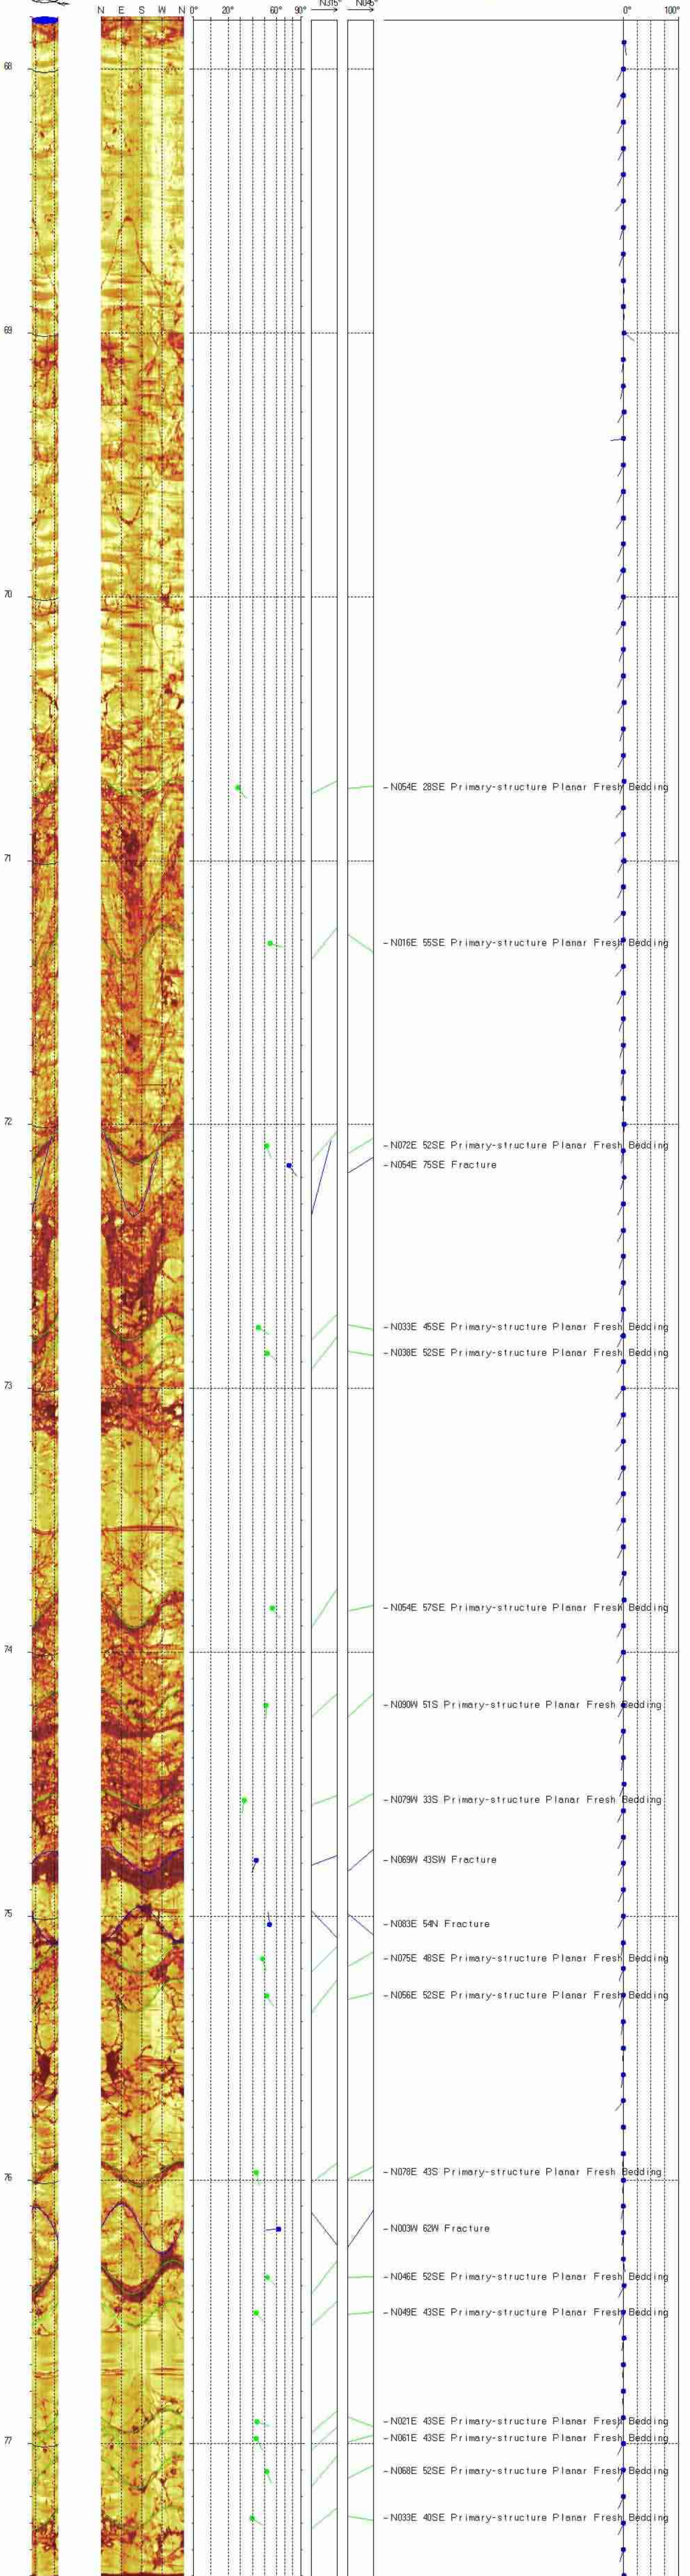
BEDDING
FRACTURE

N315° N045°

COMMENTS

DEVIATION
0° 100°

N E S W N 0° 20° 60° 90°

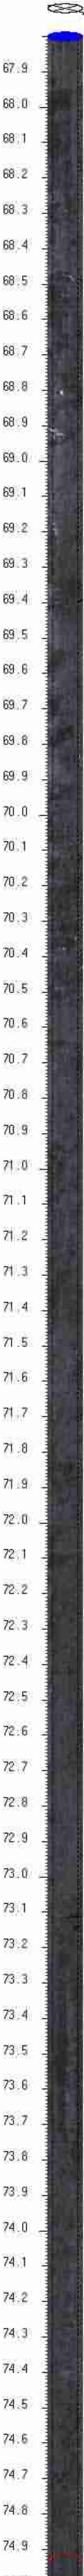
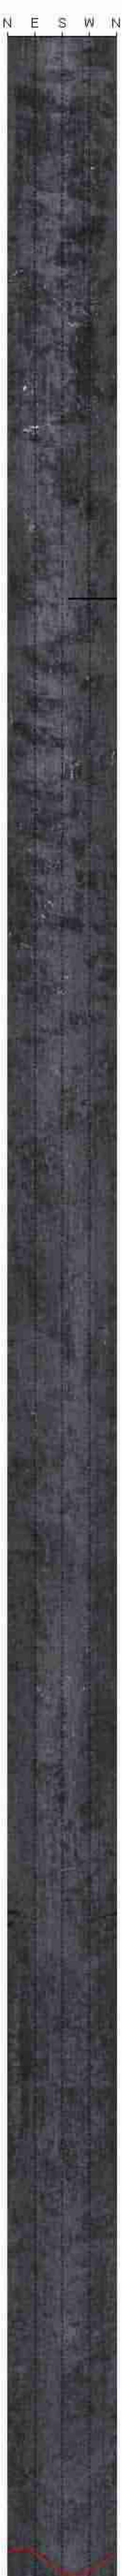
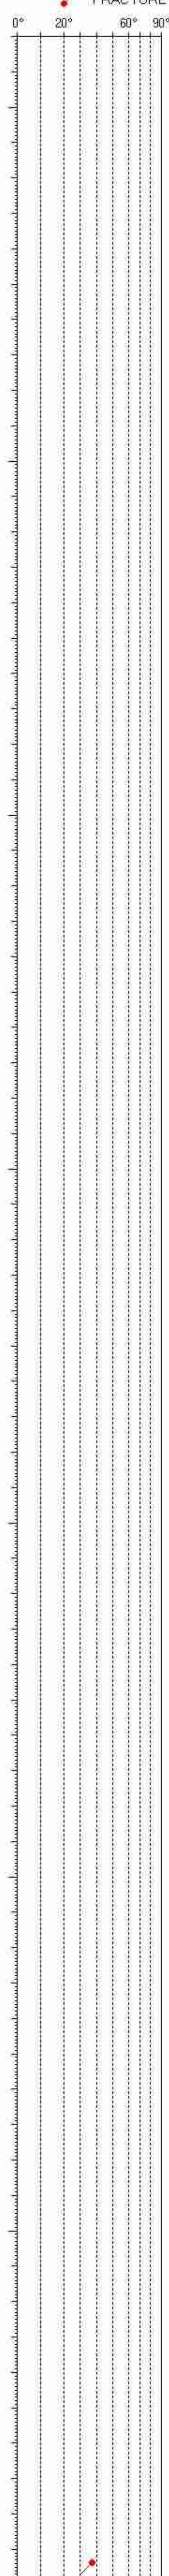
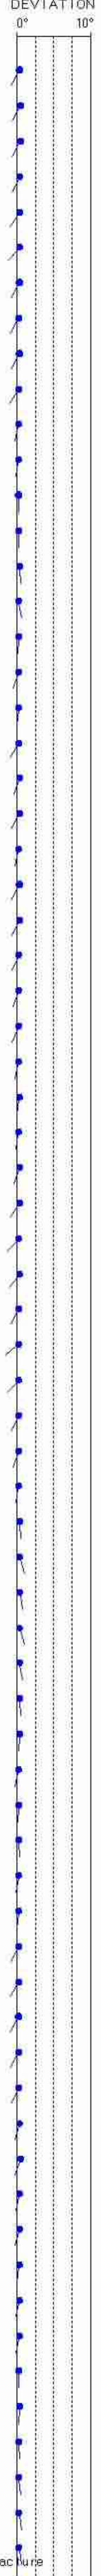
BEDDING
FRACTURE

N315°

N045°

DEVIATION
0° 10°

-N045W 38SW Fracture
